Study of the Localized Nature of Top of the Line Corrosion in Sweet Environment

Marc Singer^{†,*}

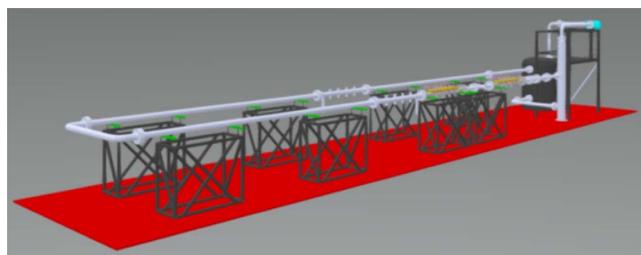
FIGURE 1. Schematic of the wet gas flow loop.

The experiments were performed in a high-temperature, high-pressure, 4-in ID (0.1-m internal diameter) flow loop (Figure 1). The flow loop is

comprised of a large tank (1,000 L) holding the bulk liquid phase, a gas blower (and in some cases a liquid pump), and a system of 4-in ID (0.1-m internal diameter) stainless steel pipes forming a loop. The system is about 30 m in total length. Various monitoring devices (pressure gauge, thermometers, gas flow meter, liquid sampling device) are installed along the pipe system. Several test sections, where the actual corrosion measurements are performed, are located along the pipe system.

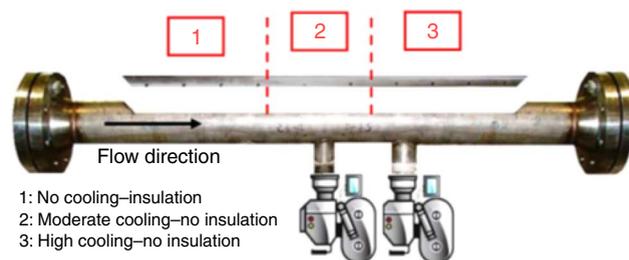
FIGURE 2. Flat slab cooling setup.

The test section utilized for this study was derived from the “flat slab” concept aiming at simulating the large pipe curvature of a 30-in ID (0.76-m internal diameter) pipeline—a size commonly encountered in oil and gas fields—which is much closer to a flat surface than the 4-in ID pipe. A portion of a pipe section was especially manufactured in order to enable the insertion of a thick, flat stainless steel slab about 1 m long (Figures 2 and 3). The stainless steel slab and the pipe were sealed together using a thermally resistant silicon resin. On top of the stainless steel slab lay an aluminum slab containing a cooling system that enabled the control of the condensation rate. A set of thermistors embedded in the stainless steel component was used to monitor the steel temperature and compute the condensation rate on each section. The condensation rate was determined by measuring the difference in temperature between the gas and the pipe wall’s inner surface using a model developed by Zhang, et al.²³

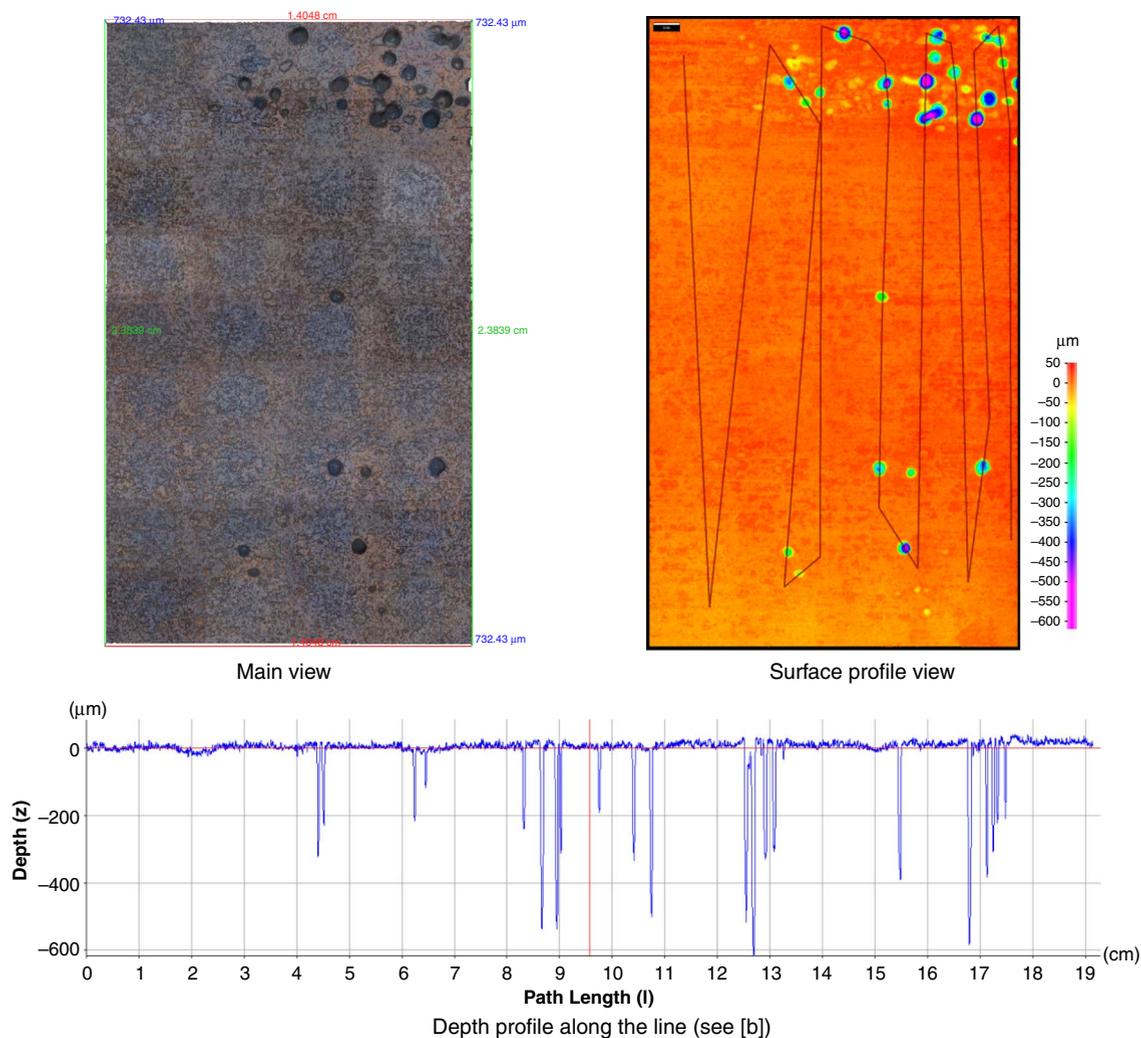
FIGURE 4. Test No. 1: 65°C—Surface profile analysis. Upstream section—Low condensation (0.13 mL/m²/s).

These initial observations were confirmed with the surface analysis on the bare steel shown in Figures 4 through 6 (once the corrosion product layer was removed using an inhibited acid solution³¹). The section of the insert exposed to a low condensation rate did present some pitting corrosion, but the pits were fairly isolated. In the middle section exposed to a medium condensation rate (not shown in this publication), the pitting density increased. The pits seemed to coalesce in the section exposed to a high condensation rate, which also showed severe mesa attack (localized corrosion with flat bottom features). The relationship between condensation rate and localized corrosion is, therefore, clearly demonstrated in this experiment. These corrosion features very much resemble what is observed in real field situations.¹

Average, minimum, and maximum localized corrosion rates were extracted from the 3D profile analysis of selected areas thought to be representative. The localized corrosion data are presented in Figure 7(a) and compared to experimental data obtained under the same conditions but for an exposure time of 21 d.¹⁸ The “21-day” experimental data were

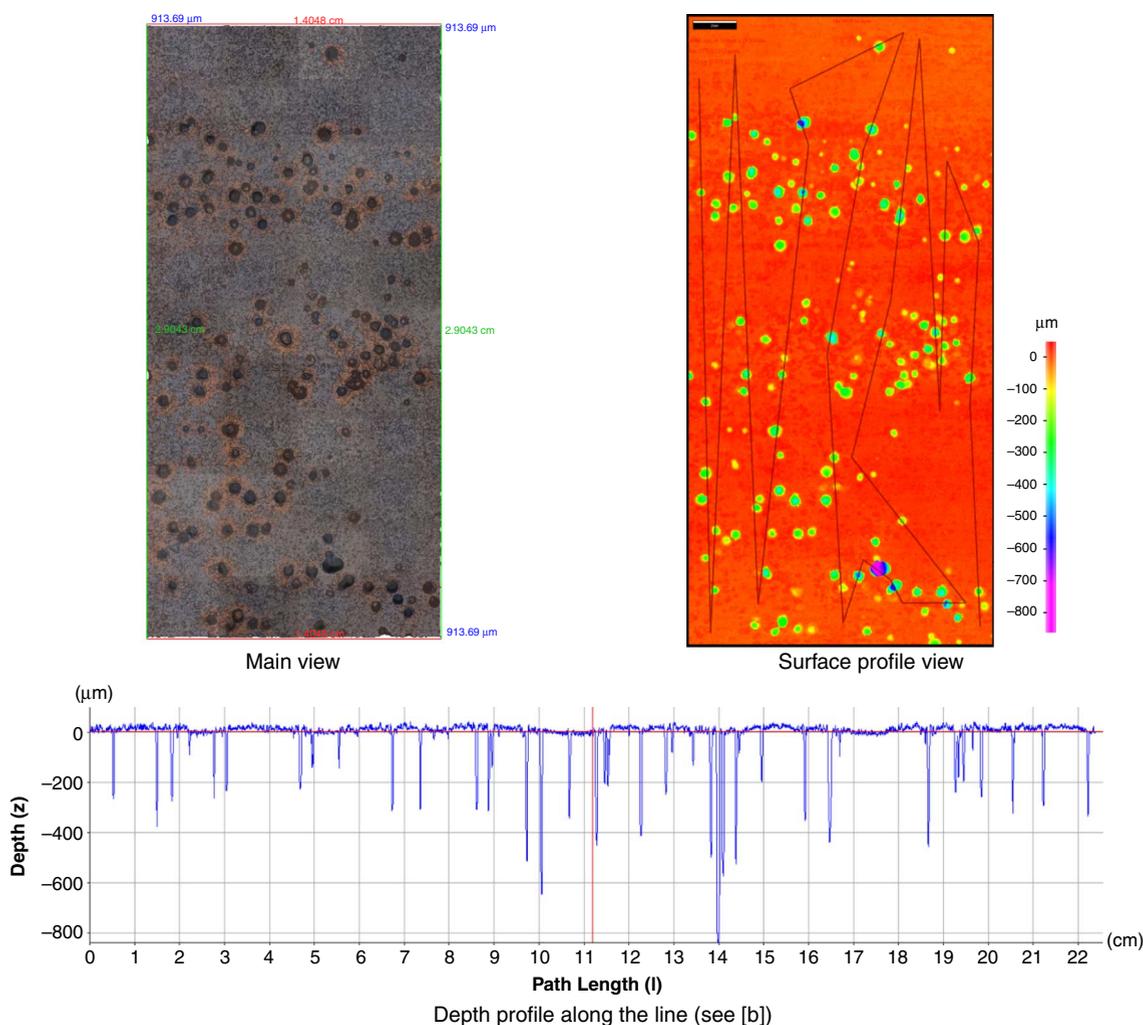
FIGURE 5. Test No. 1: 65°C—Surface profile analysis. Middle section—Medium condensation (0.41 mL/m²/s).

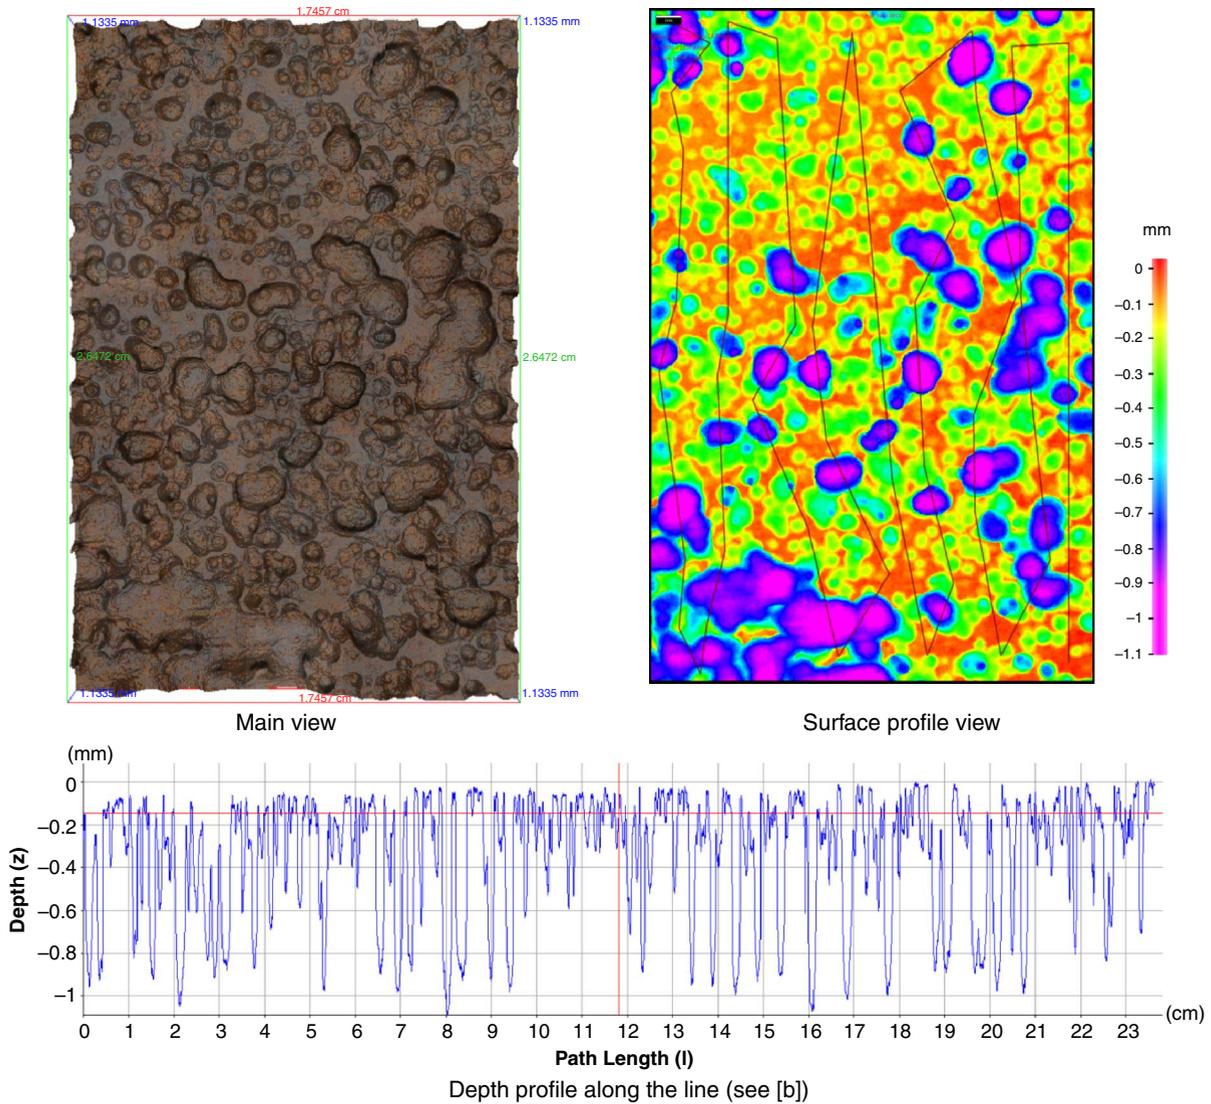
FIGURE 6. Test No. 1: 65°C—Surface profile analysis. Downstream section—High condensation (0.9 mL/m²/s).

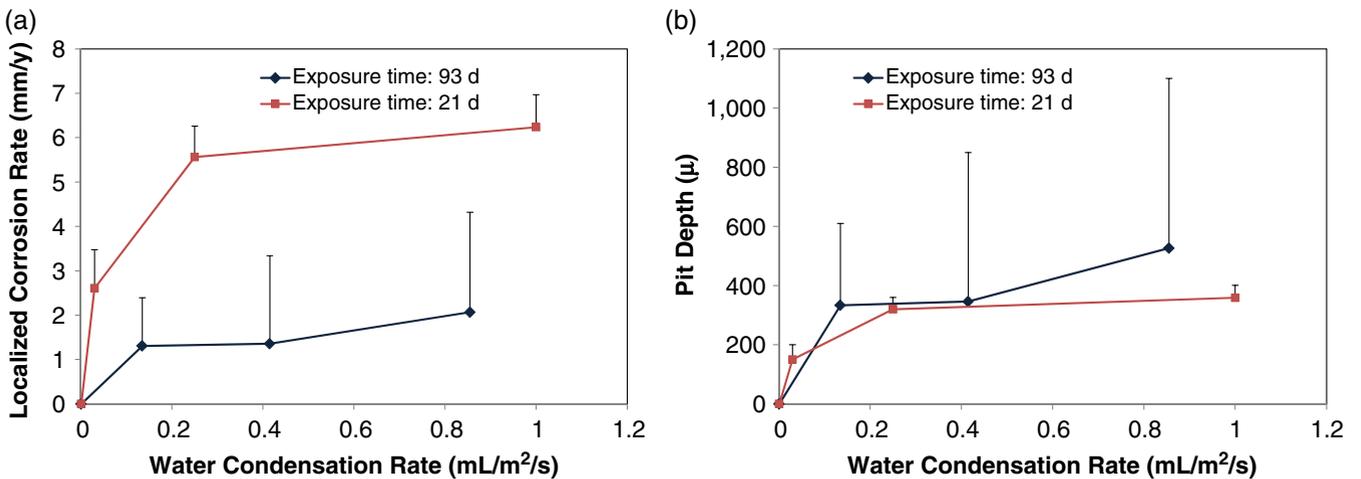
FIGURE 7. Test No. 1: 65°C. Left: Influence of the condensation rate on the localized corrosion rate. Right: Influence of the condensation rate and the exposure time on the pit/mesa depth.

obtained by performing a surface profile scan on weight loss samples. Comparing the data obtained after 21 d and 93 d of exposure, the localized corrosion rates (or more accurately—the steel penetration rates) clearly increase with the WCR but also decrease with time. Another way to compare the two sets of data is to plot the actual feature depth versus the condensation rate (Figure 7[b]). It is interesting to note that at condensation rates lower than 0.4 mL/m²/s, the average feature depth after 21 d and 93 d of exposure is very similar. It could mean that the pit or mesa attack penetration rate significantly slowed down after 21 d of exposure. At a condensation rate of 1 mL/m²/s, the localized attack depth measured after 93 d of exposure is almost 50% higher than the one measured after 21 d of testing. The hypothesis here is that TLC may have significantly slowed down at a condensation rate below 0.4 mL/m²/s, while it did not at a condensation rate of 1 mL/m²/s. This is in some ways consistent with field observations, noting the existence of a “threshold” WCR in sweet environments below which TLC is not

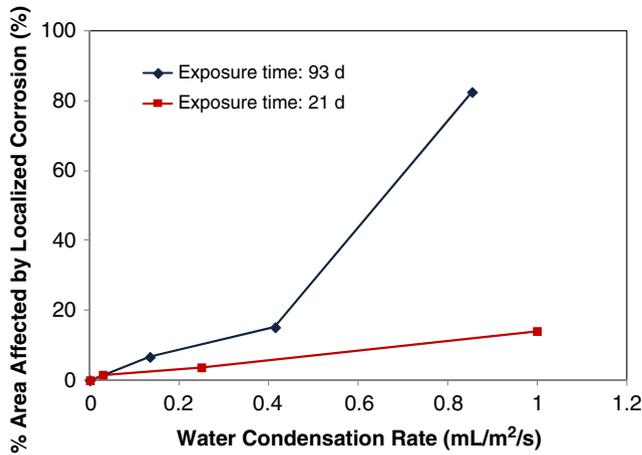
FIGURE 8. Test No. 1: 65°C—Influence of the condensation rate on the percentage of the steel surface area affected by localized corrosion.

The percentage area affected by localized corrosion could also be measured on the steel surface; the results are displayed in Figure 8 and compared with data obtained for 21 d of exposure. It is clear that, with time, a higher proportion of the steel surface area is corroded when the WCR is high. Again, this is in agreement with field observations, which seem to show that, although TLC corrosion features’ depth may not progress at a fixed rate, their numbers do increase with time.⁷ As the features grow in number, they coalesce, and the steel surface becomes more uniformly attacked. This is clearly demonstrated by the data collected in Figure 8, which shows the number of pits per surface area increasing with condensation rate, together with the average feature diameter. The maximum depth of the feature does increase as well, but to a lesser extent.

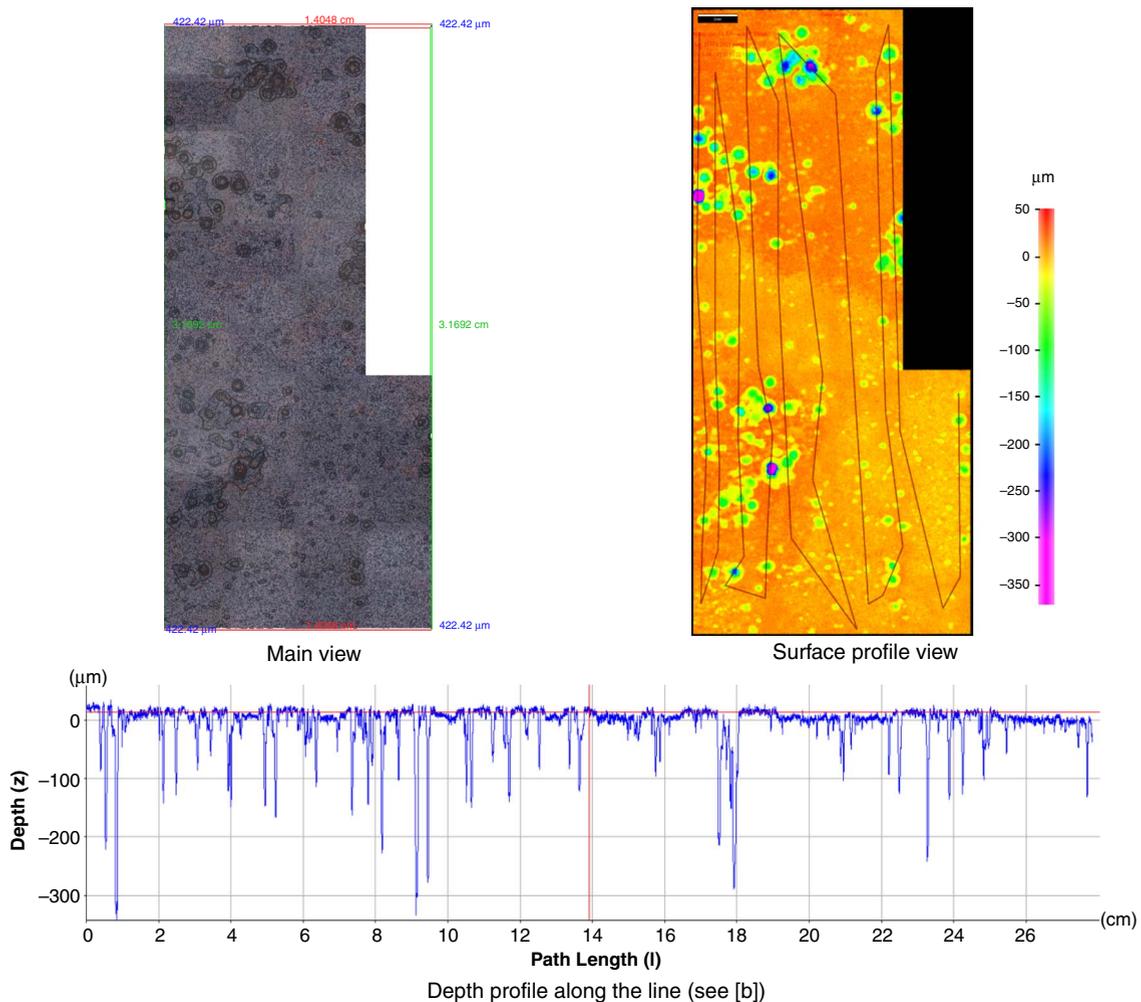
FIGURE 9. Test No. 2: 45°C—Surface profile analysis. Upstream section—Low condensation rate: 0.1 mL/m²/s.

Large areas of the steel slab were scanned using a 3D surface profilometer, and data on pit depth were collected (Figures 9 and 10). The effect of the condensation rate is clear, as the number of pits and the area affected by localized corrosion rate increased with the condensation rate.

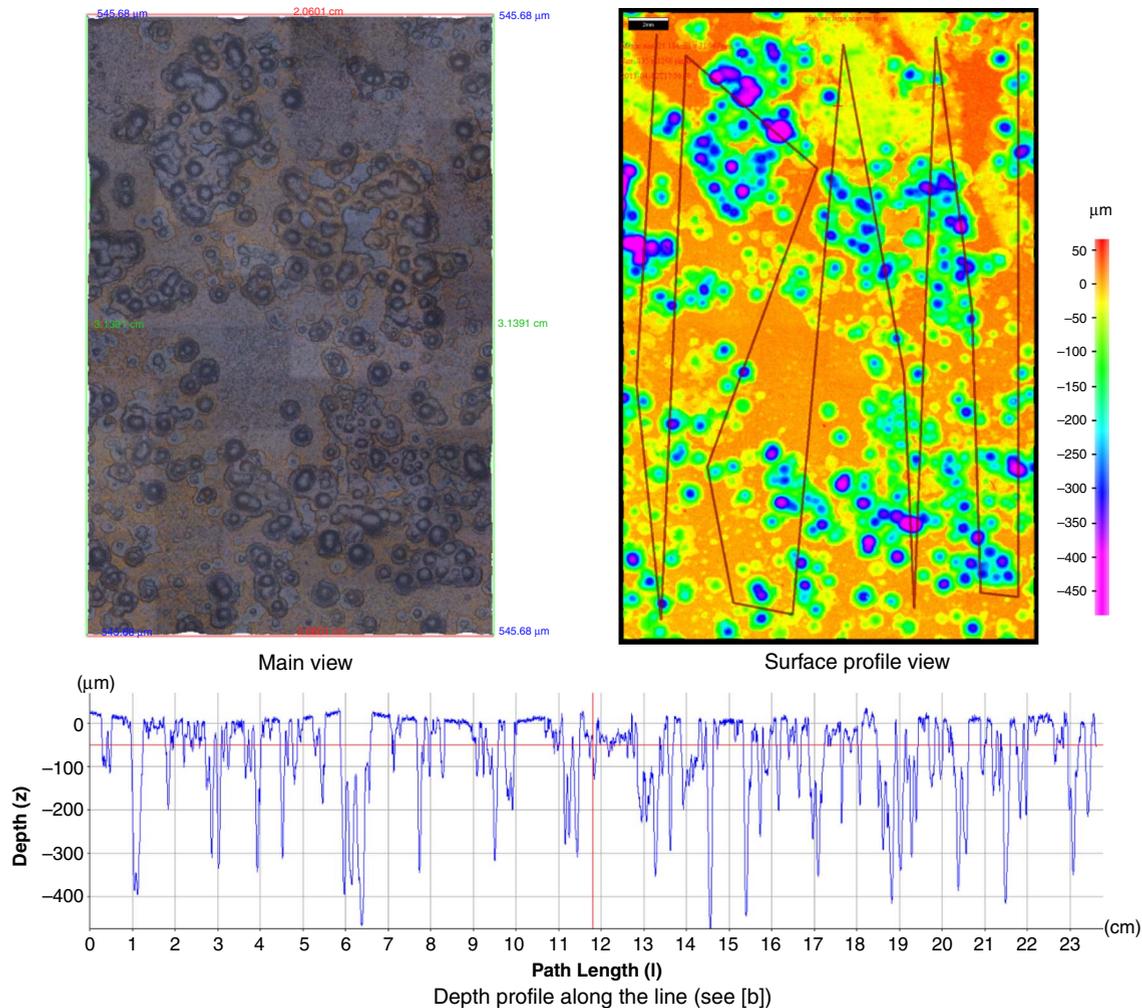
FIGURE 10. Test No. 2: 45°C—Surface profile analysis. Downstream section—High condensation rate: 0.23 mL/m²/s.

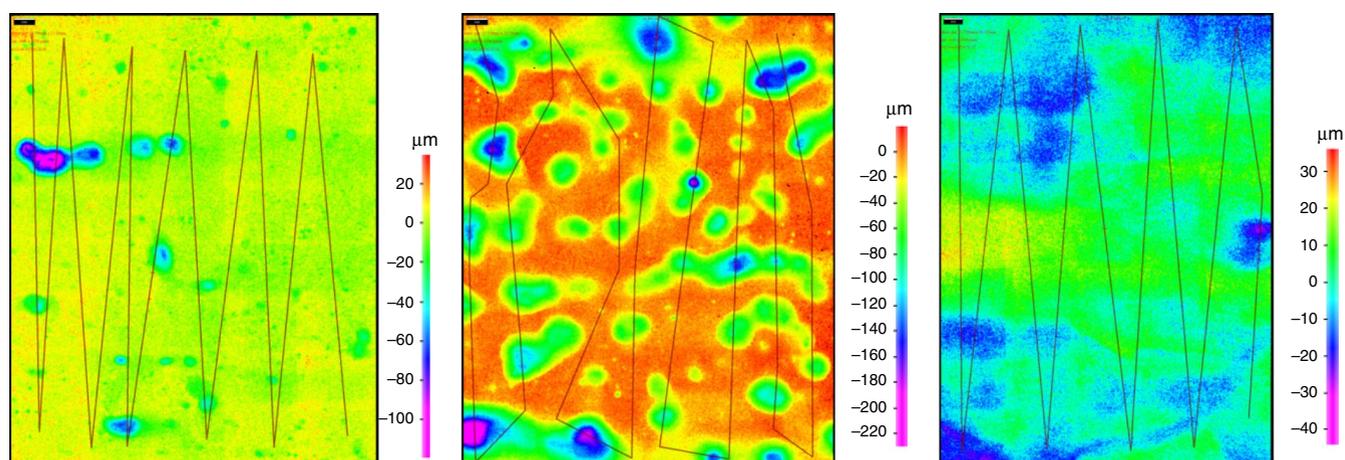
FIGURE 11. Test No. 3: 25°C—Surface profile analysis after the removal of the corrosion product layer. Left: Upstream section—Low condensation ($0.04 \text{ mL/m}^2/\text{s}$). Middle: Middle section—Medium condensation ($0.06 \text{ mL/m}^2/\text{s}$). Right: Downstream section—High condensation ($0.1 \text{ mL/m}^2/\text{s}$).

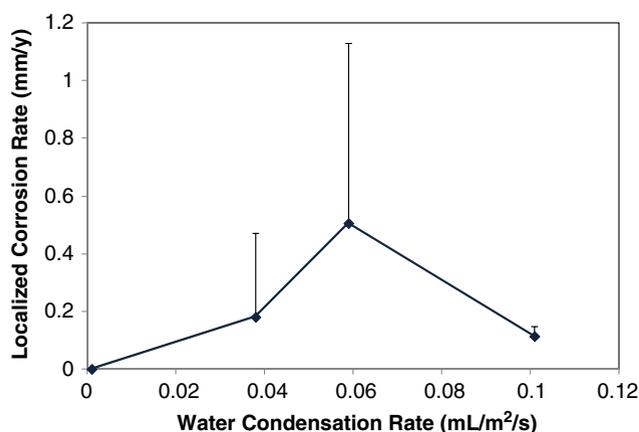
FIGURE 12. Test No. 3: Influence of the condensation rate on the pit/ mesa depth.

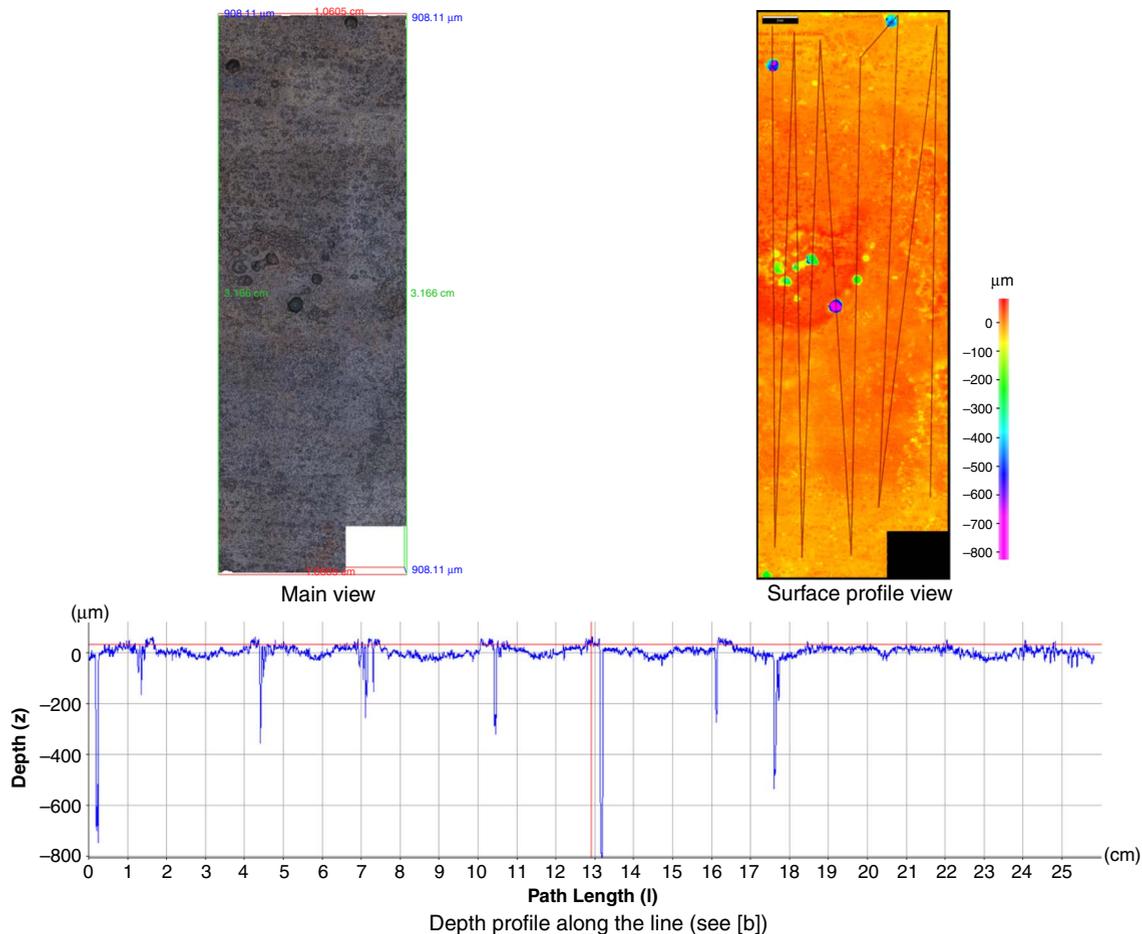
FIGURE 13. Test No. 4: 1,000 ppm CH_3COOH —Surface profile analysis. Upstream section—Low condensation rate: $0.2 \text{ mL/m}^2/\text{s}$.

The surface profile analysis was performed on the steel samples after the removal of the layer (Figures 13 and 14). The extent of the corrosion on the

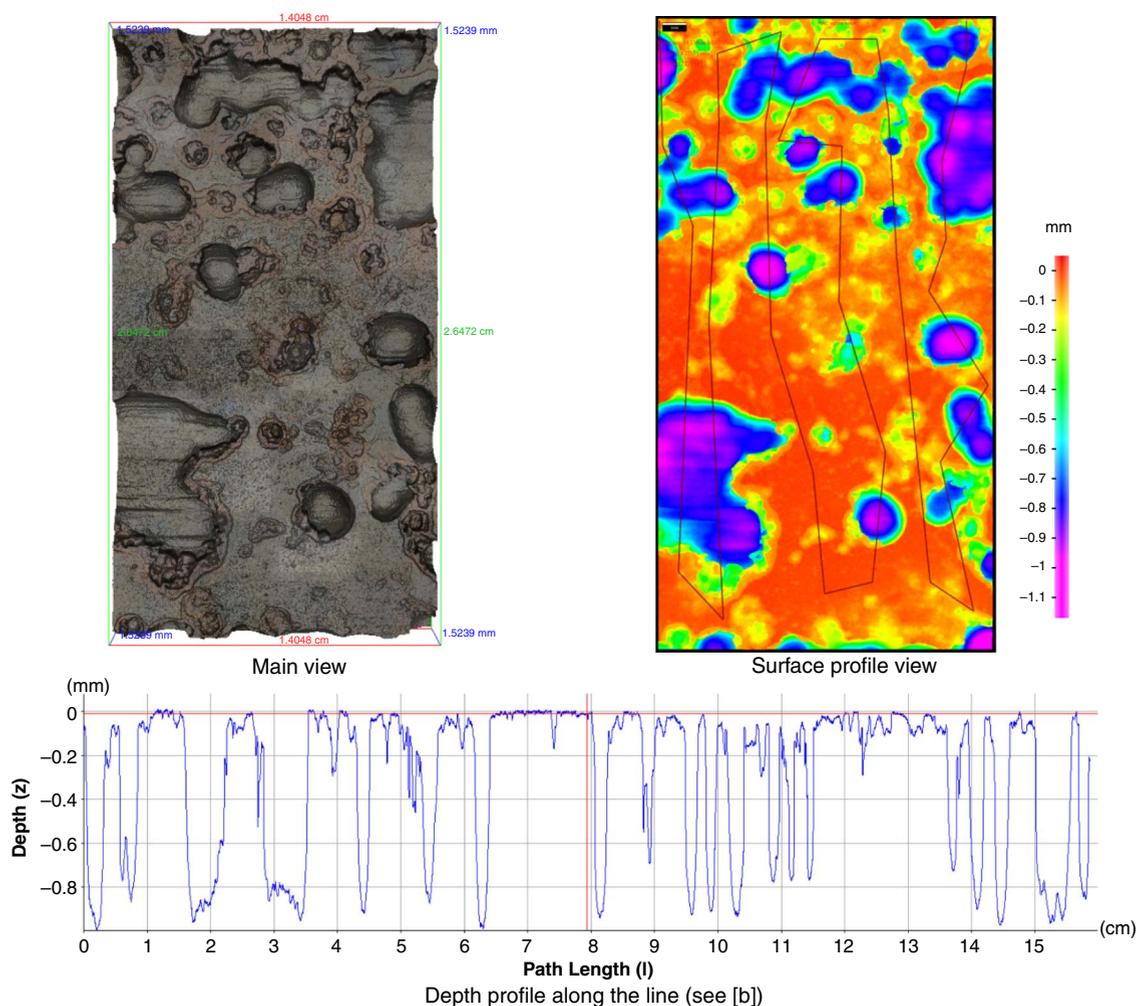
FIGURE 14. Test No. 4: 1,000 ppm CH_3COOH —Surface profile analysis. Downstream section—High condensation rate: $0.7 \text{ mL/m}^2/\text{s}$.

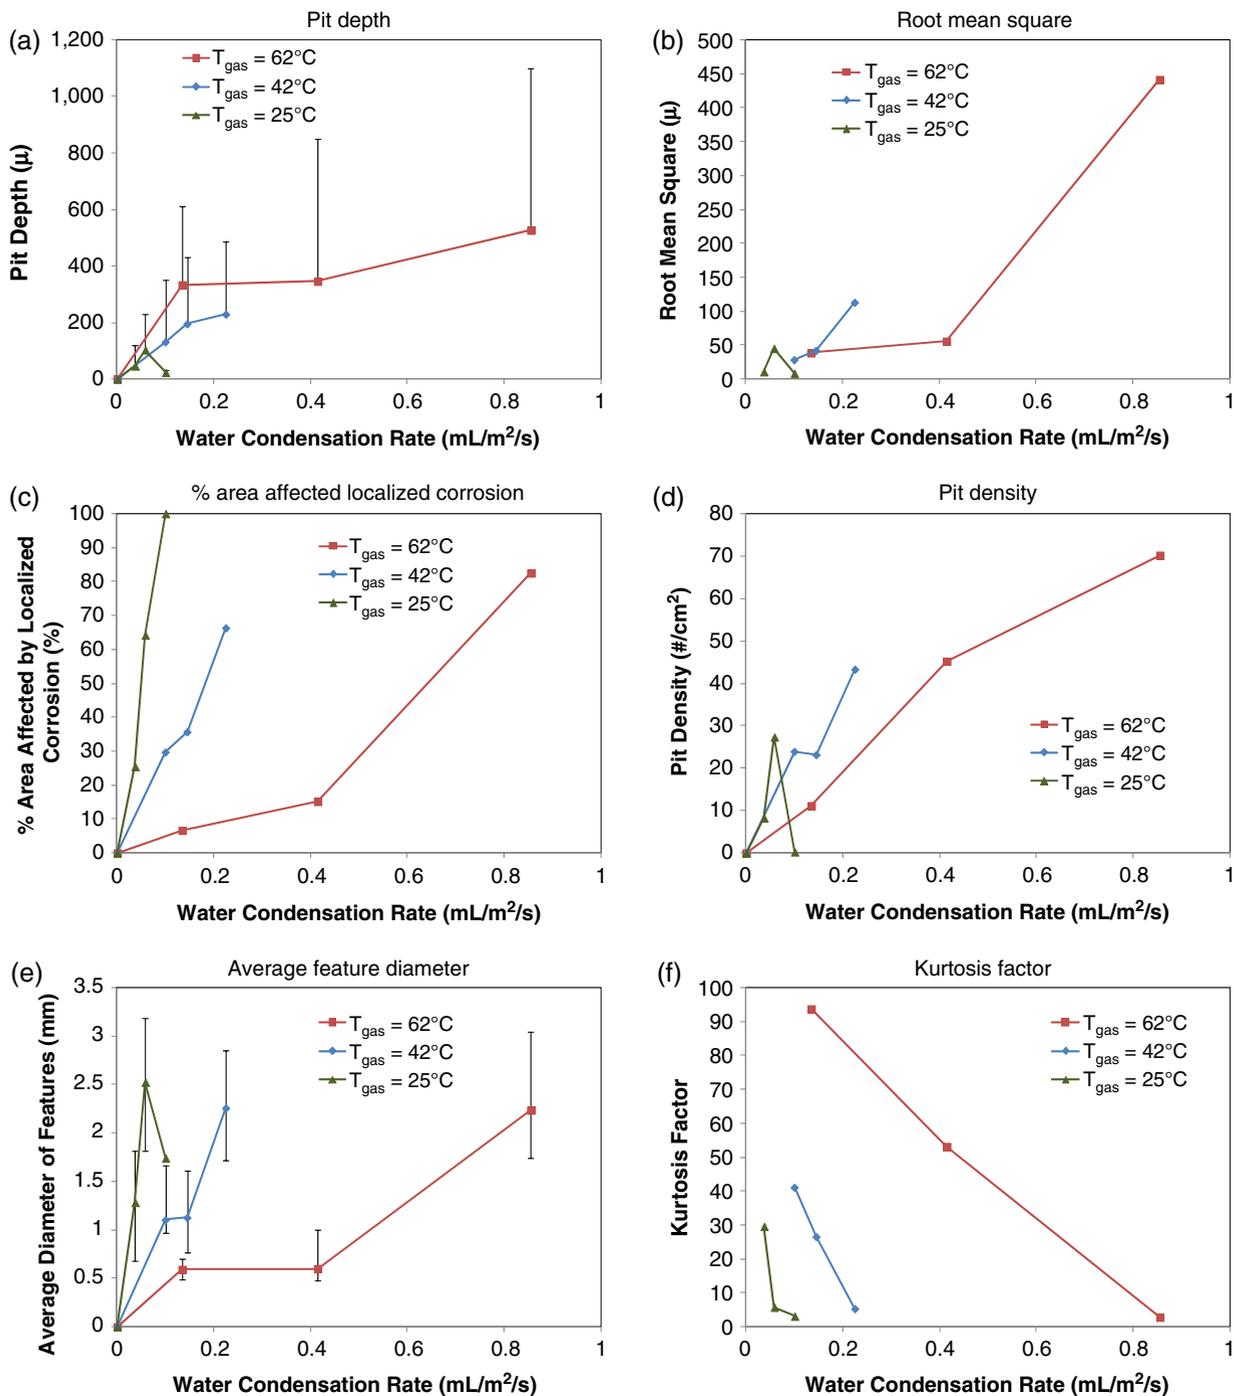
FIGURE 15. Influence of the gas temperature and the WCR. Summary of results.

Figure 15(a) shows the effect of the water condensation on the localized corrosion rates. The WCR depends on the gradient of temperature between the outside environment (steel surface) and the bulk gas. Consequently, the effect of water condensation and steel surface or gas temperature cannot be treated separately. The following comments are made:

- Low WCR is often associated with high steel surface temperature (small gradient of temperature) and leads to the formation of an adherent and protective FeCO_3 layer. At very low gas temperature, kinetics of FeCO_3 formation are not favored, but supersaturation is still easily reached because of the relatively low rate for condensed water renewal. FeCO_3 can precipitate, and pits can initiate but do not seem to progress with time.
- High WCR is often associated with lower steel surface temperature (larger gradient of temperature). Two sub-cases are then identified:

- If a partially adherent/protective FeCO_3 layer forms (as a result of moderate steel temperature), localized corrosion is initiated and can be very severe.
- If the steel temperature is too low to form an adherent corrosion product layer, localized corrosion cannot be initiated and the corrosion is uniform.
- At lower gas temperature, high WCRs are difficult to achieve, as the water vapor pressure is lower. However, for a fixed WCR, the average and maximum localized corrosion rates are only marginally higher at higher temperature.

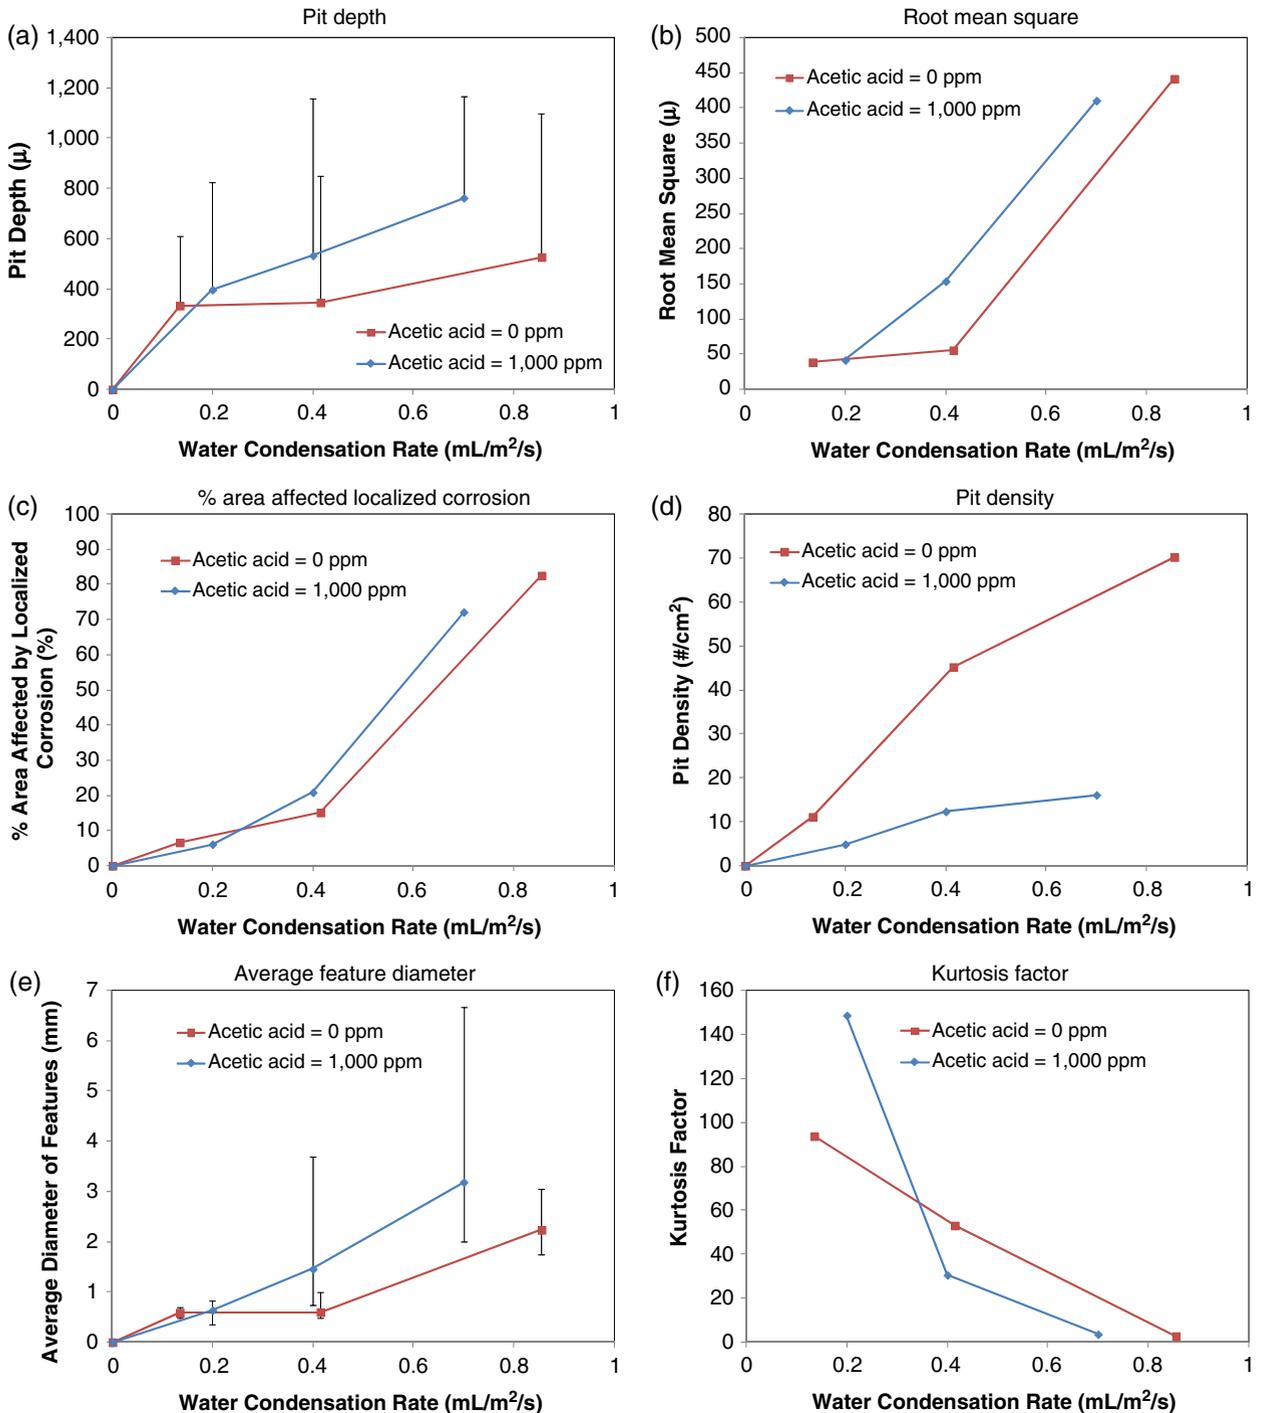
FIGURE 16. Influence of the acetic acid concentration and the WCR. Summary of results.

the steel surface affected by localized corrosion (Figure 16[c] and [e]). Because the solution is more aggressive, pits seem to cluster more easily and mesa type attack is more wide spread. The decrease in pitting density with acetic acid (Figure 16[d]) is a result of the increase in feature size.

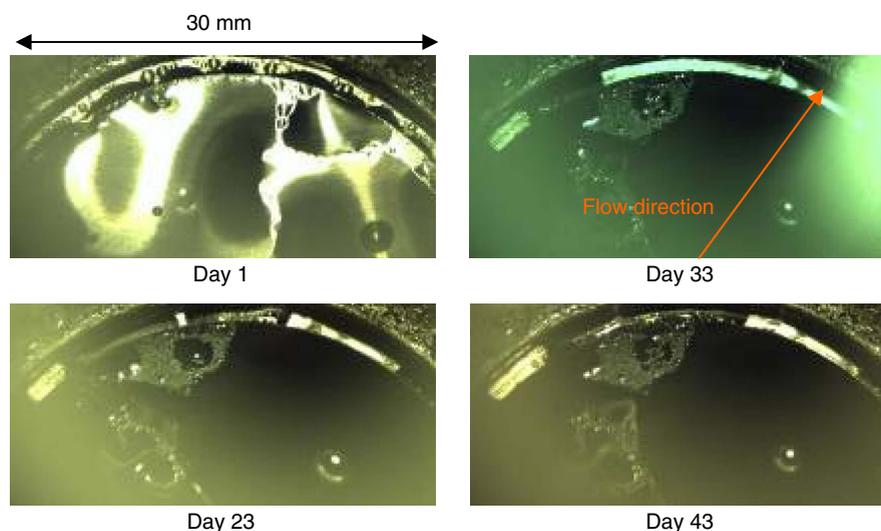
FIGURE 17. Localized corrosion test—Condensation process. A droplet of condensed water always forms at the same location.

undissociated acetic acid: 1,000 ppm, gas velocity: 4 m/s. As in Figure 17, a large droplet was always present on the steel surface more or less at the same location on the sample.

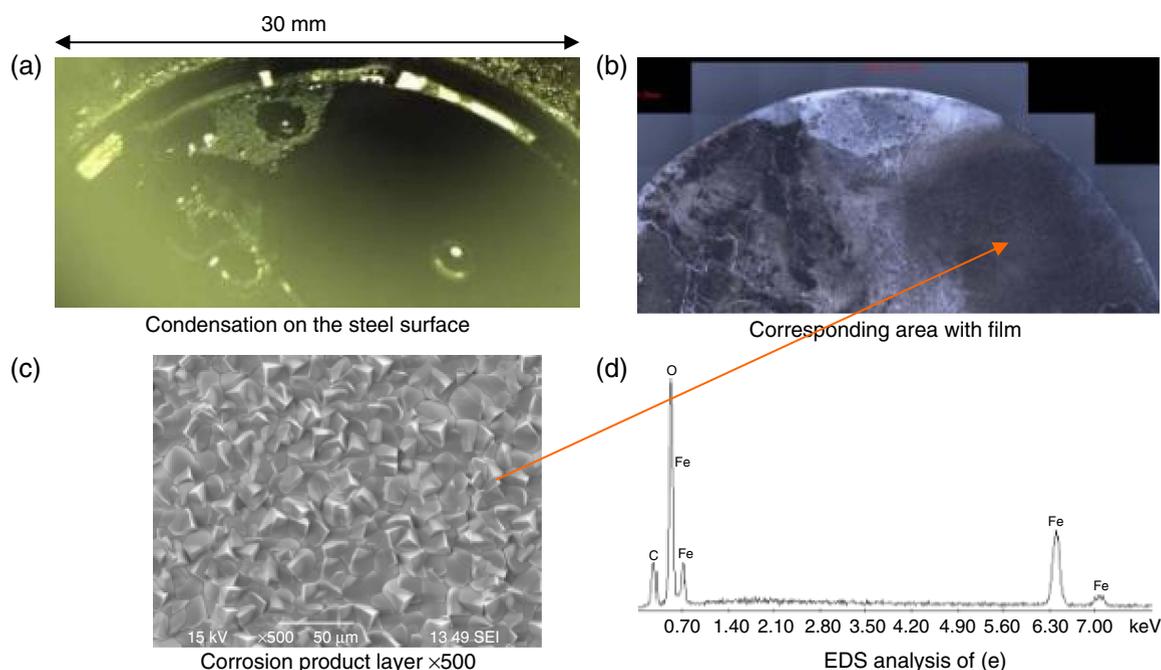
FIGURE 18. Surface analysis of the surface wetted by the droplet.

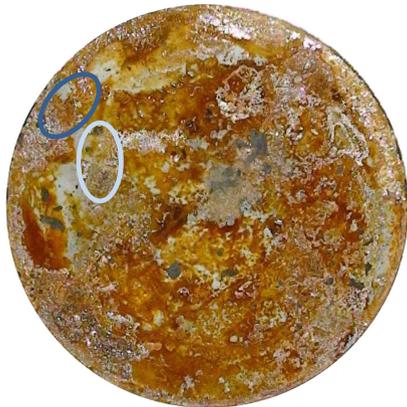
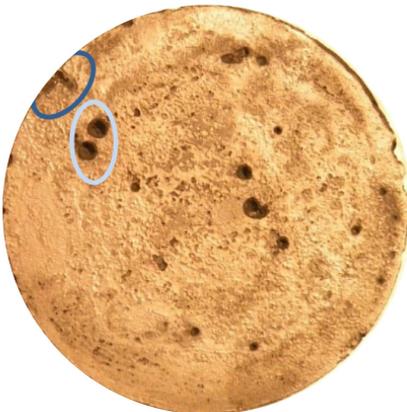
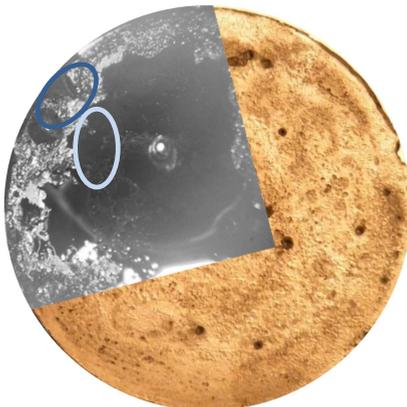
Picture of the sample before removal of the corrosion product layer

Picture of the sample after removal of the corrosion product layer

Picture of the droplet of condensed water super imposed on the sample steel surface after removal of the corrosion product layer

FIGURE 19. Interaction between corrosion product, condensation process and pitting.

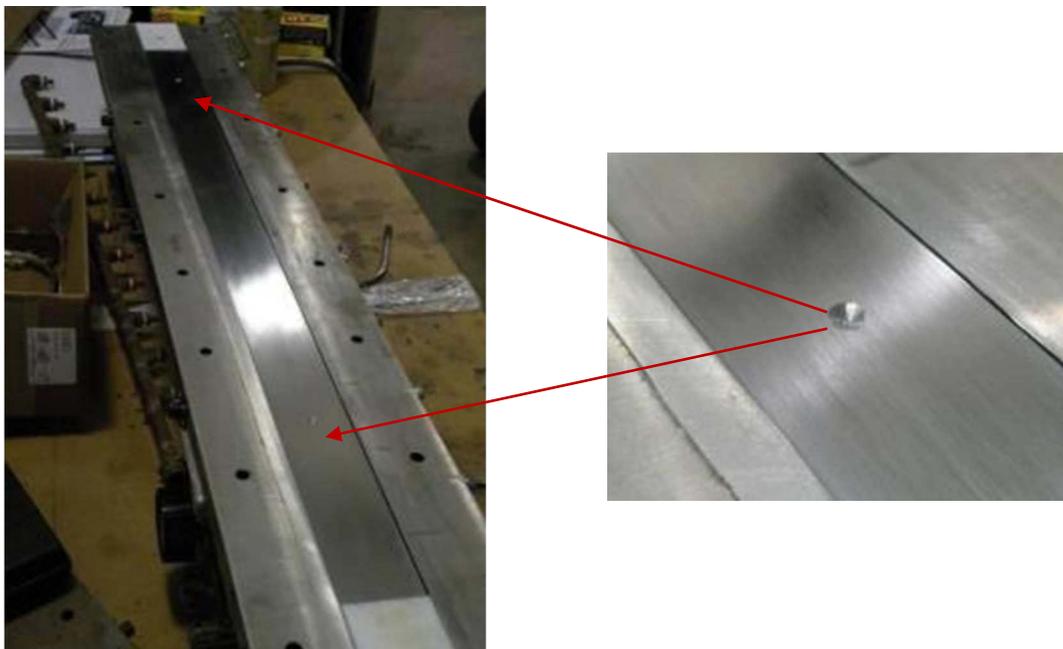
FIGURE 20. Artificial indentations created on the steel insert before the beginning of the test.

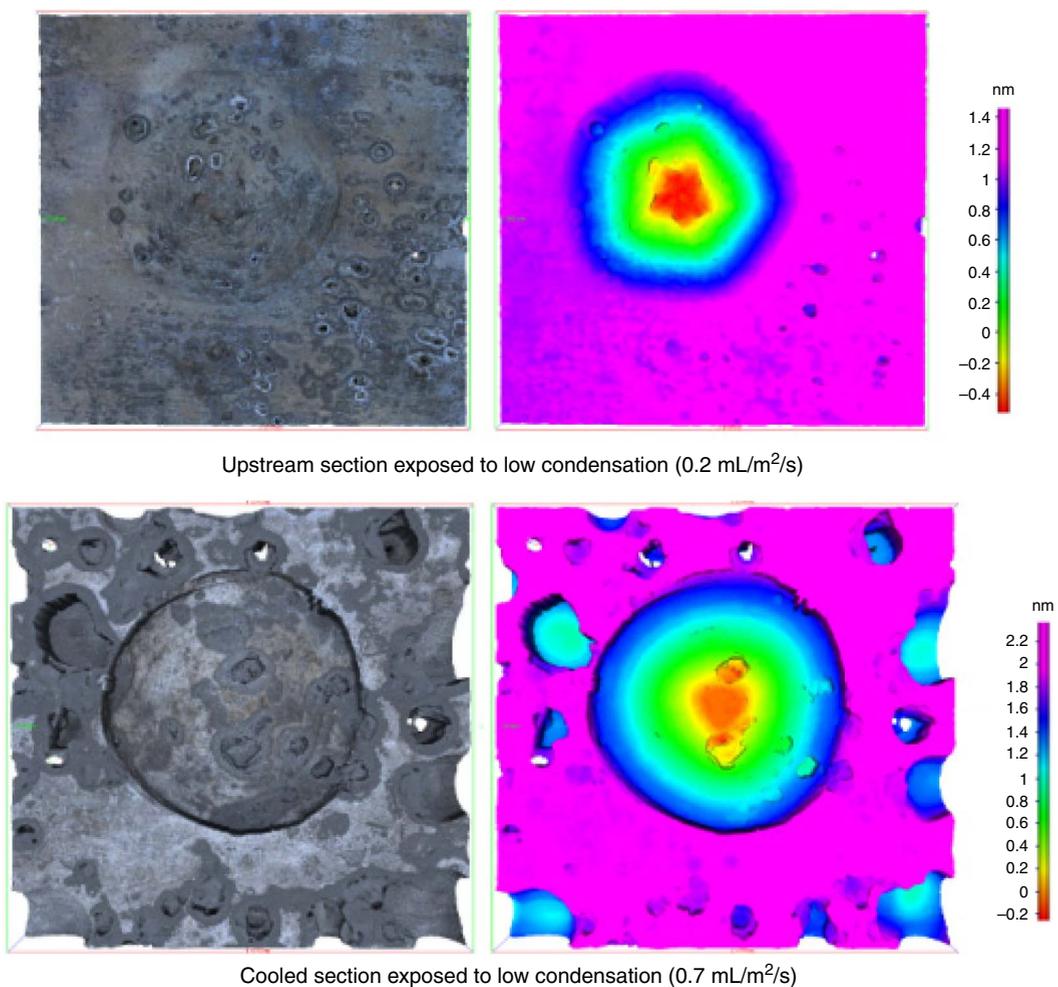
FIGURE 21. Morphology of the artificial indentation after the end of the experiment.

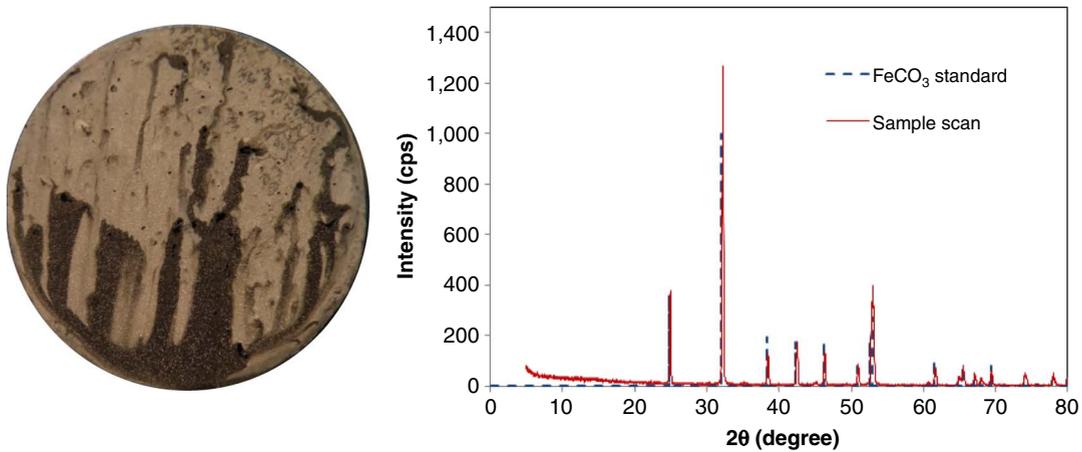
FIGURE 22. Weight loss sample with corrosion product layer (right) and XRD analysis identifying the presence of FeCO_3 (left).

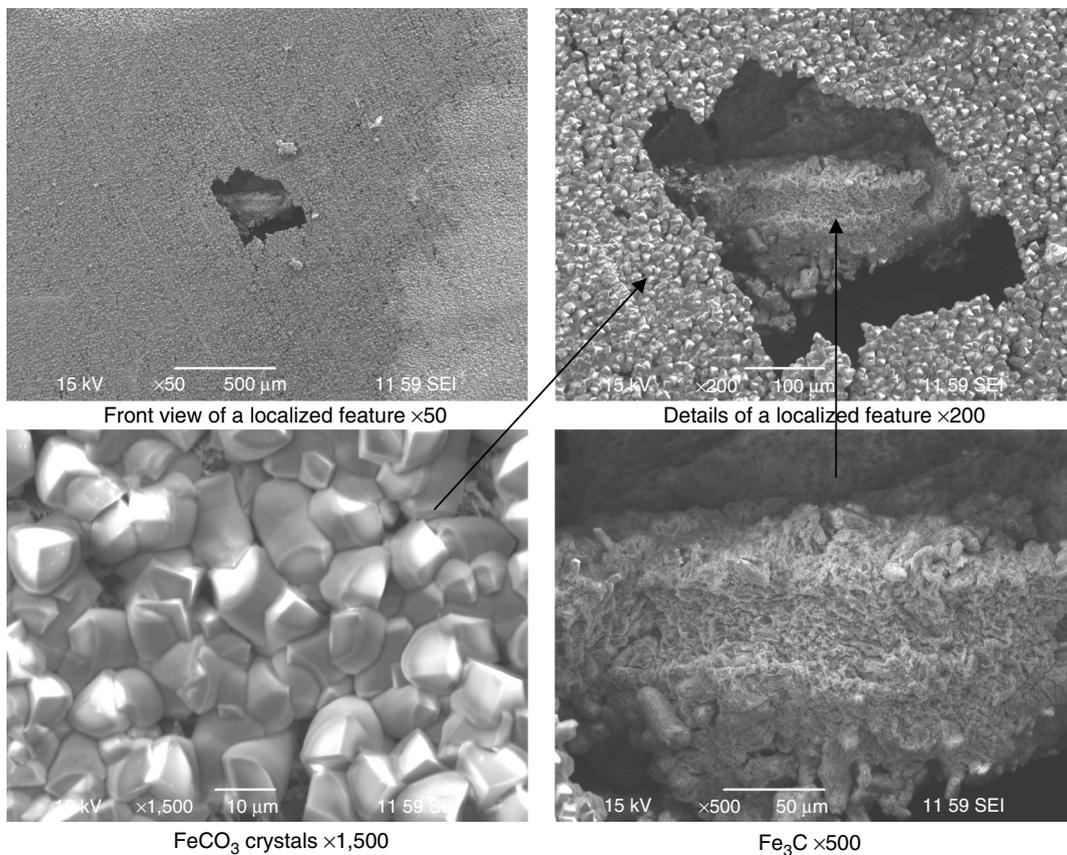
FIGURE 23. EDS analysis of the corrosion product layer and associated breakdowns.

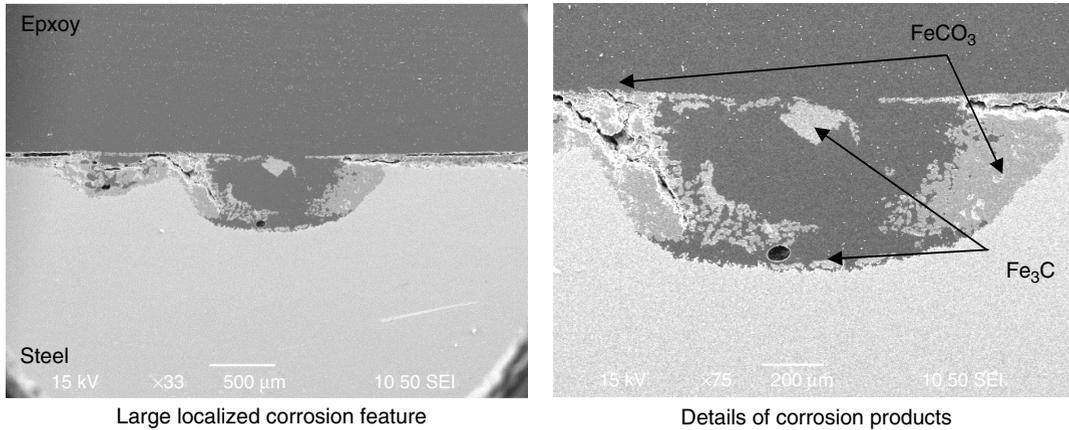
FIGURE 24. Cross-section analysis—Morphology of large localized features.

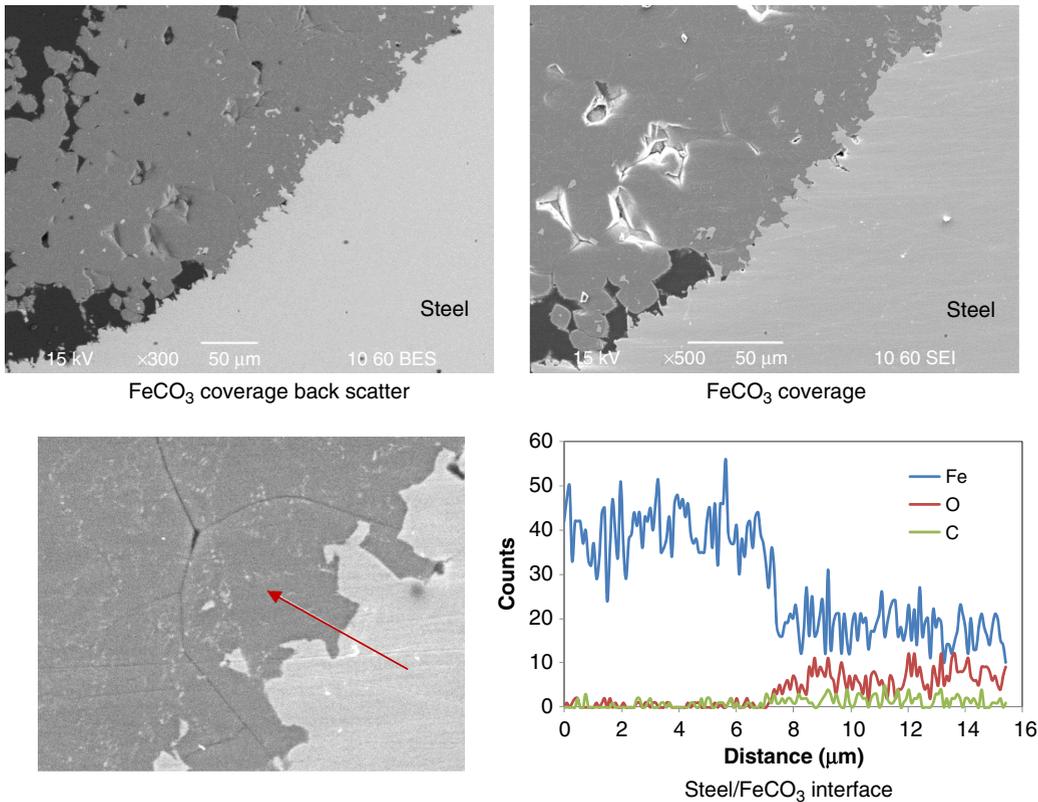
FIGURE 25. Cross-section analysis— FeCO_3 coverage on the side of the localized feature and EDS Line scan (along the red line).

Large amounts of $FeCO_3$ crystals were encountered on the side walls of the pits (Figure 25). $FeCO_3$ seemed to precipitate preferentially on already formed $FeCO_3$ crystals, rather than on the bare steel surface.
