Study of the Localized Nature of Top of the Line Corrosion in Sweet Environment

Marc Singer^{†,*}

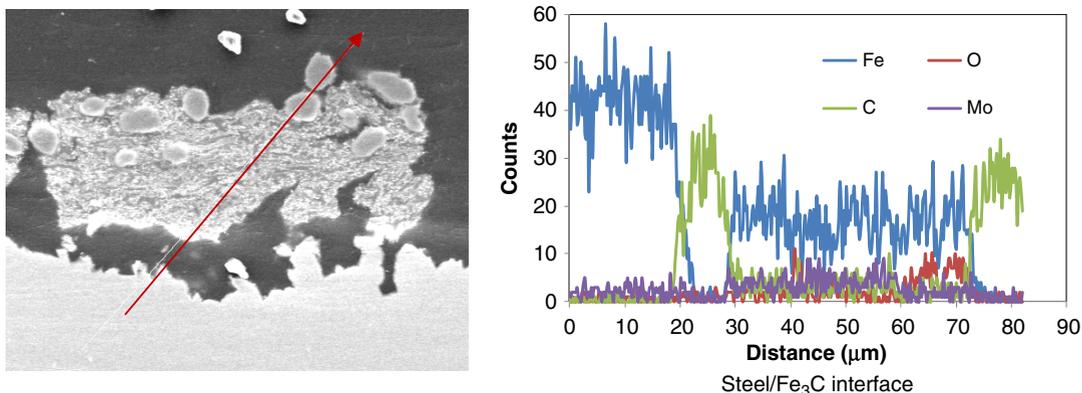
FIGURE 26. Cross-section analysis— Fe_3C coverage on the side of the localized feature and EDS Line scan (along the red line).

This was especially true if the corrosion rate was high and the undermining effect considerable. On the areas well covered by FeCO_3 , the crystals were tightly packed and formed an effective mass transfer barrier. Pearlite lamellae were superimposed onto the FeCO_3 crystal network (Figure 25[d]). Fe_3C was identified at the bottom or at the center of the pit. This was not an indication that the pH inside the pit was acidic. It was, rather, an indication that FeCO_3 did not precipitate at that specific location (Figure 26). A line EDS

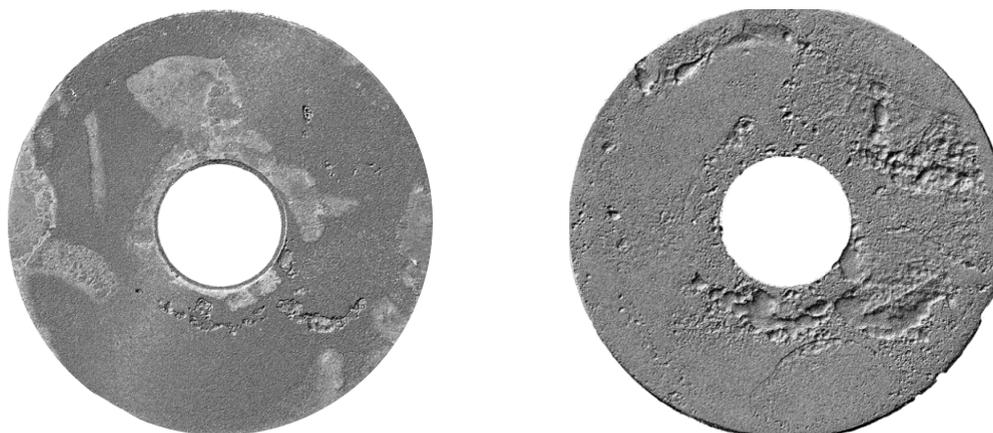
3D profile before removal of the corrosion product layer

FIGURE 27. Localized corrosion features growth underneath FeCO_3 layer. $T=70^\circ\text{C}$, WL X65, $\text{HAc}=0$ ppm, $\text{WCR}=1$ $\text{mL/m}^2/\text{s}$, Exposure time = 21 d.

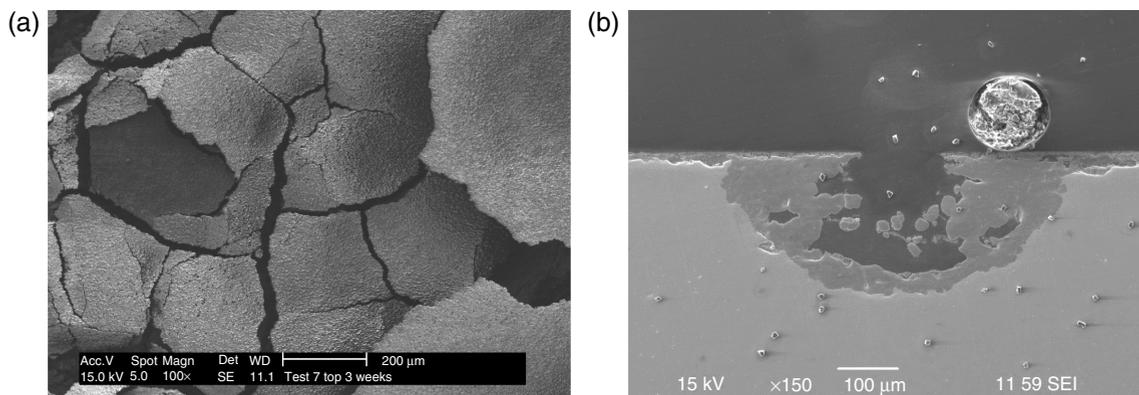
FIGURE 28. FeCO_3 top layer collapsing (a) and FeCO_3 layer regaining coverage on the metal surface (b) $T = 70^\circ\text{C}$, WL X65, $\text{HAc} = 1,000$ ppm, $\text{WCR} = 1$ $\text{mL/m}^2/\text{s}$, Exposure time = 21 d.

Localized Corrosion Termination/Sustainability — Figure 28(b) presents a cross section of a TLC localized feature whose bottom part seems to be well covered by an FeCO_3 layer and, therefore, protected against further corrosion. This shows that not all of the TLC features remain “active” throughout the exposure to the corrosive environment. The reason behind such behavior is unclear but could be a result of mass transfer limitation, which would make FeCO_3 precipitation more likely at the bottom of deep and narrow
