Removal of Iron Carbide in Turbulent Flow Conditions and Influence of Iron Carbonate Formation in Aqueous CO₂ Corrosion of Mild Steel

Maria C. Di Bonaventura, * ** *** Bruce Brown, * Marc Singer*

* Institute for Corrosion and Multiphase Technology, Department of Chemical and Biomolecular Engineering, Ohio University, Athens, OH 45701, USA

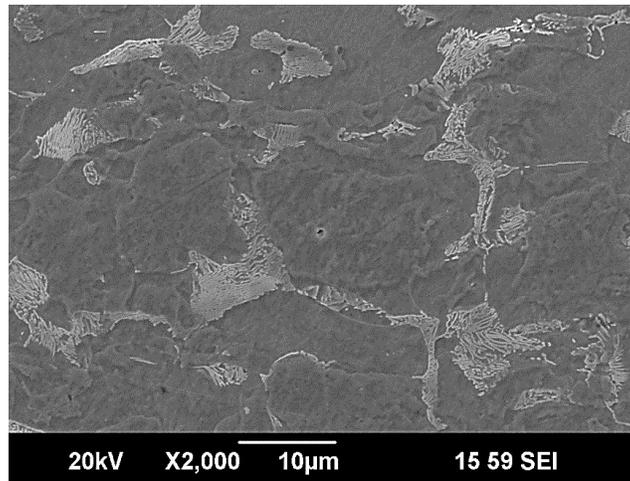
Figure 2. SEM image of ferritic-pearlitic microstructure of UNS G10180^{2,3}

When considering steels with less than 0.76 wt.% C with a ferritic pearlitic microstructure, as shown in Figure 1, the microconstituents are proeutectoid ferrite and pearlite colonies, which are alternating lamellar-like layers of α-ferrite and Fe₃C.^{2,3} Clover, *et al.*,⁴ have demonstrated that corrosion rate depends on material microstructure when the reduction reaction is hydrogen reduction.. It was found that a ferritic-pearlitic microstructure experiences localized corrosion, whereas a tempered martensite or ferritic microstructure undergoes uniform corrosion,⁴ due to preferential corrosion of the ferrite over Fe₃C.

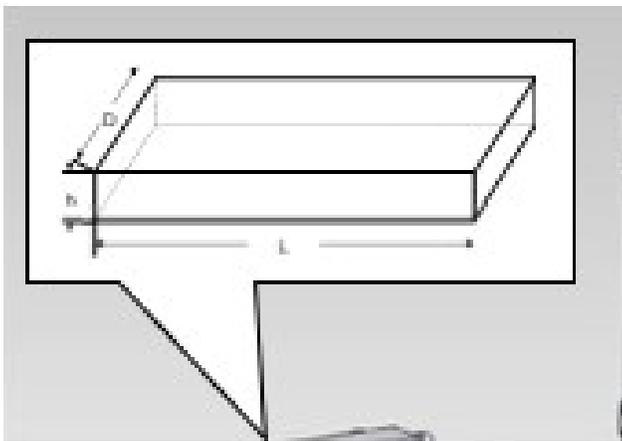
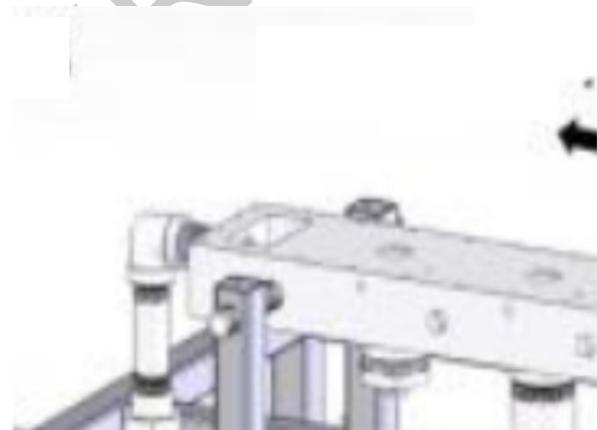
Figure 3. (a) Thin Channel Flow Cell (TCFC) (b) specimen mount and flow test section of TCFC (images courtesy of Cody Shafer, ICMT)

This set of experiments were carried out in equipment built in-house called a Thin Channel Flow Cell (TCFC), which has a 316L stainless steel thin rectangular flow channel (3 mm height, 90 mm width, 600 mm length), shown in Figure 3(a). This test set-up can accommodate up to 4 specimens with a surface area of *ca.* 7cm² (three for surface and cross-section characterization and one for electrochemical measurements). The samples are flush mounted in the flow channel once experimental (including flow regime) conditions have been reached in order avoid oxygen contamination, shown in Figure 3(b). The pH and iron concentration of the solution were not held constant as compared to previous studies;^{2,13} however, due to the large 150-liter (~40 gallon) volume of the TCFC, these parameters, which were monitored continuously, remained relatively stable throughout the course of each experiment. pH was measured with a temperature compensate pH meter and iron concentration tested using a spectrophotometer. This was done by drawing 20 mL out of the TCFC and filtered with 0.45 μm filter; 10 mL were used as a blank solution and

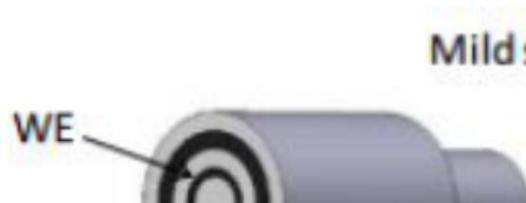
Figure 4. Specimens used for TCFC experiments (a) electrochemical specimen (b) characterization specimens¹³

A Gamry^{II} potentiostat was used for electrochemical measurements. The working electrode was polarized ± 5 mV versus the open circuit potential using a scan rate of 0.125 mV/s for linear polarization resistance (LPR) measurements. Figure 4(a) shows the electrochemical sample used for LPR measurements, where the working electrode (WE) has a surface area of *ca.* 0.88 cm². The counter electrode (CE) is made American Iron and Steel Institute (AISI) 316L stainless steel. The Ag/AgCl reference electrode is located downstream of the test channel. The B value that was used was 26 mV/decade obtained from the literature as being typical for low temperature CO_2 corrosion of mild steel.^{3,5,10,11} The polarization resistance from LPR measurements was used to calculate the current density (i_{corr} , A/cm²) and convert the corrosion rate in millimeters per year (mm/yr) using the Stern-Geary Equation^{1,12,13} as follows:

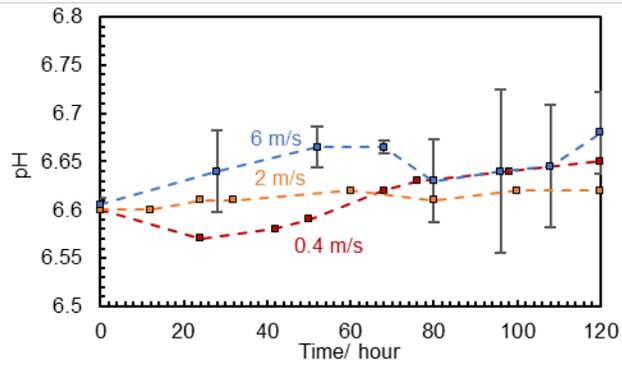
Figure 5. Comparison of pH over time for 0.4 m/s ($V_{eq} = 0.75$ m/s, $\tau = 0.8$ Pa), 2 m/s ($V_{eq} = 4.7$ m/s, $\tau = 20$ Pa) and 6 m/s ($V_{eq} = 12$ m/s, $\tau = 100$ Pa) experiments with ferritic-pearlitic UNS G10180

Figure 5 and Figure 6 show changes in water chemistry, pH and ferrous ion concentration, respectively, in the TCFC set up for the UNS G10180 ferritic-pearlitic tested at three different velocities. It can be seen that some deviations from the initial pH and ferrous ion concentration are noticed, due to the fact that these parameters were not controlled as opposed to experiments described in previous studies.^{2,3,14} Changes in water chemistry, especially in pH, can result in saturation value, $S(\text{FeCO}_3)$, deviations. However, these were not drastic as shown in Figure 7, and did not affect the results of this set of experiments, thus, the removal of Fe₃C could be properly analyzed without any environmental factors affecting validity of the results.

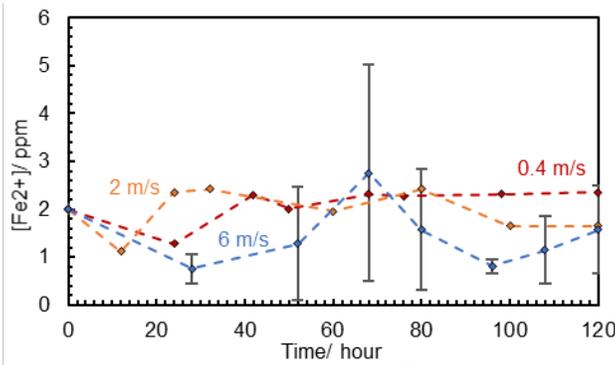
Figure 6. Comparison of $[Fe^{2+}]$ over time for 0.4 m/s ($V_{eq} = 0.75$ m/s, $\tau = 0.8$ Pa), 2 m/s ($V_{eq} = 4.7$ m/s, $\tau = 20$ Pa) and 6 m/s ($V_{eq} = 12$ m/s, $\tau = 100$ Pa) experiments with ferritic-pearlitic UNS G10180

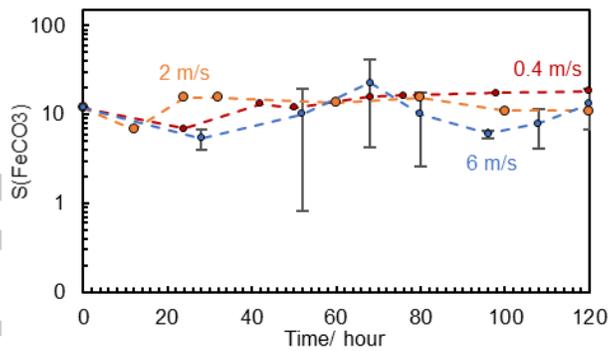
Figure 7. Comparison of $S(FeCO_3)$ over time for 0.4 m/s ($V_{eq} = 0.75$ m/s, $\tau = 0.8$ Pa), 2 m/s ($V_{eq} = 4.7$ m/s, $\tau = 20$ Pa) and 6 m/s ($V_{eq} = 12$ m/s, $\tau = 100$ Pa) experiments with ferritic-pearlitic UNS G10180

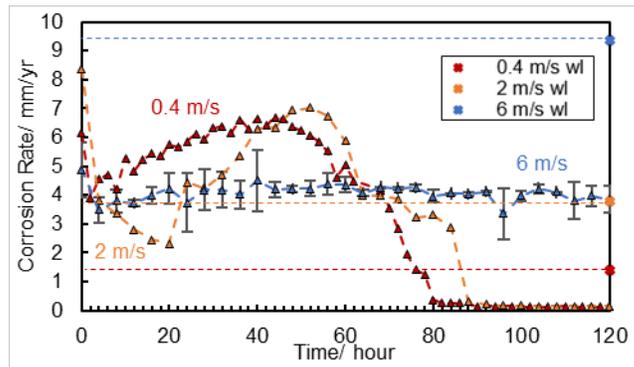
Figure 8. Comparison of LPR corrosion rate over time for 0.4 m/s ($V_{eq} = 0.75$ m/s, $\tau = 0.8$ Pa), 2 m/s ($V_{eq} = 4.7$ m/s, $\tau = 20$ Pa) and 6 m/s ($V_{eq} = 12$ m/s, $\tau = 100$ Pa) experiments with ferritic-pearlitic UNS G10180. Legend highlights the weight loss (wl) measurements at the end of the experiment

Figure 8 includes both LPR and WL corrosion rate measurements during the course of the experiments with ferritic-pearlitic UNS G10180 tested at three different velocities. It can be seen that for the 0.4 m/s ($V_{eq} = 0.75$ m/s, $\tau = 0.8$ Pa) and 2 m/s ($V_{eq} = 4.7$ m/s, $\tau = 20$ Pa), the corrosion rate increased over time until it reached a value of about 7 mm/yr after about 40 hours. As seen in previous studies, this was because of the progressive exposure of Fe₃C acting as an additional cathodic area and causing galvanic corrosion of the anodic α -ferrite. This stage is commonly described as the active corrosion stage.^{2,3,12,13,16} For the 0.4 m/s ($V_{eq} = 0.75$ m/s, $\tau = 0.8$ Pa), the corrosion rate started decreasing at about the 45th hour to a low and stable value of about 0.2 mm/yr. This can be attributed to the nucleation and growth of FeCO₃.^{2,3,12,13,16} In comparison with results obtained from previous experiments,^{2,3,16} for the same conditions and fluid velocity, there is a good reproducibility of the results even though the experimental set ups were different. For the 2 m/s ($V_{eq} = 4.7$ m/s, $\tau = 20$ Pa) experiments, the corrosion rate started decreasing at about the 60th hour to a low and stable corrosion rate value of about 0.2 mm/yr, similar to the one obtained for 0.4 m/s. For the 6 m/s ($V_{eq} = 12$ m/s, $\tau = 100$ Pa) experiment, however, the corrosion rate was stable at a value of about 4 mm/yr, indicating absence of the active corrosion stage previously observed at the lower velocities. This stable corrosion rate value is attributed to the removal of Fe₃C, which caused the corrosion rate behavior to perform similarly to that of pure iron, as seen in previous studies.² The high and stable corrosion rate also correlates well with Akeer's previous findings.¹⁴ Additionally, the time averaged weight loss corrosion rates show a similar trend: for the 6 m/s ($V_{eq} = 12$ m/s, $\tau =$

100 Pa) experiment, the corrosion rate was 9.4 mm/yr, which was significantly higher than the two other measurements at lower velocities. Lastly, the corrosion rate obtained through weight loss measurements does not match the corrosion rate obtained through electrochemical measurements, which is similar to the findings in UNS G10180 ferritic-pearlitic since the presence of Fe₃C accelerates electrochemical corrosion rates.

LPR corrosion rate results shown in Figure 8 obtained from the TCFC experiments were compared with those obtained with a 4-liter, controlled mass transfer and controlled water chemistry setup described in previous studies.^{2,3,16} In the previous studies performed in a 4-liter glass cell, FeCO₃ formed after *ca.* 100 hours at 250 rpm ($Ve_{eq} = 0.6$ m/s, $\tau = 0.5$ Pa). In comparison, FeCO₃ formation in the TCFC at 0.4 m/s ($Ve_{eq} = 0.75$ m/s, $\tau = 0.8$ Pa) occurred after *ca.* 40 hours, which both showed that minor to no precipitation of FeCO₃ occurred.

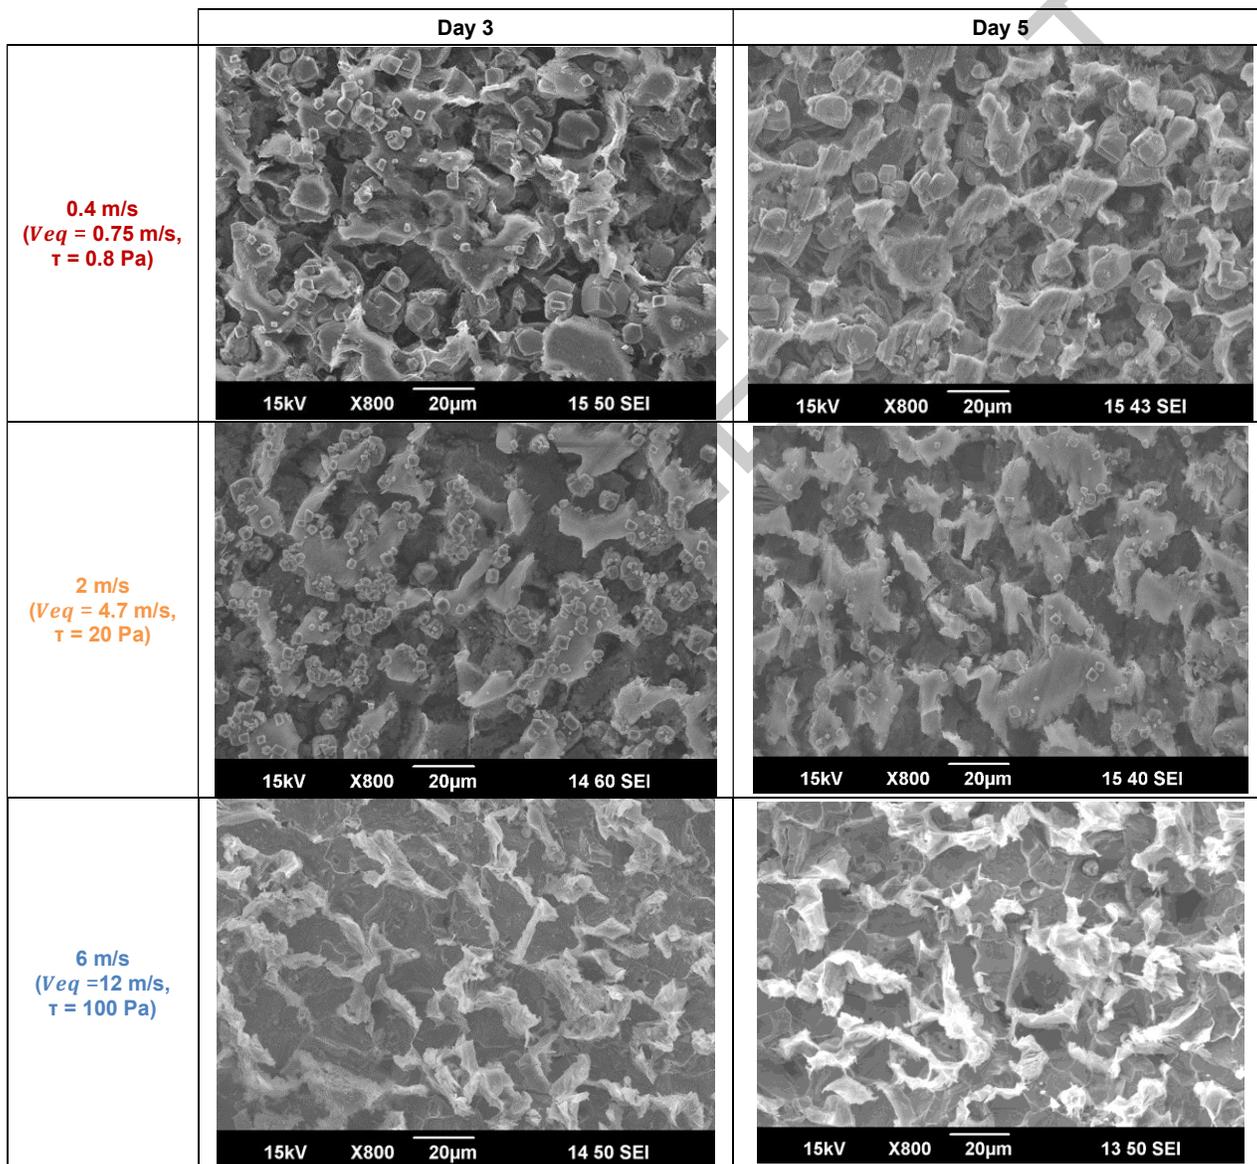
Figure 9. SEM images showing comparison of surface morphologies over time for 0.4 m/s ($V_{eq} = 0.75$ m/s, $\tau = 0.8$ Pa), 2 m/s ($V_{eq} = 4.7$ m/s, $\tau = 20$ Pa) and 6 m/s ($V_{eq} = 12$ m/s, $\tau = 100$ Pa) experiments with ferritic-pearlitic UNS G10180

Figure 9 shows the surface morphologies of the specimens taken out on days 3 and 5 for each experiment. For the 0.4 m/s ($Ve_{eq} = 0.75$ m/s, $\tau = 0.8$ Pa) and 2 m/s ($Ve_{eq} = 4.7$ m/s, $\tau = 20$ Pa) experiments, specimens for days 3 and 5 show similar surface morphologies with a non-uniform surface. This uneven surface confirms that the preferential dissolution of ferrite had occurred, while the Fe₃C acted as a cathode and remained on the steel surface.^{1, 5-8,10,11,14} The 0.4 m/s specimen surface morphology is similar to the findings from previous studies under the same environmental conditions,^{2,3,16} as FeCO₃ prisms precipitated on the surface of the specimens. The 2 m/s ($Ve_{eq} = 4.7$ m/s, $\tau = 20$ Pa) specimens also show some FeCO₃ precipitation on the steel surface. Raman spectra shown in Figure 10 and Figure 11 for 0.4 m/s ($Ve_{eq} = 0.75$ m/s, $\tau = 0.8$ Pa) and 2 m/s ($Ve_{eq} = 4.7$ m/s, $\tau = 20$ Pa) specimens, respectively, retrieved after day 5, confirm that the corrosion product was FeCO₃ based on spectra obtained from the literature.²⁰⁻²²

For the 6 m/s ($Ve_{eq} = 12$ m/s, $\tau = 100$ Pa) specimen, however, a bare steel surface with small, disconnected residues is observed, which may be due to the almost complete removal of Fe₃C due to turbulent conditions. There was no evidence of initial polishing marks or grooves, which can be indicative of carbide remaining on the steel surface.^{12,13} This surface morphology shows similar results to Akeer's previous study.¹⁴ Figure 12 (a) shows SEM images of locations used for EDS analysis in order to determine the nature of the residues; the points labeled 1 and 2 were analyzed. Figure 12 (b) shows the EDS spectrum for the point labeled 1 which analyzes the residue. It is noteworthy that there was enrichment of alloying elements (87 atom% Fe, 5.4 atom% Cu, 3.3 atom% Ni, 2.4 atom% Mn and 1.9 atom% Cr) and as indicated by the atom% values, there was no significant presence of carbon. Given the appearance of the specimen surface and surface enrichment with respect to the alloying elements of the UNS G10180, this was not indicative of Fe₃C remaining on the surface as witnessed in previous studies.³ EDS analysis was also performed on the point labeled 2 on Figure 12 (a), which showed that this is indeed a bare steel surface as only the presence of iron was detected. This finding correlates with Akeer's previous study, where no carbide was witnessed on the surface of such a steel specimen exposed to high flow velocity.¹⁴

Figure 14 shows cross-sectional morphologies of specimens shown in Figure 9. The 0.4 m/s ($Ve_{eq} = 0.75$ m/s, $\tau = 0.8$ Pa) specimens show a Fe_3C network with $FeCO_3$ precipitation, which correlates to the corrosion rate shown in Figure 8. These results are similar to what was found in the same test conditions in previous studies.^{2,3,16} The 2 m/s ($Ve_{eq} = 4.7$ m/s, $\tau = 20$ Pa) specimen also shows a Fe_3C network with $FeCO_3$ precipitation. However, the Fe_3C network is more visible in areas where precipitation of $FeCO_3$ did not occur. On the other hand, the 6 m/s ($Ve_{eq} = 12$ m/s, $\tau = 100$ Pa) specimen shows no significant Fe_3C network nor $FeCO_3$ precipitation, which can further confirm that the removal of Fe_3C occurred and hence prevented the precipitation of $FeCO_3$. This is also supported by the corrosion rate trend shown in Figure 9, for the 6 m/s ($Ve_{eq} = 12$ m/s, $\tau = 100$ Pa) experiment, where the corrosion rate was high and stable over time.¹²⁻¹⁴

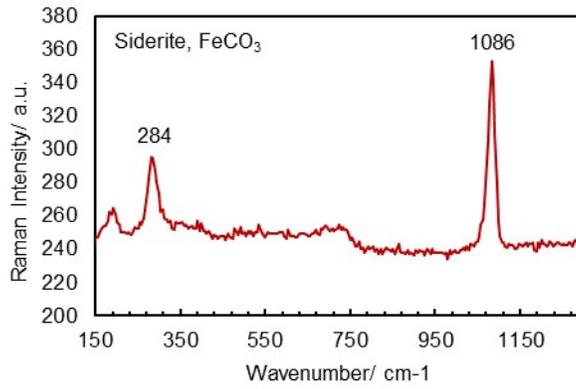
Figure 10. Raman spectra of surface confirming FeCO₃ as a corrosion product for 0.4 m/s ($V_{eq} = 0.75$ m/s, $\tau = 0.8$ Pa) experiment with ferritic-pearlitic UNS G10180

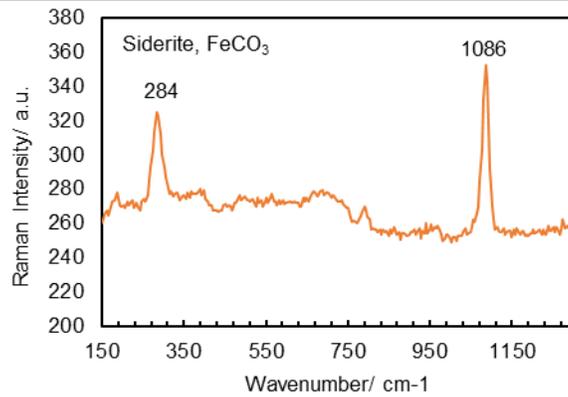
Figure 11. Raman spectra of surface confirming FeCO₃ as a corrosion product for 2 m/s ($V_{eq} = 4.7$ m/s, $\tau = 20$ Pa) experiment with ferritic-pearlitic UNS G10180

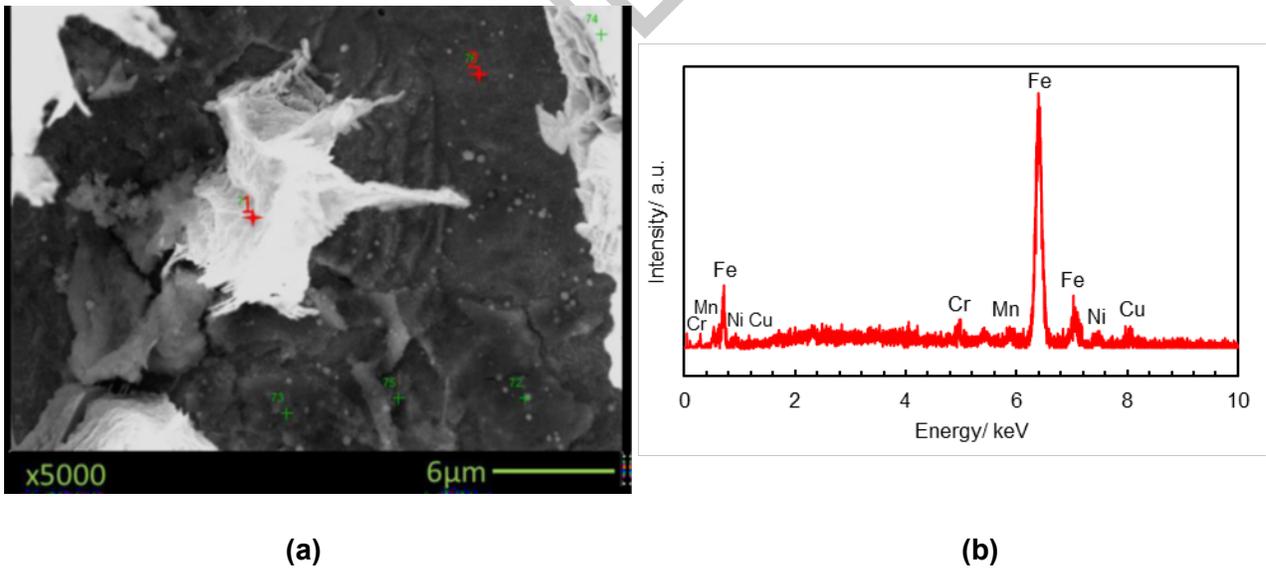
Figure 12. (a) SEM image used for EDS analysis showing surface morphology after day 5 for 6 m/s ($V_{eq} = 12$ m/s, $\tau = 100$ Pa) experiment with ferritic-pearlitic UNS G10180, (b) EDS spectrum taken at point labeled 1 in (a) confirming presence of alloying elements

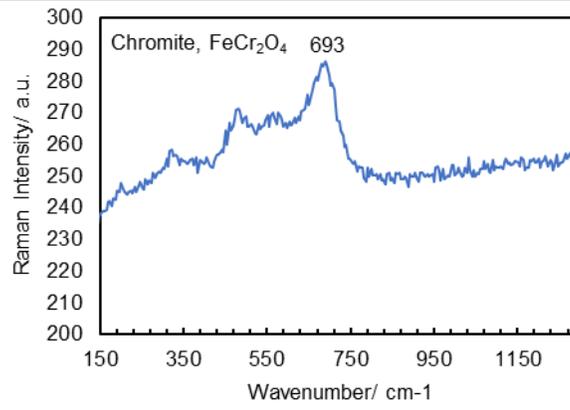
Figure 13. Raman spectra of surface for 6 m/s ($V_{eq} = 12$ m/s, $\tau = 100$ Pa) experiment with ferritic-pearlitic UNS G10180

Raman analysis was also performed to determine if there was evidence of any corrosion product on the surface of the specimen, shown in Figure 13. It can be seen that there was no peak corresponding to siderite (1084 cm⁻¹). However, a peak was found at 693 cm⁻¹. Upon searching of the literature on Raman spectroscopy and given the content of alloying elements in the UNS G10180, shown in Table 2, it was found that this peak could correspond to FeCr₂O₄ (chromite).²³ Raman spectra, surface morphologies, EDS analysis and corrosion rate trend obtained from LPR measurements confirm that no FeCO₃ formed on the specimen surface and no Fe₃C was retained. Fe₃C was removed by high flow velocities, similar to what Akeer established.¹⁴

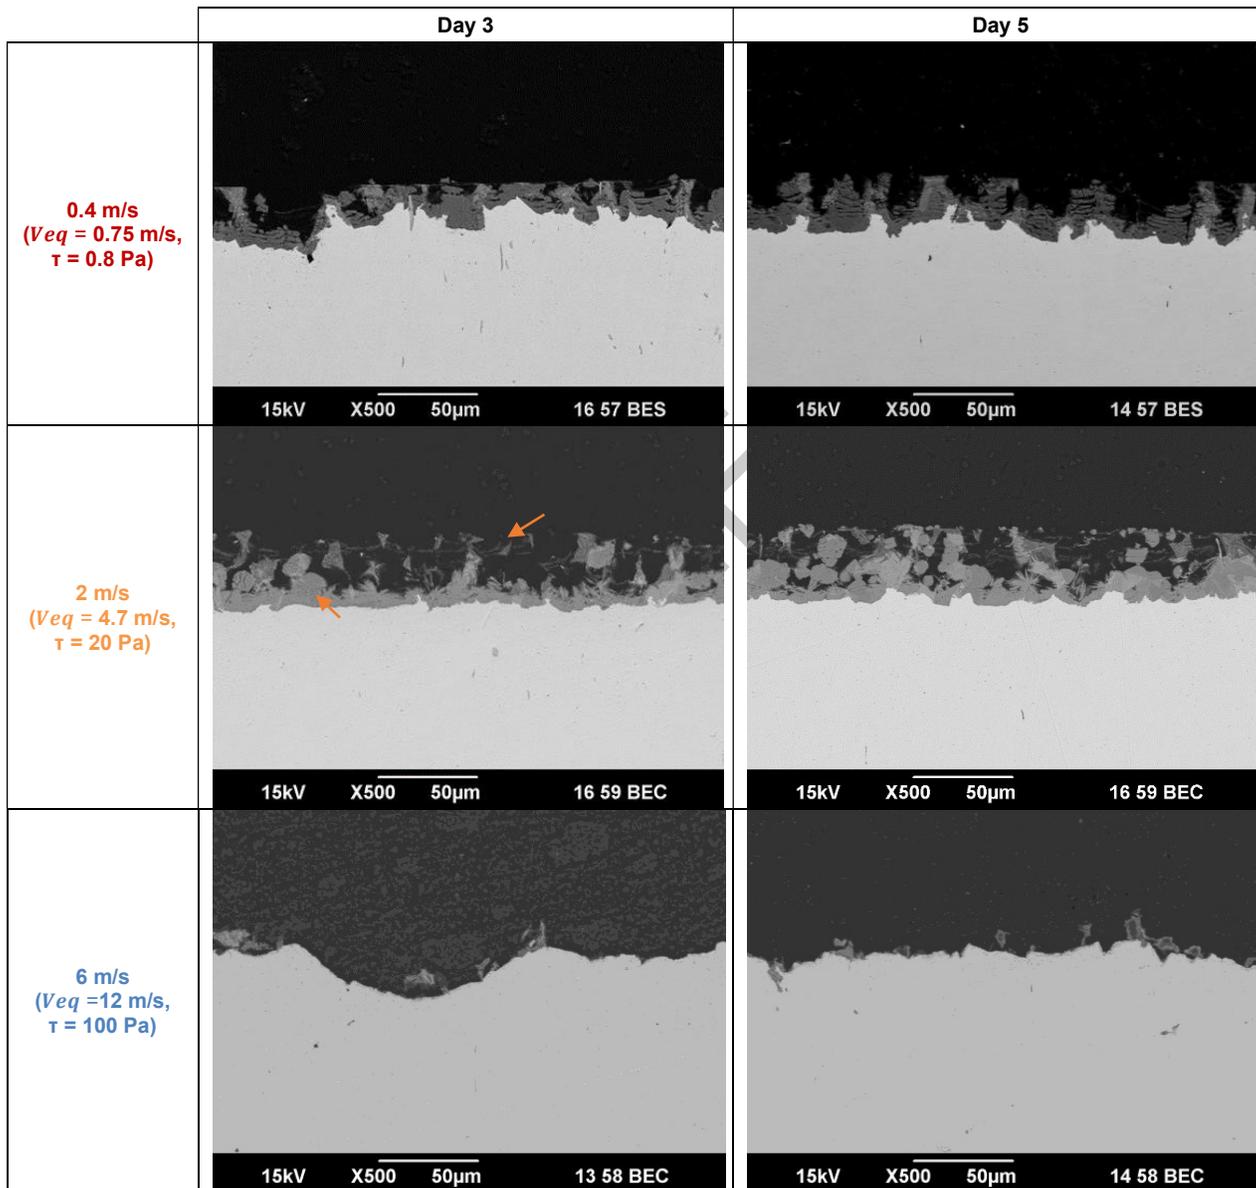
Figure 14. SEM images showing cross-sectional morphologies over time for 0.4 m/s ($V_{eq} = 0.75$ m/s, $\tau = 0.8$ Pa), 2 m/s ($V_{eq} = 4.7$ m/s, $\tau = 20$ Pa) and 6 m/s ($V_{eq} = 12$ m/s, $\tau = 100$ Pa) experiments with ferritic-pearlitic UNS G10180
