Paper No.

2592

## ELEMENTAL SULFUR CORROSION OF MILD STEEL AT HIGH CONCENTRATIONS OF SODIUM CHLORIDE

Haitao Fang, David Young and Srdjan Nešić  
Institute for Corrosion & Multiphase Technology  
Department of Chemical & Biomolecular Engineering  
Ohio University  
342 West State Street  
Athens, OH 45701

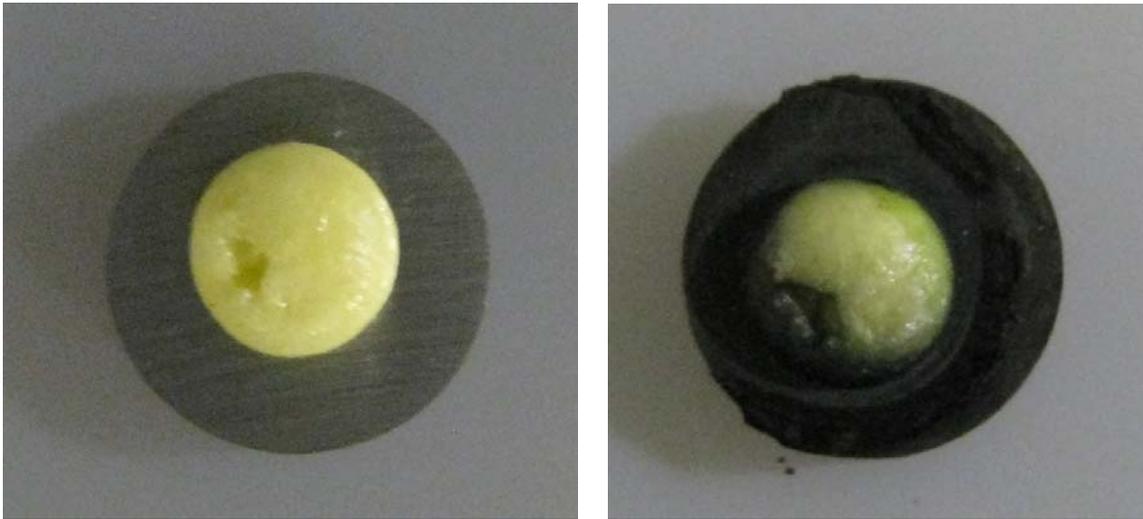
Figure 1. Corrosion coupon before and after 1 day exposure at 25°C.

Coupons with elemental sulfur on the surface before and after 1, 4 and 5 days exposure at 25°C are shown in Figure 1,

Figure 2 and Figure 3. Interestingly, a black iron sulfide film was formed on the coupon area which has no direct contact with elemental sulfur. This is quite different from what has been observed in salt free conditions, where only the portion of coupon surface underneath the sulfur was significantly blackened after exposure. Detailed comparisons of experimental results between salt free and high salt concentration conditions will be shown later.

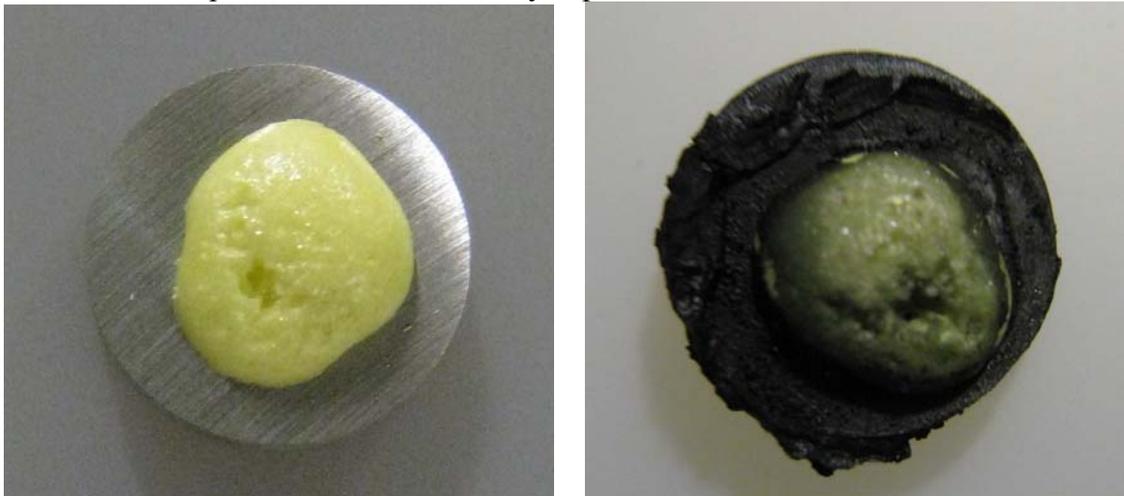
Figure 2. Corrosion coupon before and after 4 days exposure at 25°C.

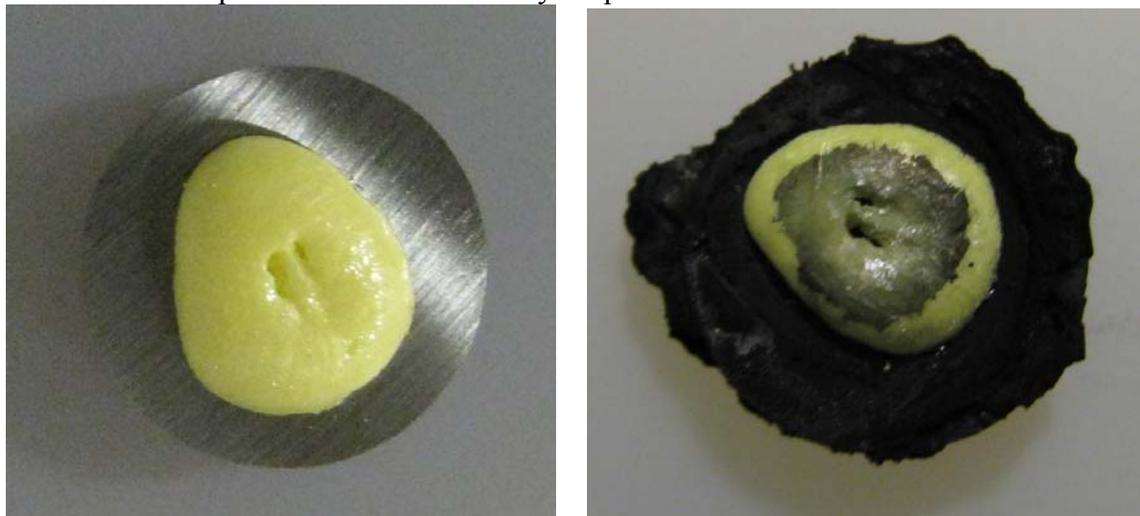
Figure 3. Corrosion coupon before and after 5 days exposure at 25°C.

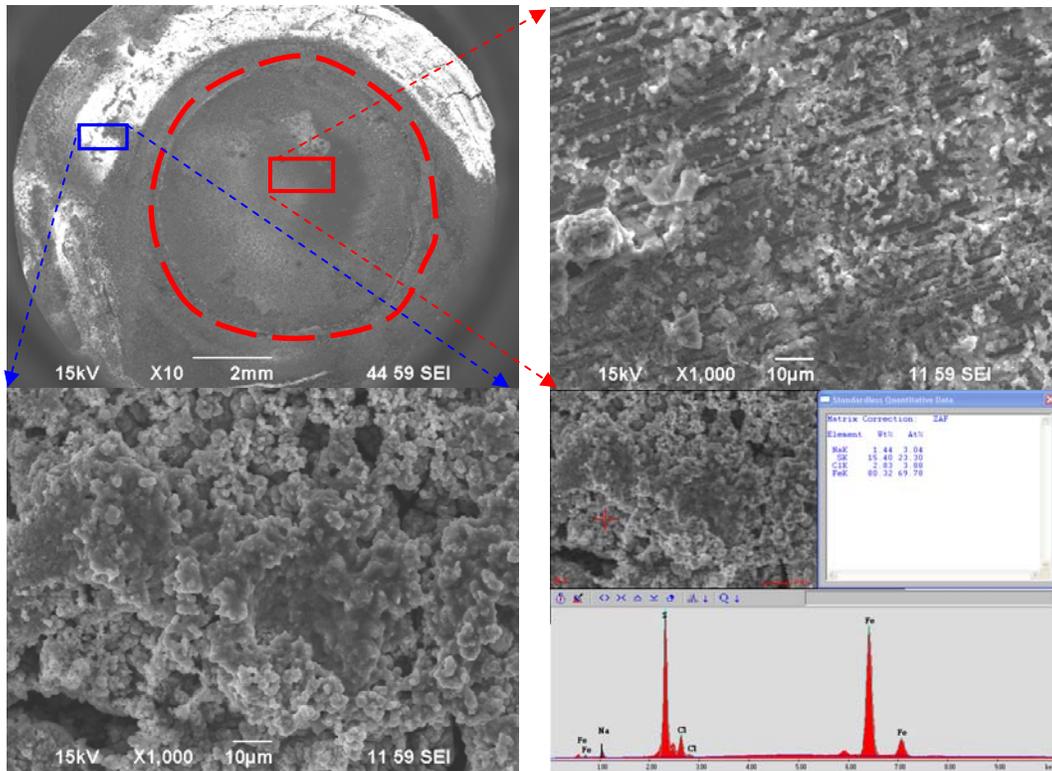
Figure 4. Corrosion coupon contacted with elemental sulfur for 1 day at 25°C, with film.

Representative SEM/EDX data for the corrosion coupon surface that has been in direct contact with elemental sulfur for one day at 25°C is shown in Figure 4. The red circled area represents the area that was covered by the sulfur pellet. Most film generation occurred in close proximity to the periphery of the sulfur pellet. This phenomenon confirms the observation made by Smith in 1990<sup>9</sup>. A further

enlargement of the small area underneath the sulfur pellet (top right) shows clear polishing marks covered by small quantity of corrosion product. A high magnification SEM picture shows the outer area which was uncovered by sulfur, a much thicker film was generated in this area. The composition of the film was shown by EDX to consist of iron sulfide. The IFM image of the corrosion coupon after the iron sulfide has been removed reveals severe localized corrosion in the outer area (Figure 5). The top right and bottom left images correspond to the small regions marked on the “whole coupon” picture. The line across the top right of the image corresponds to the profile data of the coupon surface. IFM data show that the coupon surface beneath the sulfur pellet was barely corroded. Comparison with the SEM pictures of coupon surface with film reveals that the steel corrodes more severely when more film is generated on the coupon surface. After four days at 25°C a thicker film has formed at both the inner and outer surface, see Figure 6. However, the film on the outer coupon surface is still much thicker than the film on the inner coupon surface. Cracking of the film is observed on the coupon surface. From EDX, it is clear that the film chemistry remains fundamentally unchanged with longer exposure. IFM data, Figure 7, indicates that several shallow holes start to form on the sulfur covered region. This is indicative of initiation of pitting corrosion. Localized corrosion attack on the outer coupon surface is still significant. The corrosion depth is about 25  $\mu\text{m}$  and it increases with time. After a 5 day exposure at 25°C, see Figure 8, the films seem to be even thicker and coarser than before. However, the polishing marks are still observable in the region which was covered by elemental sulfur. IFM data, Figure 9, show that the shallow pits generated at the fourth day continue to grow. The outer surface also shows greater localized corrosion depth.

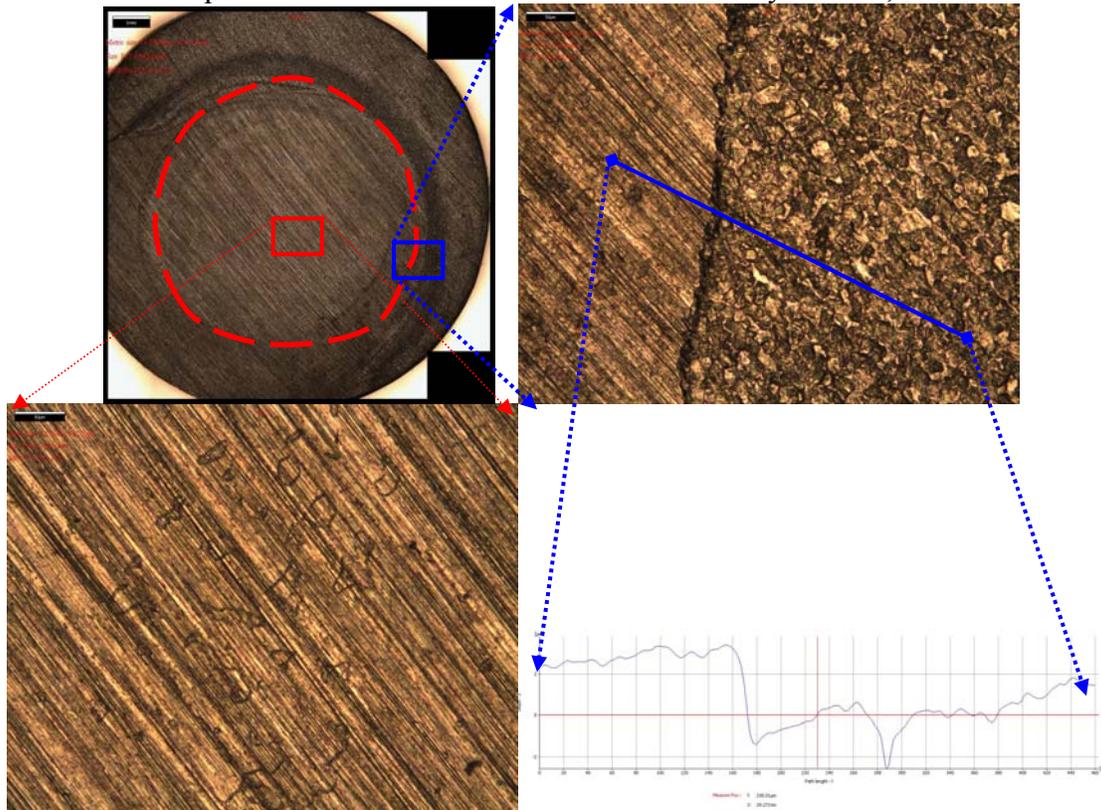
Figure 5. IFM data for corrosion coupon for 1 day at 25°C, without film, appearance of the surface and a line profile.

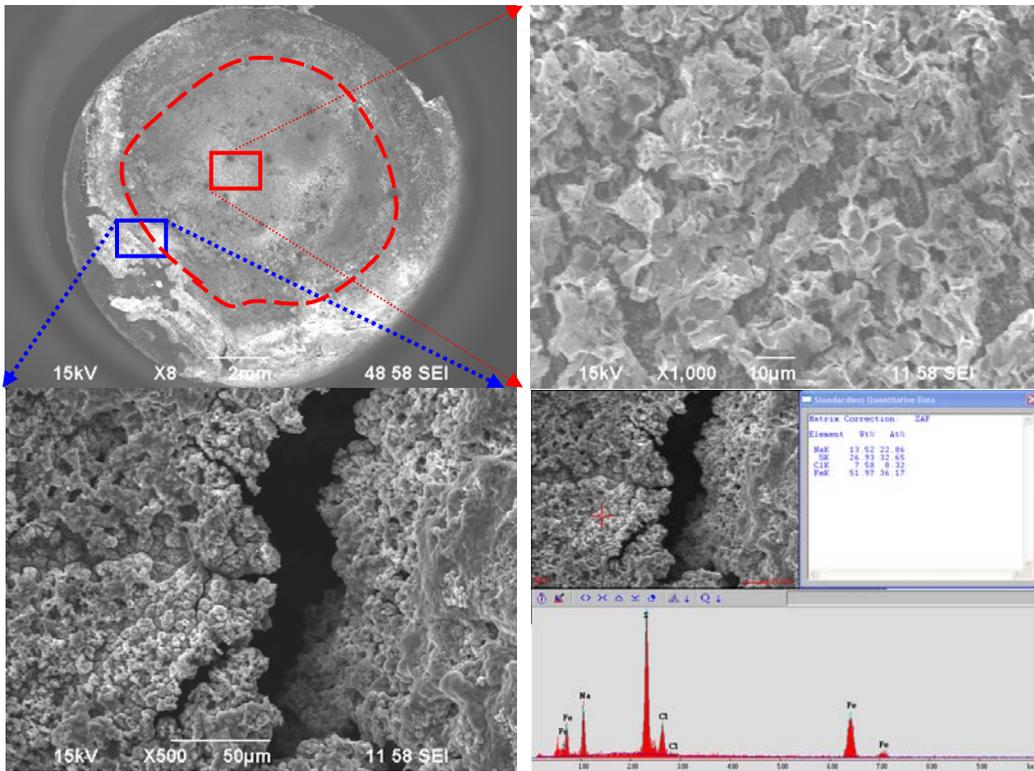
Figure 6. Corrosion coupon contacted with elemental sulfur for 4 days at 25°C, with film.

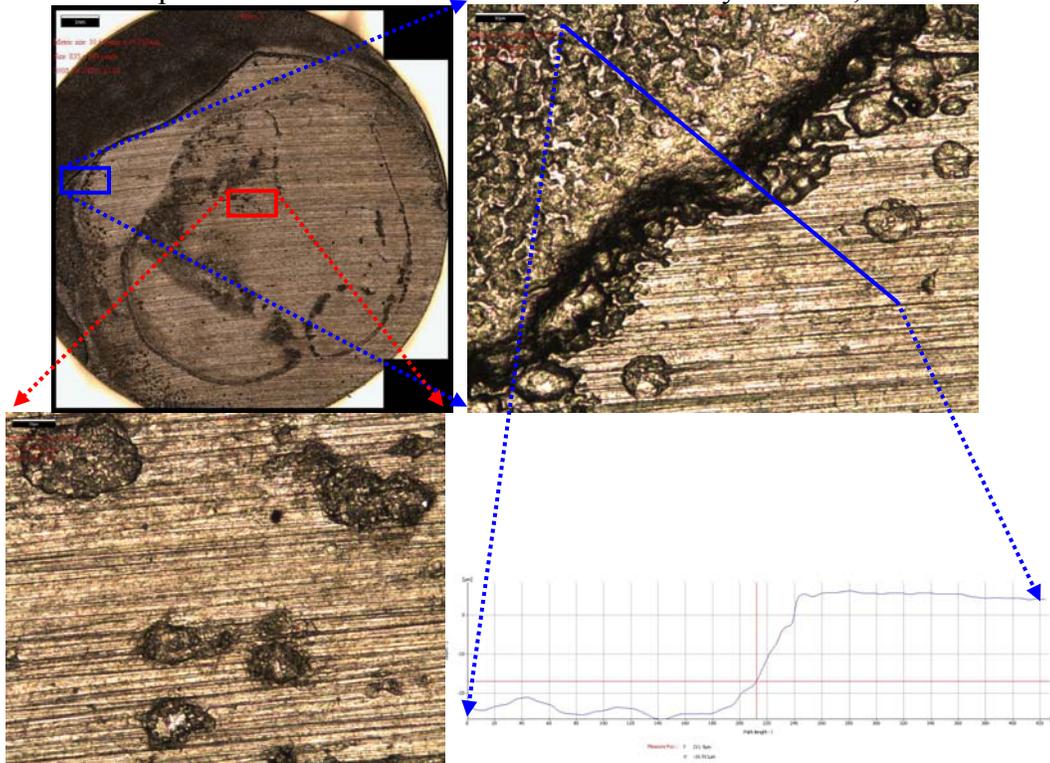
Figure 7. IFM data for coupon contacted with sulfur for 4 days at 25°C, without film, appearance of the surface and a line profile.

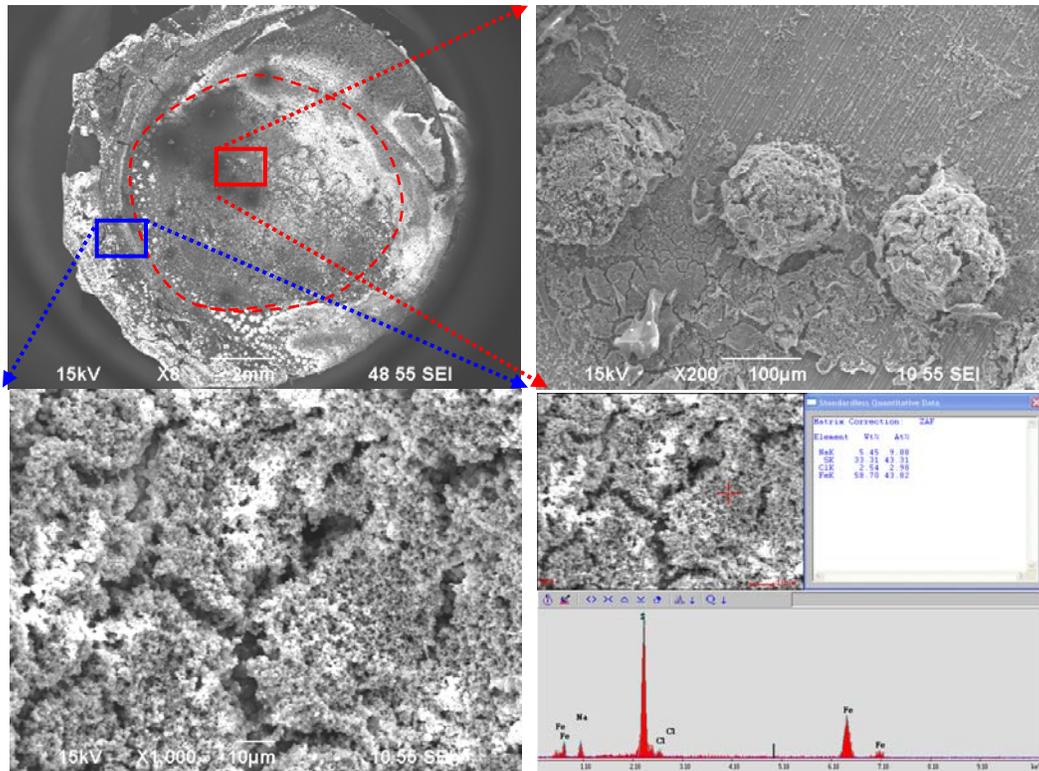
Figure 8. Corrosion coupon contacted with elemental sulfur for 5 days at 25°C, with film.

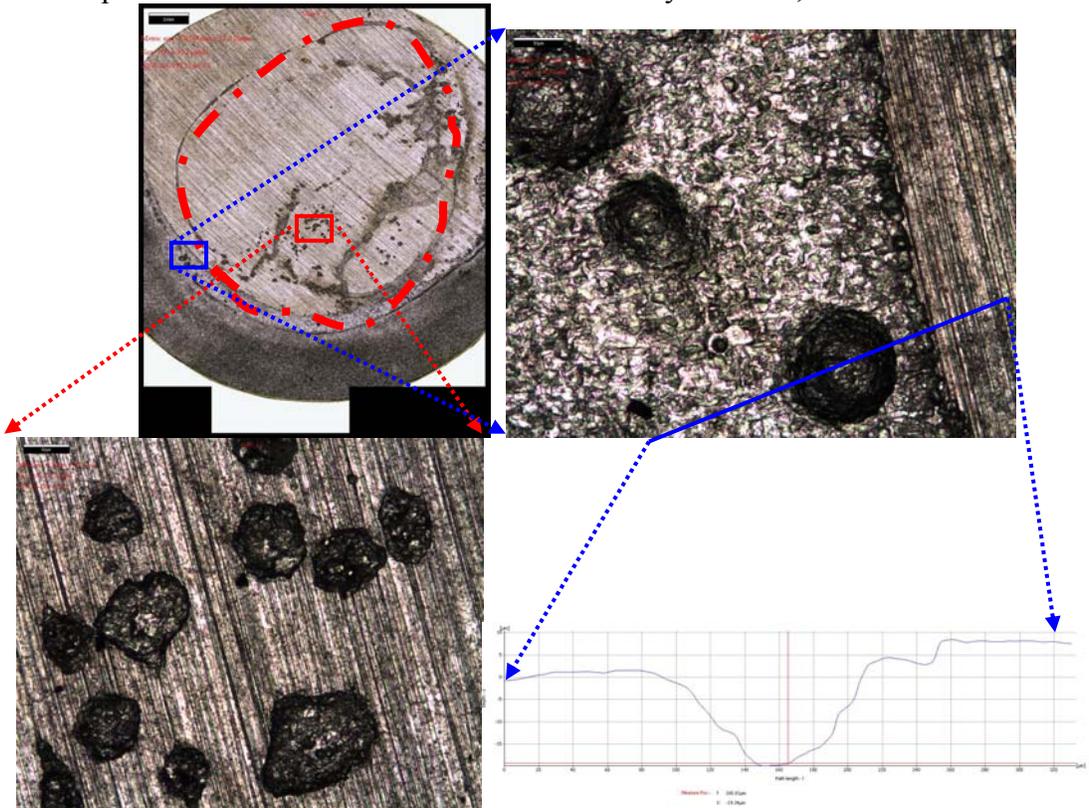
Figure 9. IFM data for coupon contacted with sulfur for 5 days at 25°C, without film, appearance of the surface and a line profile.

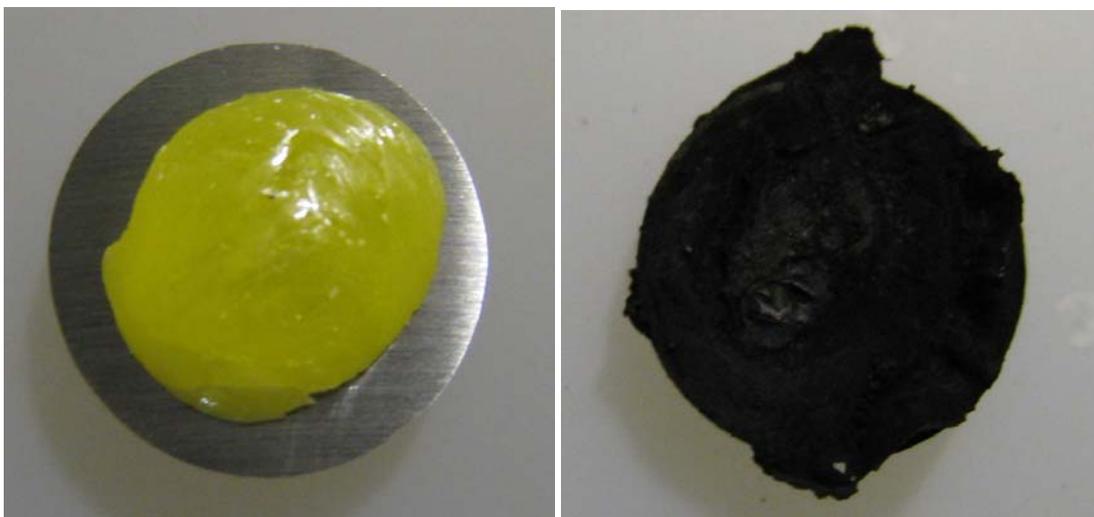
Figure 10. Corrosion coupon before and after 1 day exposure at 80°C.

A similar series of experiments was conducted at 80°C. Coupons with elemental sulfur on the surface before and after 1, 4 and 5 days exposure at 80°C are shown in Figure 10, Figure 11 and Figure 12. Similar to the experimental results at 25°C, the corrosion product films appeared to be all over the coupon surface.

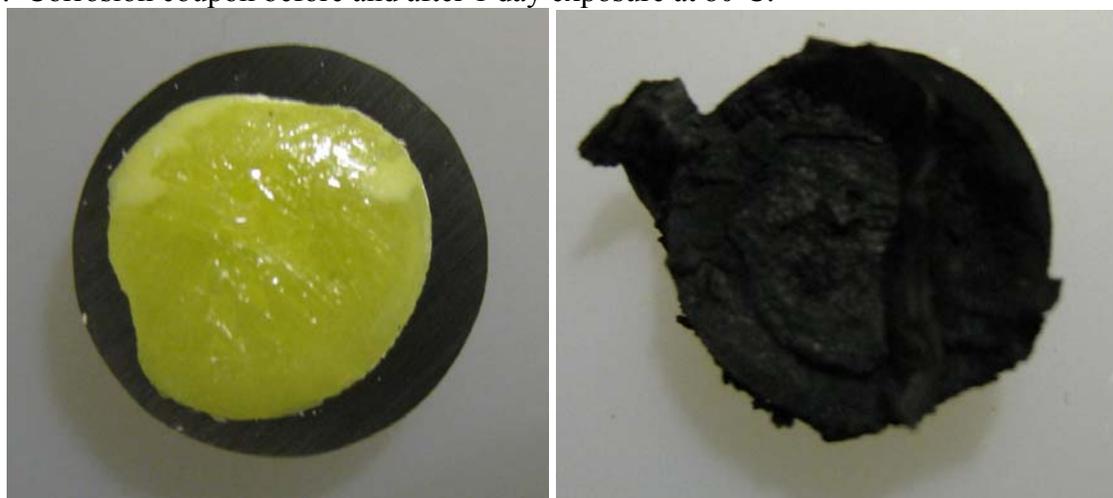
Figure 11. Corrosion coupon before and after 4 days exposure at 80°C.

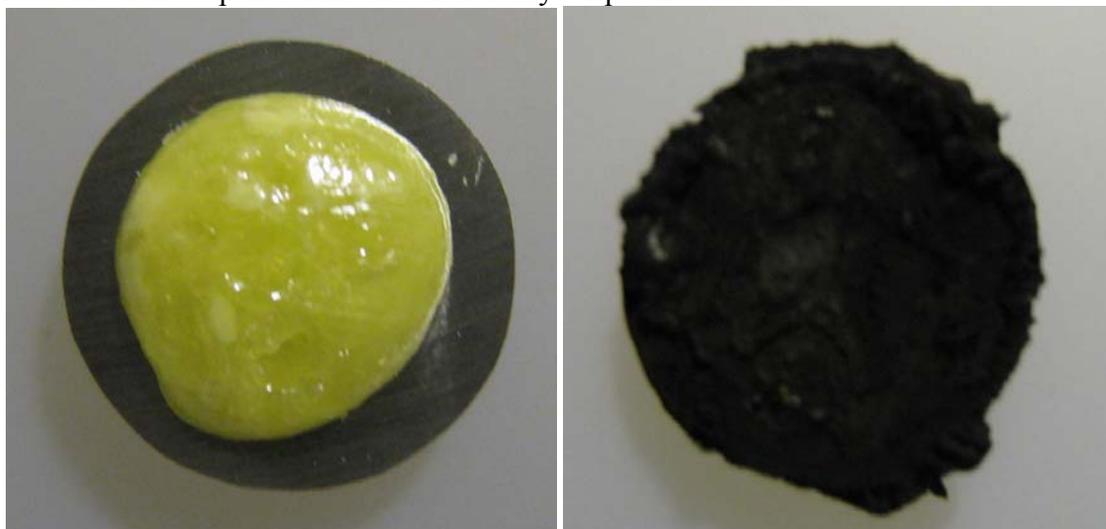
Figure 12. Corrosion coupon before and after 5 days exposure at 80°C.

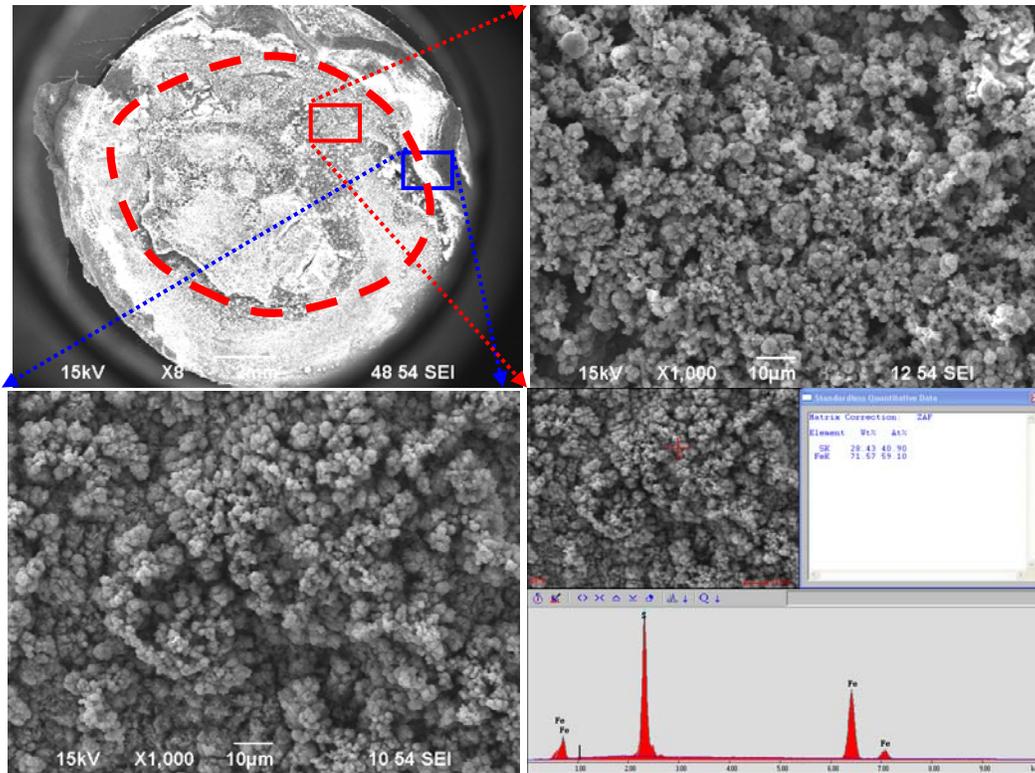
Figure 13. Corrosion coupon contacted with elemental sulfur for 1 day at 80°C, with film

After one day at 80°C there is a much thicker film present on the coupon surface than was observed at 25°C, see Figure 13. The white regions of the image are caused by deposition of sodium chloride. The thickness and macroporosity of film makes it difficult to completely dissolve the salt from the coupon surface. IFM data, Figure 14, of the coupon surface after film removal clearly shows a much more severe localized corrosion attack. Interestingly, in the region of the sulfur covered surface, part of the steel was corroded away yet another region of the coupon surface remained with the original appearance (polishing marks visible). The localized corrosion depth around the outer surface is around 55  $\mu\text{m}$ , representing a 20 mm/yr corrosion rate. This is an extremely high corrosion rate. After 4 days at 80°C, Figure 15, the film has become thicker and coarser. After 5 days at 80°C, Figure 16, the entire surface seems to be covered by a coarse and cracked film. The films appear to be much denser and highly crystalline. IFM data show the coupon surface after film removal. A layer of the original steel surface was corroded away. It is difficult to quantify the localized corrosion depth because the original coupon surface is gone. However, a surface profile analysis is still given for reference. The depth is around 35 $\mu\text{m}$ . It was noted that the corrosion rate decreased with time.

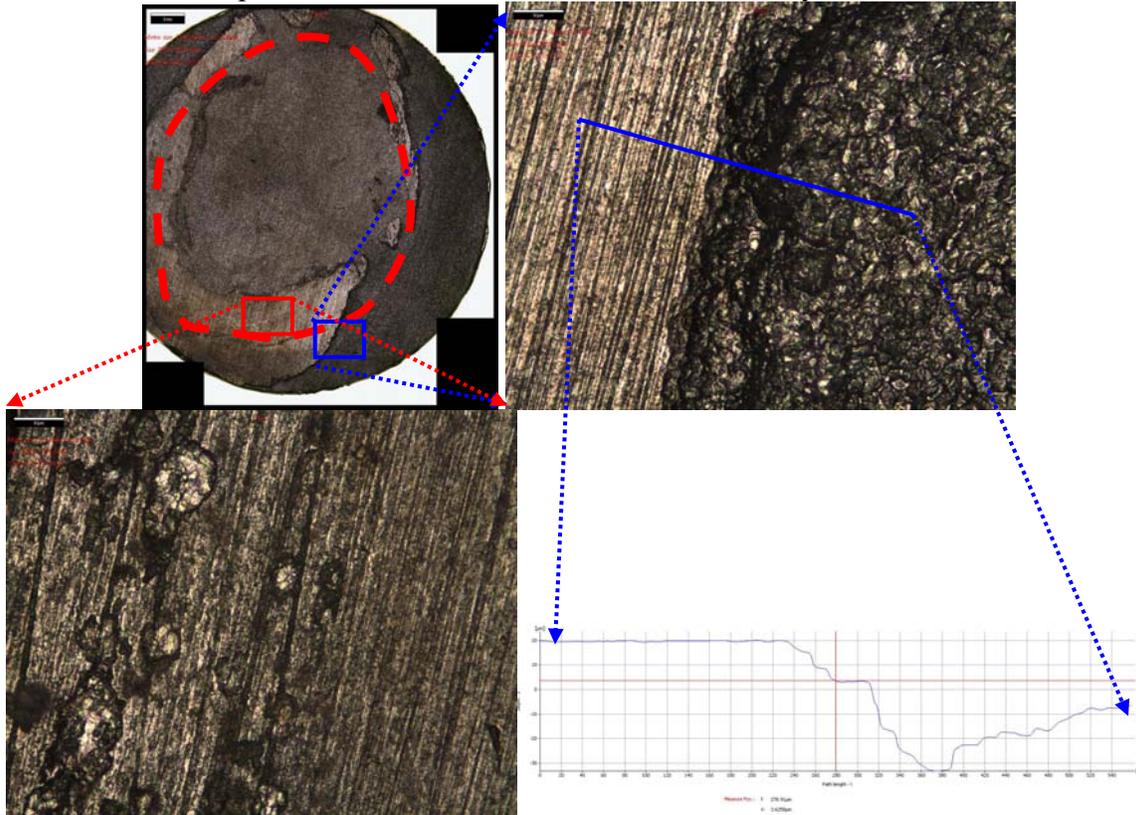
Figure 14. IFM data for coupon contacted with sulfur for 1 days at 80°C, without film, appearance of the surface and a line profile.

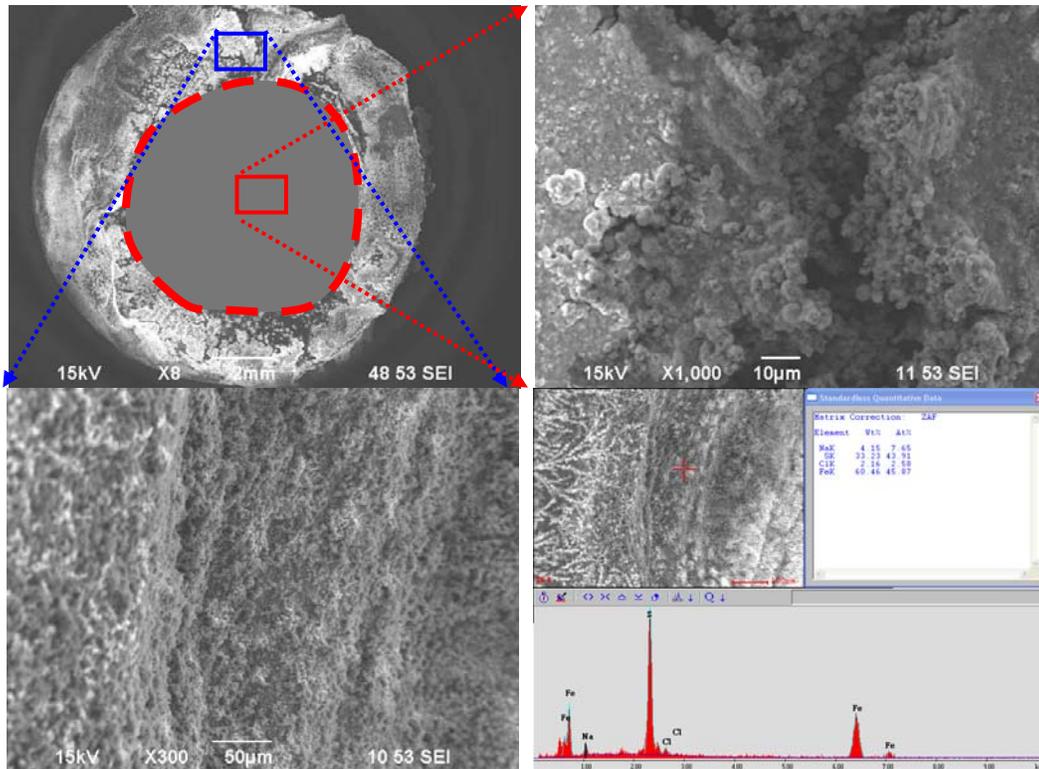
Figure 15. Corrosion coupon contacted with elemental sulfur for 4 days at 80°C, with film.

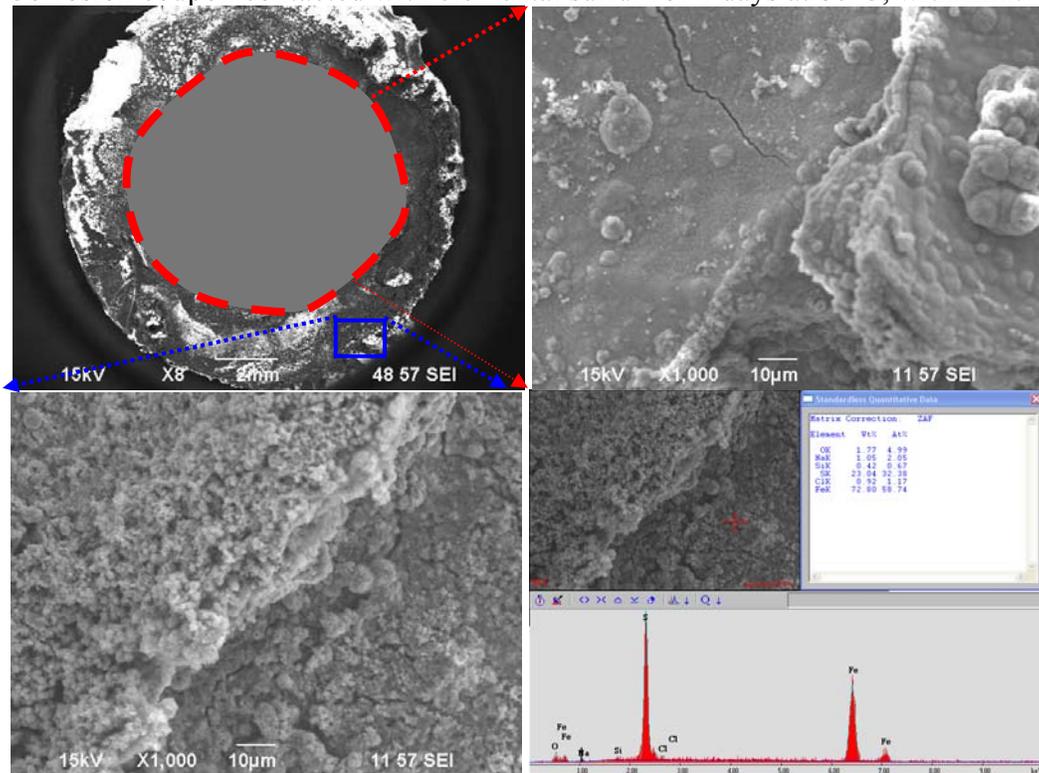
Figure 16. Corrosion coupon contacted with elemental sulfur for 5 days at 80°C, with film.

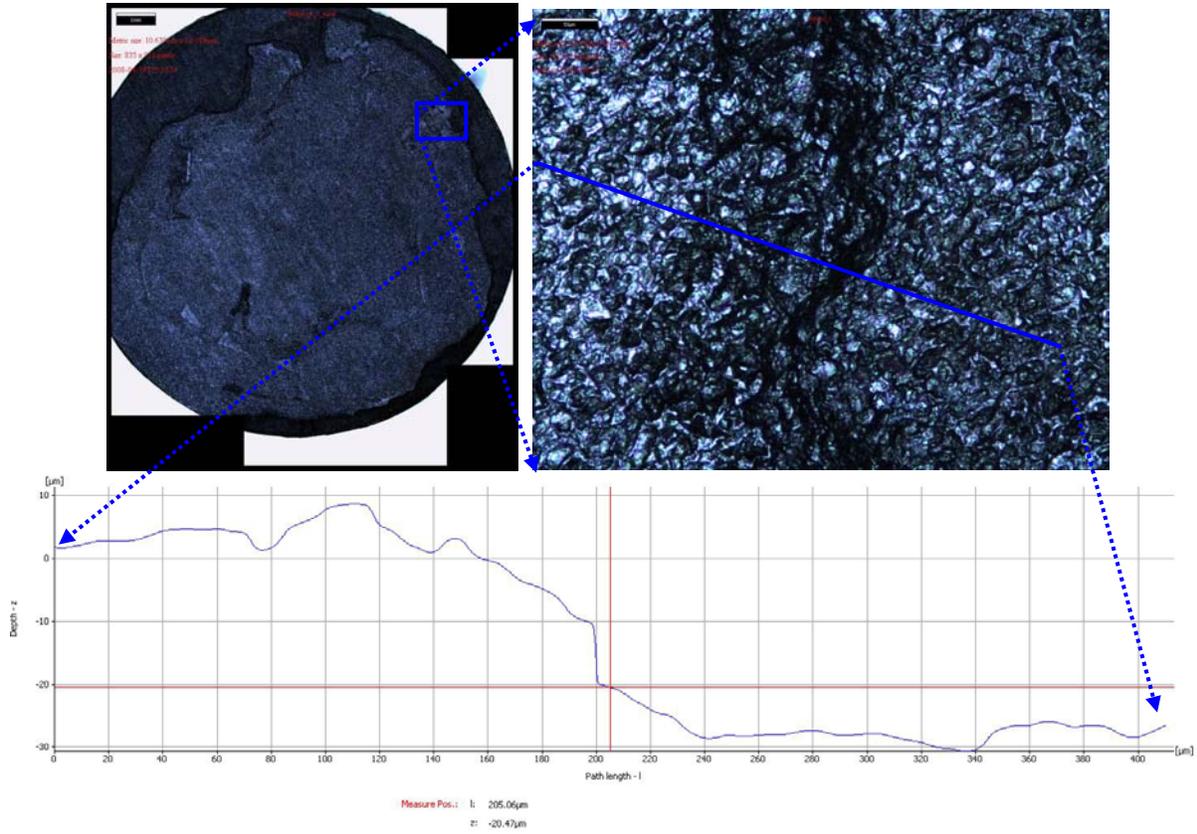
Figure 17. IFM data for coupon contacted with sulfur for 5 days at 80°C, without film, appearance of the surface and a line profile.

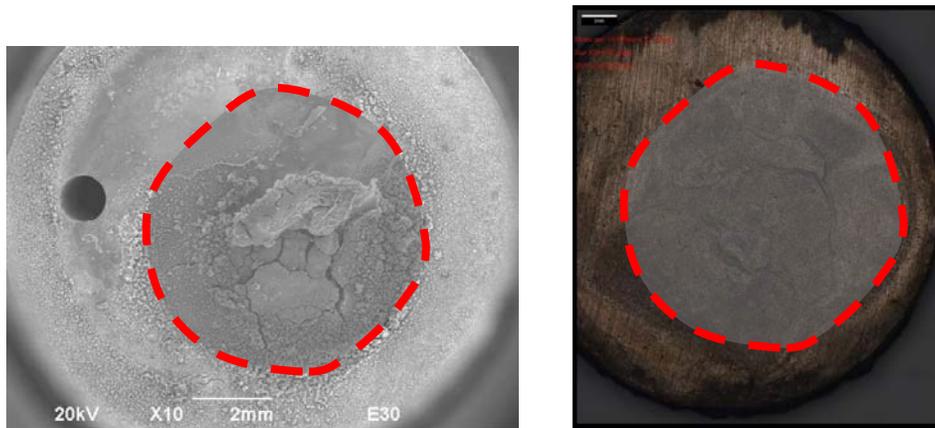
Figure 18. Corrosion coupon contacted with elemental sulfur for 4 days with and without film at 25°C, salt free condition

Figure 19 shows the comparison of general corrosion rates between salt free and 10 wt.% NaCl conditions at 25°C. Results clearly indicate that an increase of salt concentration significantly increases the general elemental sulfur corrosion rates. General corrosion rates increased two to three times when salt concentration was increased from 0 wt.% to 10 wt.% at 25°C. Another significant difference between the experimental results at salt free and high salt concentration conditions is the nature of film formation. From Figure 18, it is seen that the thick deposits of iron sulfide on the steel substrate formed

directly beneath the elemental sulfur at salt free conditions. However, at high salt concentration, most of the corrosion product films were generated in the region which is not covered by elemental sulfur. Similar observations of film formation were first reported by Smith<sup>9</sup>. Hydrogen polysulfide formed by hydrogen sulfide and elemental sulfur at the periphery of the sulfur pellet was suggested to explain these phenomena. However, in the present experiments, no H<sub>2</sub>S is added into the system, which is different from Smith's experiments. Therefore, other scenarios need to be investigated to further explain the observed phenomena.

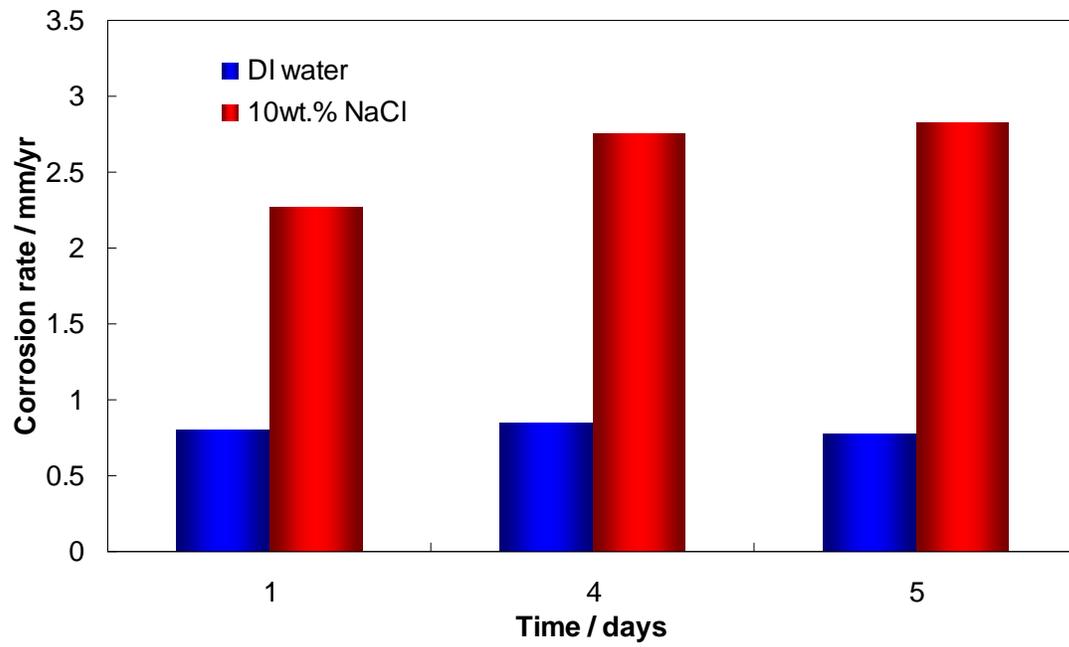
Figure 19. Comparisons of general corrosion between salt free and 10 wt.% NaCl conditions at 25°C.
