Investigation of Localized Corrosion of Carbon Steel in H₂S Environments

A dissertation presented to
the faculty of
the Russ College of Engineering and Technology of Ohio University

In partial fulfillment
of the requirement for the degree
Doctor of Philosophy

Haitao Fang

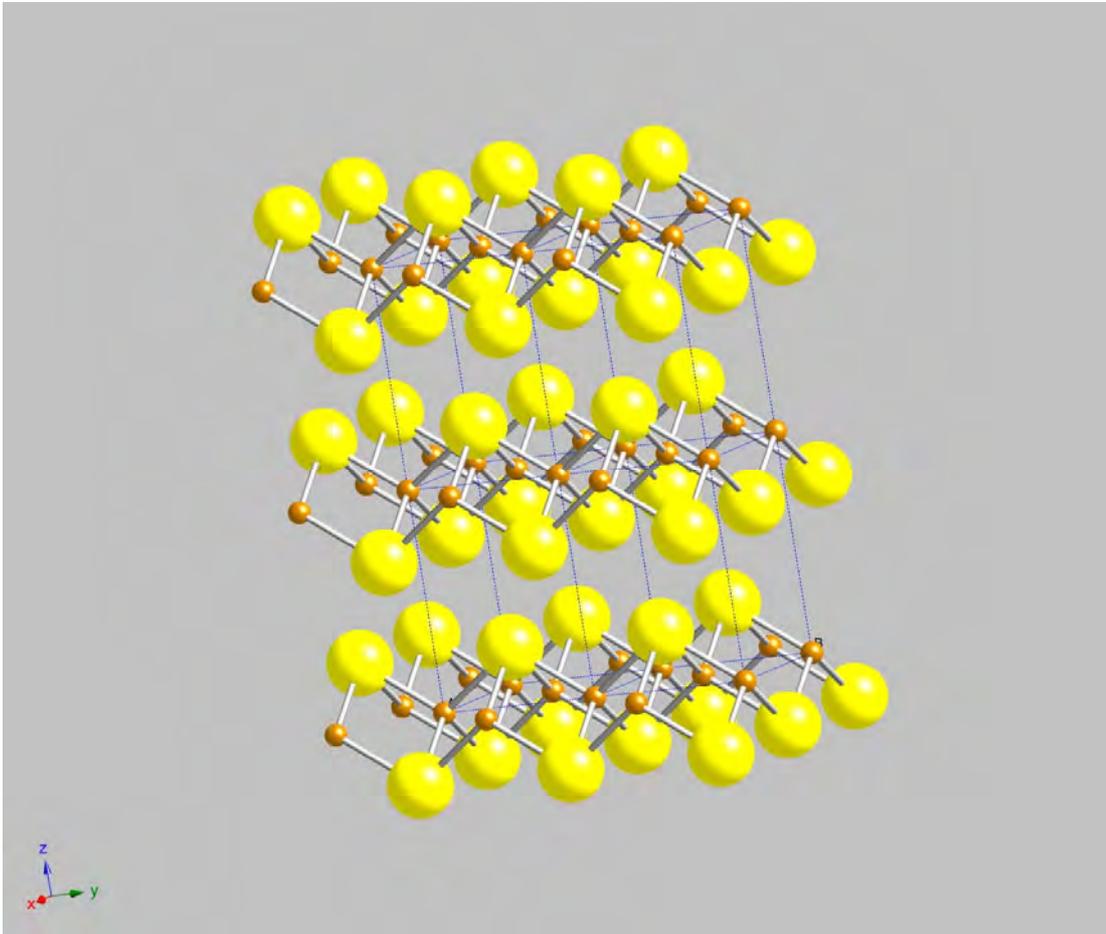
Figure 5. Crystal structure of mackinawite (generated with Crystallmaker™ software).

Mackinawite has been typically reported to be a sulfur deficient iron sulfide with a formula Fe_{1+x}S , where $x = 0.057$ to 0.064 ²⁷. This reported non-stoichiometry is likely an artifact relating to chemical analysis, with its actual formula being FeS ²⁷. Mackinawite is a two dimensional layer structure consisting of stacked FeS sheets, see Figure 5. Thermodynamically, mackinawite is unstable compared with other iron sulfide minerals, such as pyrrhotite⁶⁰. It has been found that mackinawite is converted to greigite, marcasite and pyrite by reaction with sulfur²⁷. In low H_2S concentration environments, the first iron sulfide corrosion product is usually mackinawite²⁷.

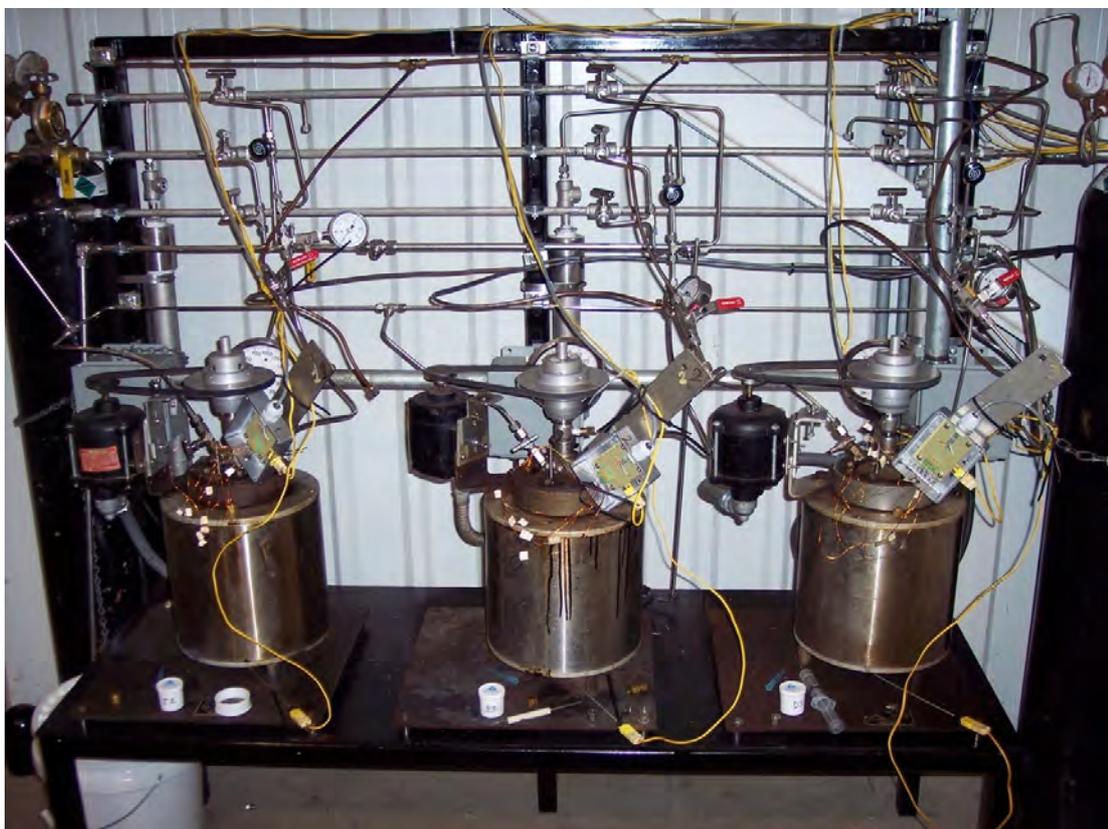
Figure 7. Experimental setup for high partial pressure of H₂S.

For the experiments at high partial pressure of H₂S, the tests were conducted in a set of autoclaves. Figure 7 shows the actual picture of the overall view of the experimental setup. The main components of the setup are the three autoclaves with surrounding heating elements. Temperature was controlled by a digital controller. A schematic of the 1 liter autoclave is shown in Figure 8. Stainless steel tubing with a check valve was used to purge the solution. A temperature probe was inserted into the thermal well. Test specimens were hung on the specimen holder and isolated from any galvanic corrosion by heat shrinkable tubing while immersed in the test solution.

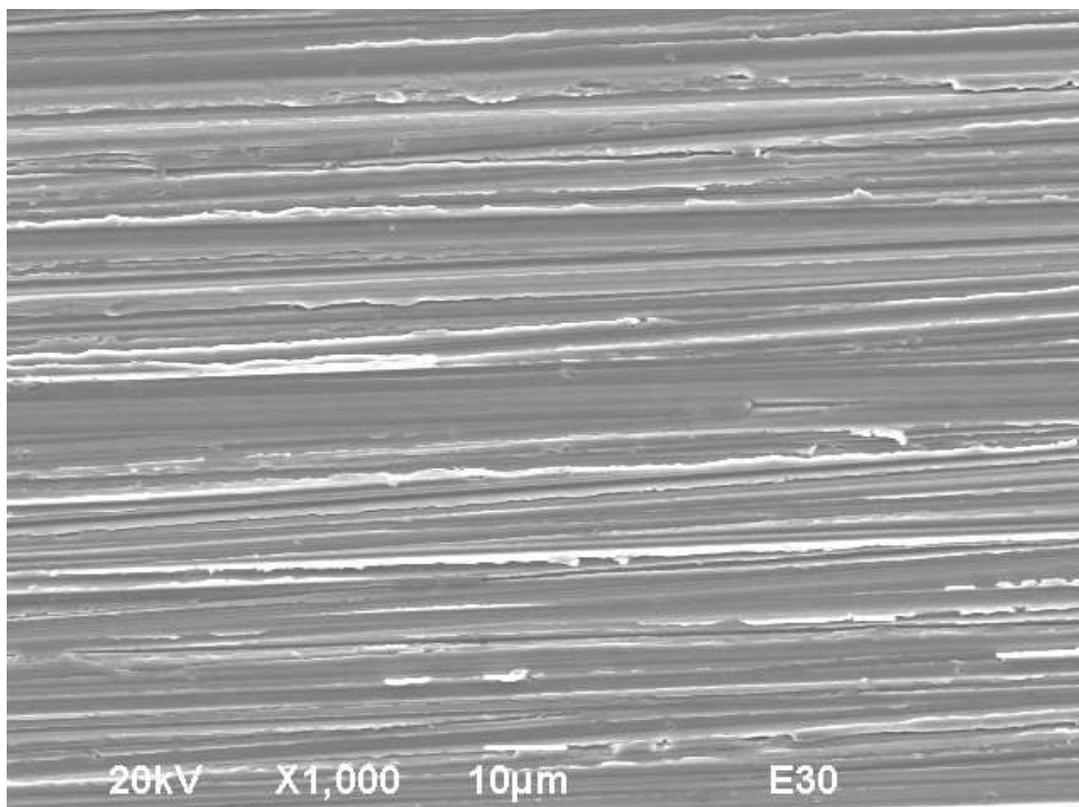
Figure 9. Image of bare steel surface polished by sand paper.

A fresh polished carbon steel specimen was scanned by SEM before it was exposed to the corrosive environment. A SEM picture of a bare metal surface is shown in Figure 9 for comparison with the surface of corrosion specimens after corrosion. The polishing marks are clearly seen in the SEM image.

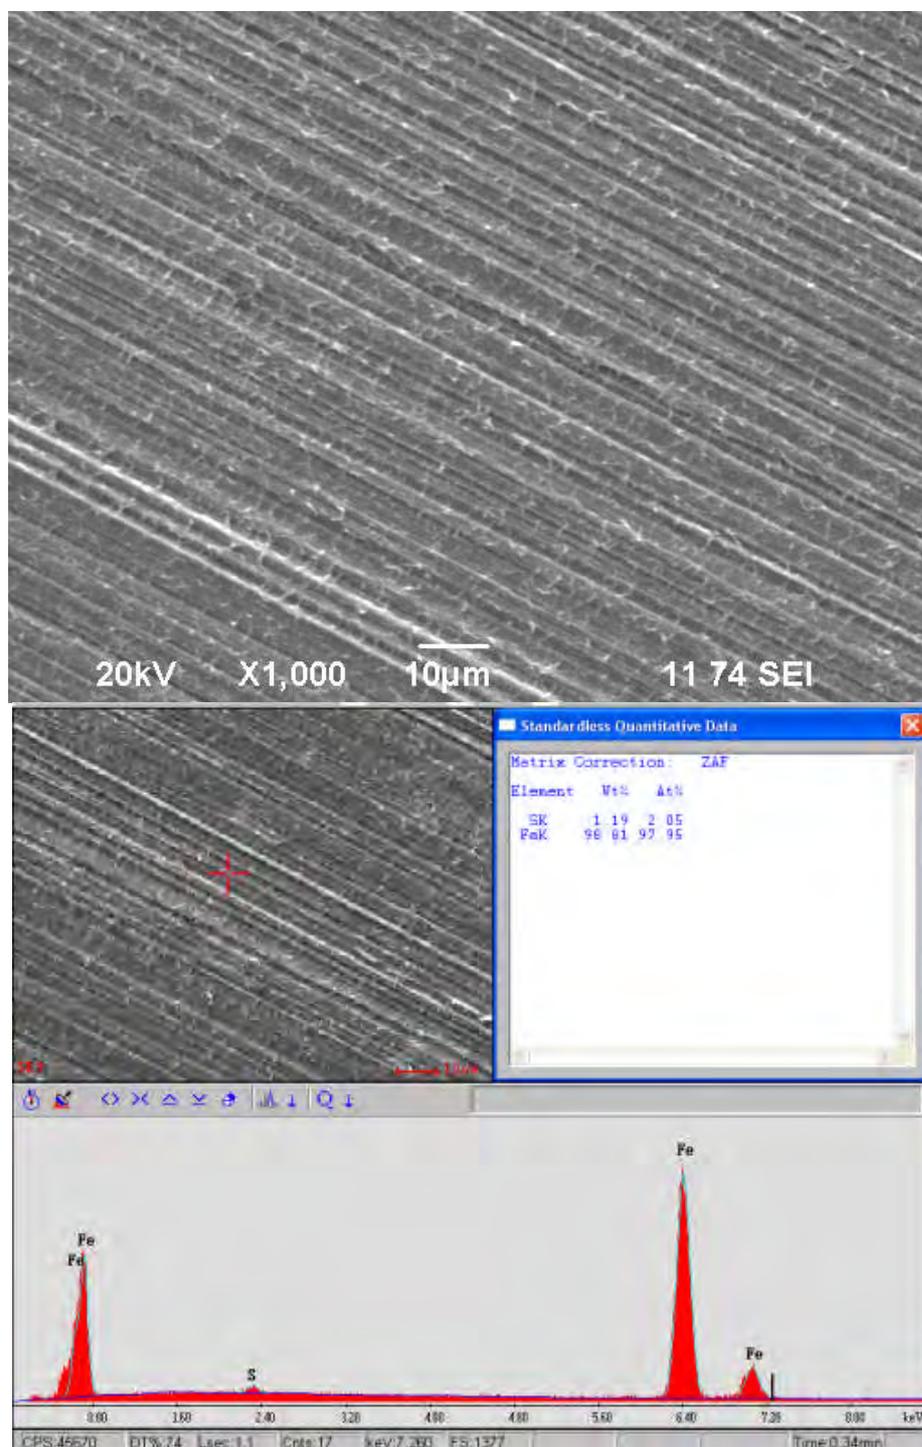
Figure 10. Corrosion specimen exposed to H₂S for 1 day at 0 wt% NaCl, 25°C, with corrosion product layer.

The first set of steel specimens was taken out after 1 day exposure to the test solution. Figure 10 shows the SEM image and EDX spectrum of the specimen surface after a 1 day exposure. It has been observed that a very thin layer of corrosion scale formed on the specimen surface. Polishing marks are still obvious on the surface. This suggests that the corrosion rate is relatively low at this condition. It is also noticed that the scale appears to be fragmented. EDX data show that sulfur and iron are the main components of the scales, consistent with the formation of FeS.

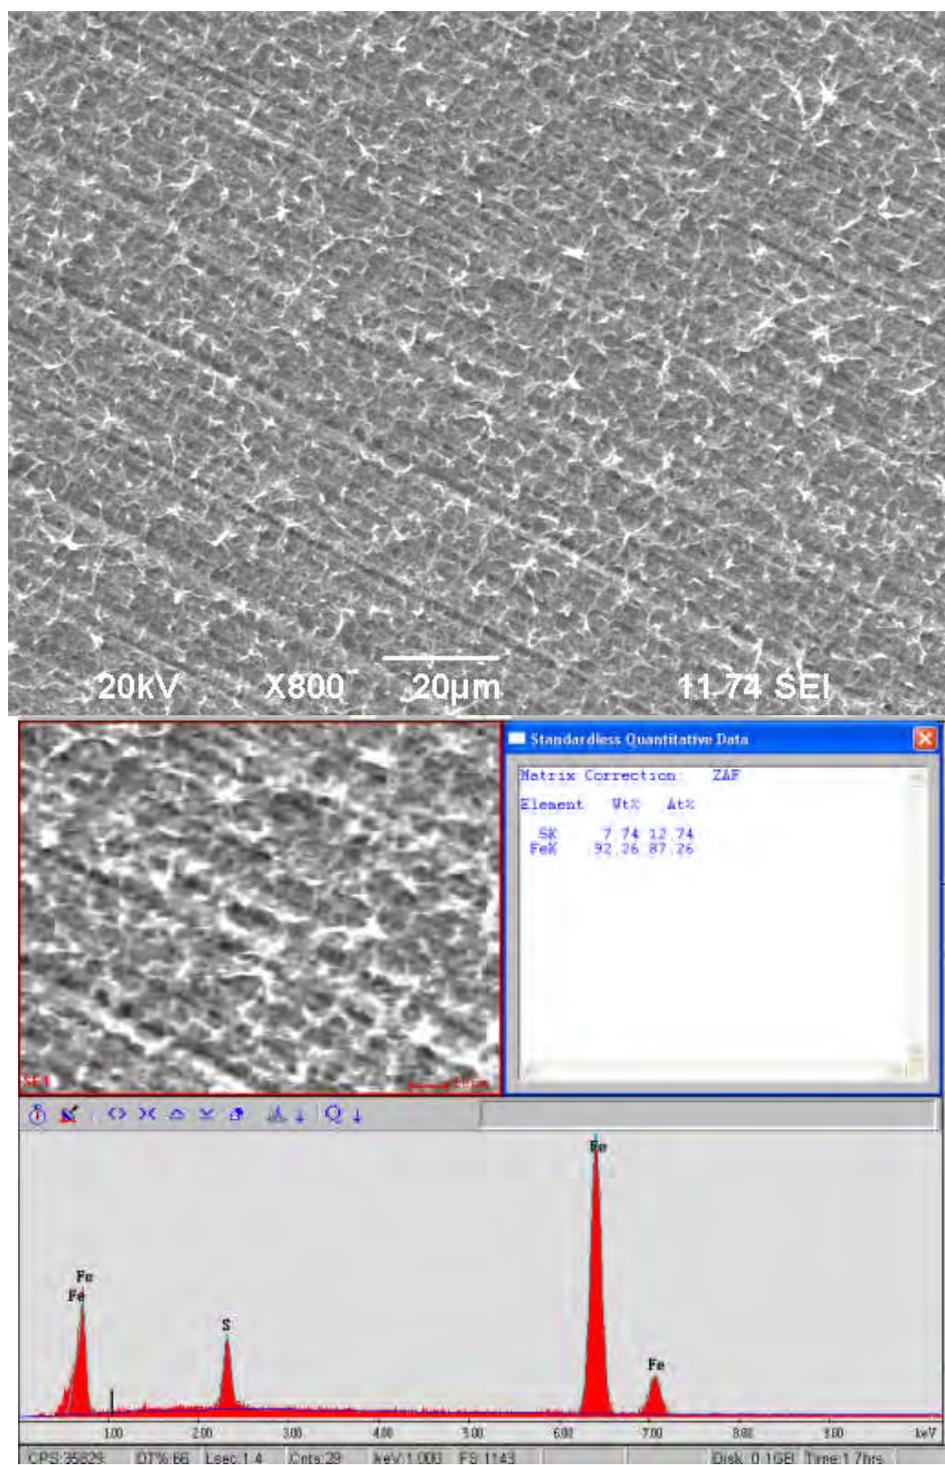
Figure 11. Corrosion specimen exposed to H_2S for 4 days at 0 wt% NaCl, 25°C, with corrosion product layer.

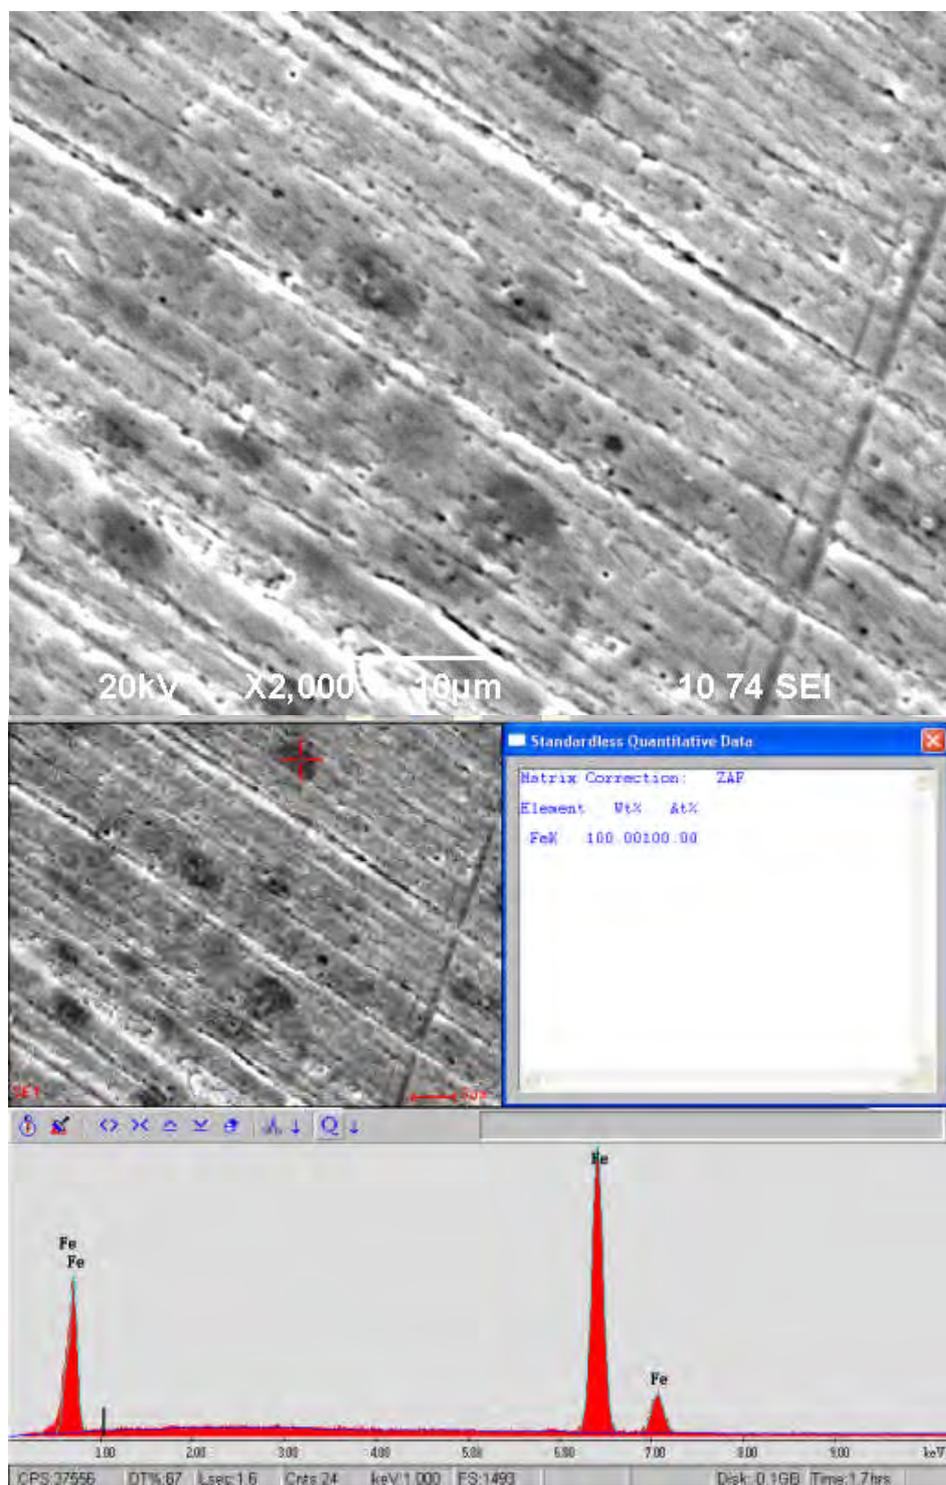
Figure 12. Corrosion specimen exposed to H₂S for 4 days at 0 wt% NaCl, 25°C, without corrosion product layer.

To detect possible localized corrosion on the steel surface, iron sulfide scale was removed by Clarke's solution (2% Sb_2O_3 , 5% $SnCl_2$, in concentrated HCl). The SEM image of the specimen surface after Clarke treatment is shown in Figure 12. The EDX analysis shows that the iron sulfide layer has been removed from the surface. Clearly, the test specimen underwent corrosion attack after four days exposure to H_2S . However the corrosion attack was not significant and appears to be general attack. No initiation of localized corrosion was observed under this condition.

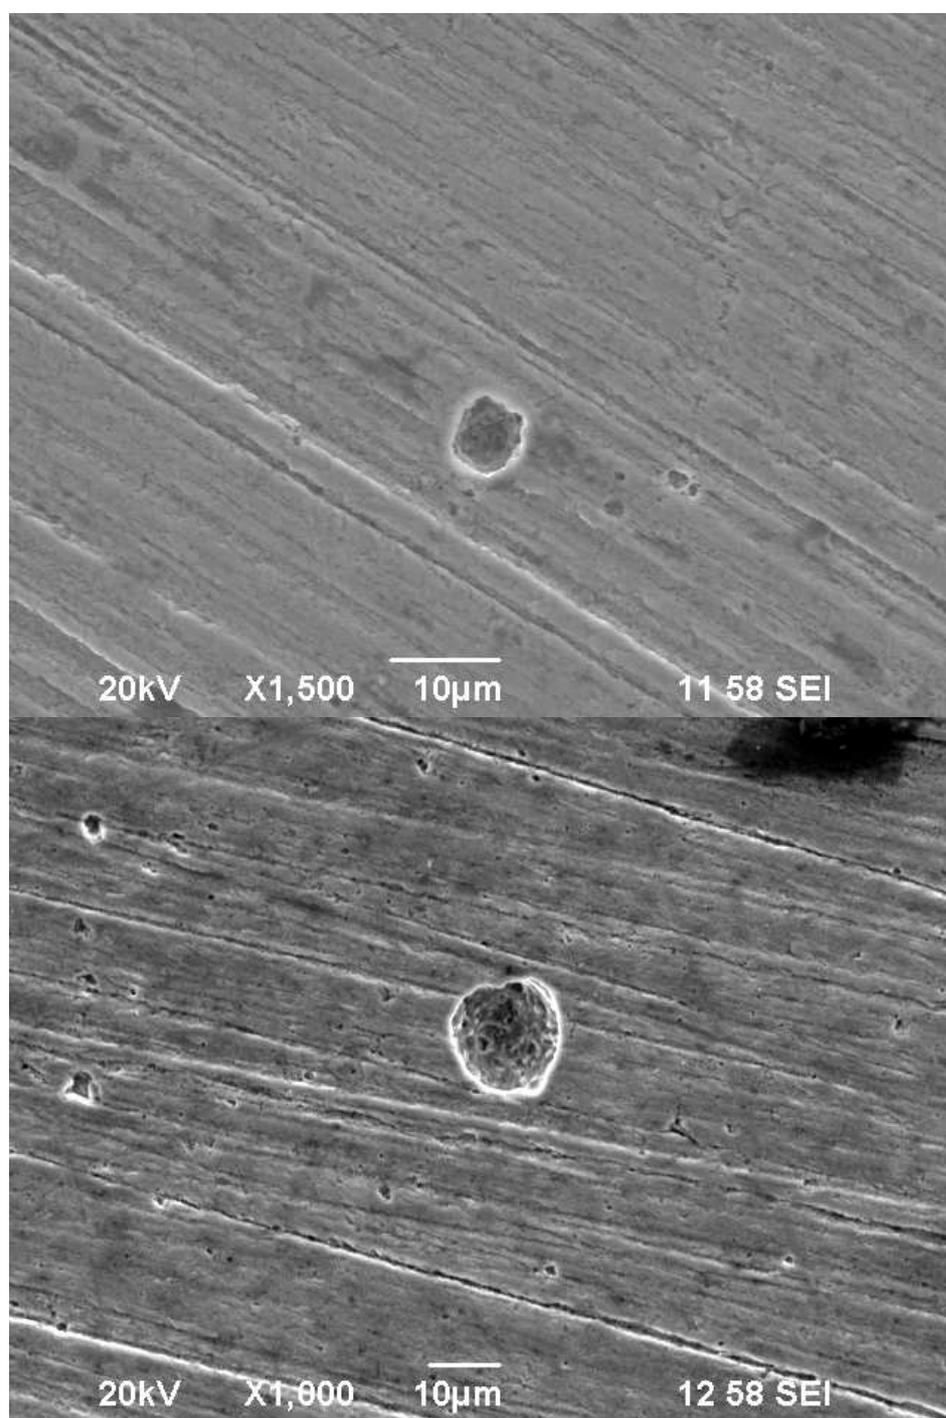
Figure 14. Corrosion specimen exposed to H₂S for 6 days at 0 wt% NaCl, 25°C, without corrosion product layer.

An SEM image of the specimen surface after corrosion product layer removal is shown in Figure 14. This confirms what was suspected to occur. Several points showing pitting attack were observed on the metal surface. The diameter of these small pits was from 6 μm to 15 μm .

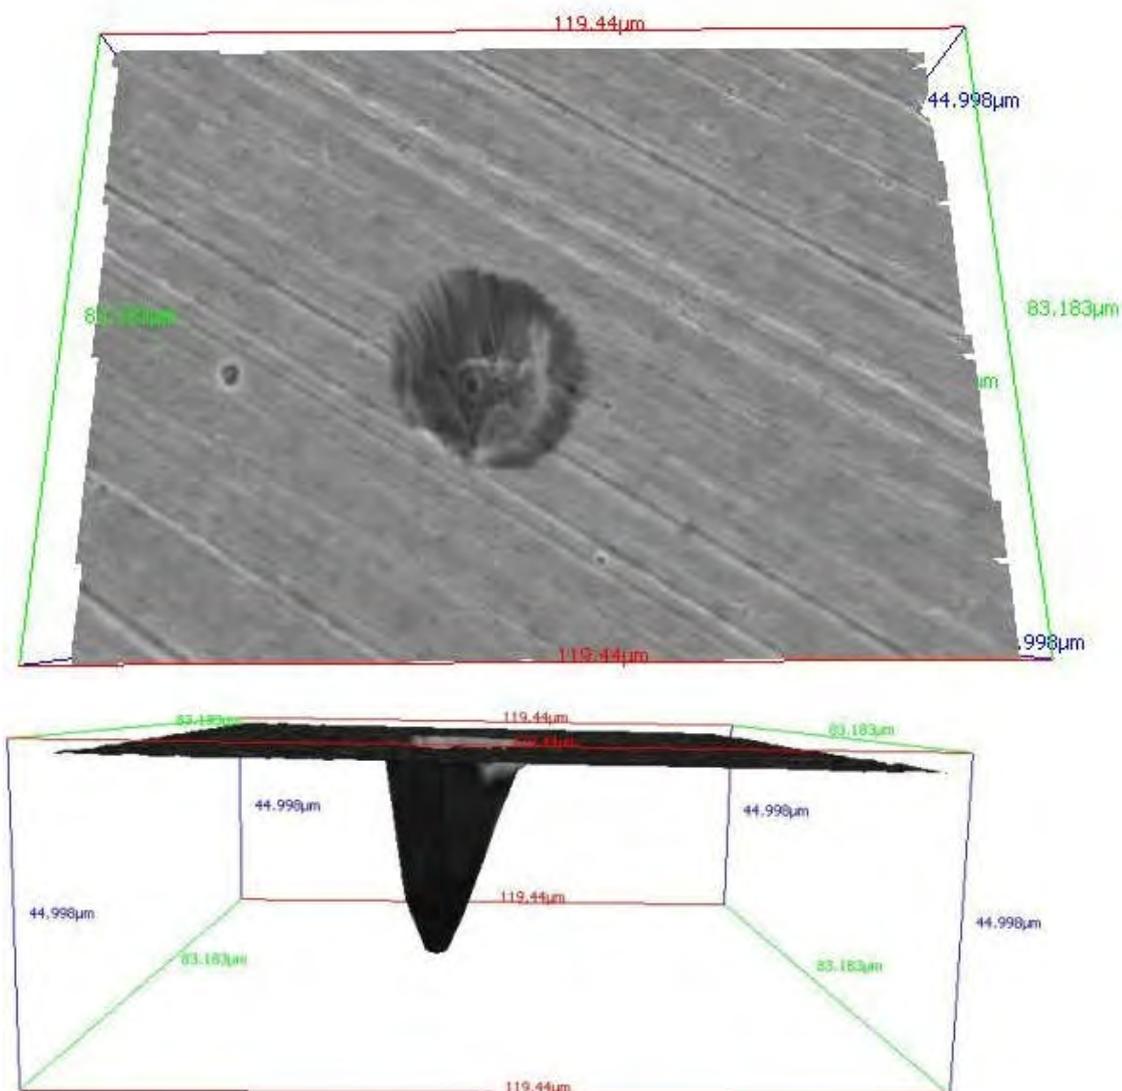
Figure 15. 3D view of corrosion specimen exposed to H_2S for 6 days at 0 wt% NaCl, $25^\circ C$, without corrosion product layer.

The MEX- 3D reconstruction of SEM Images software was used to analyze the pit depth. Figure 15 shows the 3D view of one pit. The pit depth is around 40 μm and the pitting rate is around 2.4 mm/yr. Compared with the general corrosion rate of 0.017 mm/yr, the localized corrosion rate is over two orders of magnitude higher. The results suggest that even without the aid of chloride ion, localized corrosion was still initiated. The cause for these phenomena must be further investigated.

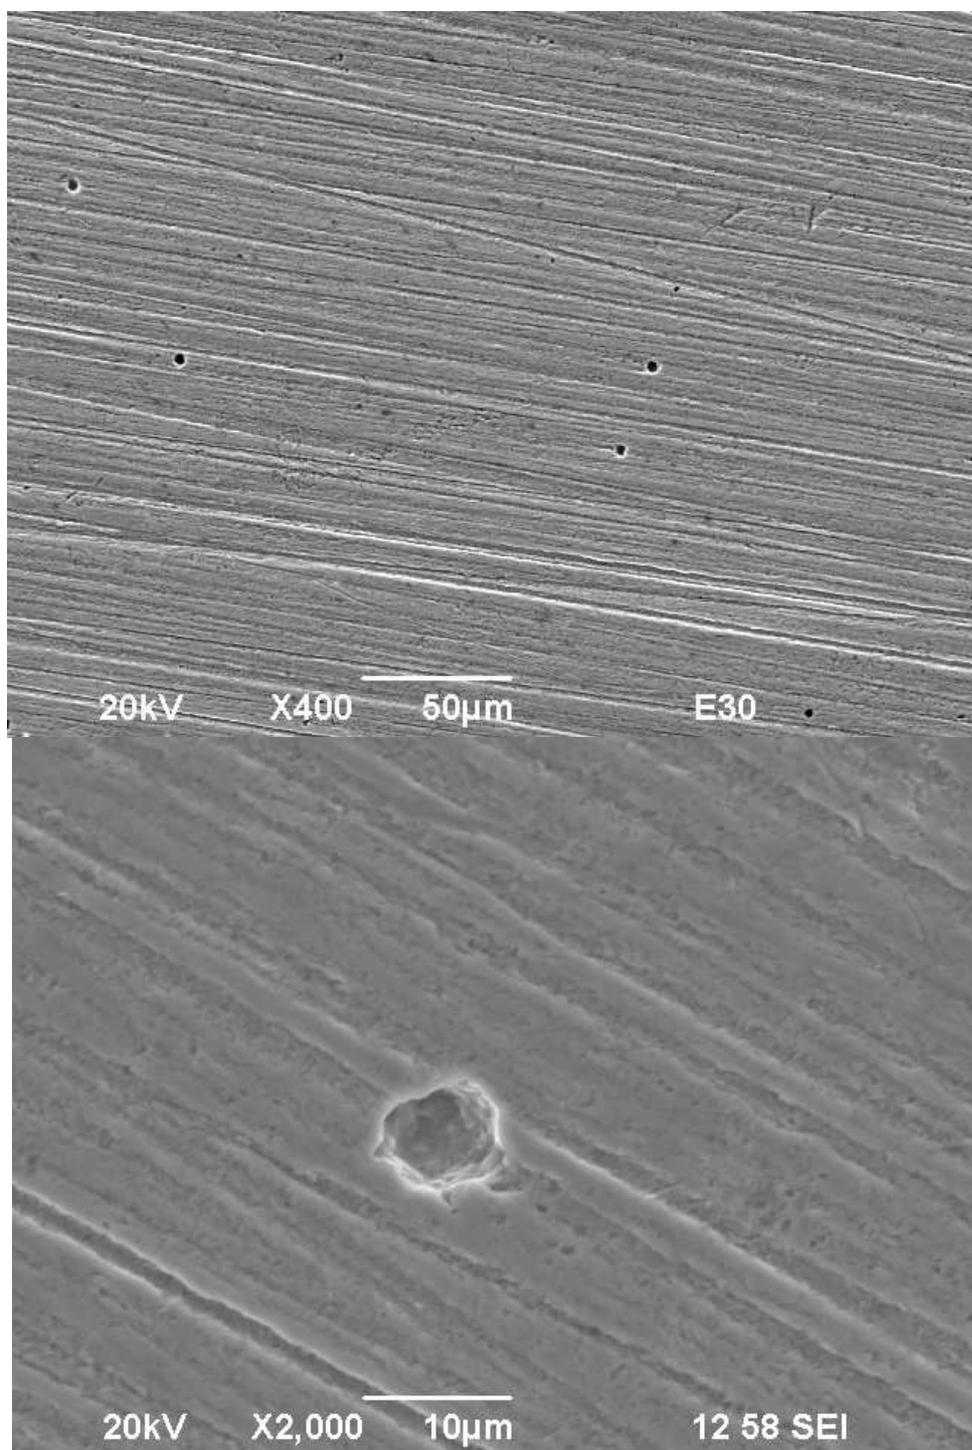
Figure 17. Corrosion specimen exposed to H₂S for 12 days at 0 wt% NaCl, 25°C, without corrosion product layer.

Pitting corrosion was also observed at 12 days after the specimen surface was revealed by Clarke's solution treatment. The pitting density at 12 days is higher than at 6 days (Figure 17). More and more small pits were observed after the corrosion product layer was removed by Clarke's solution. It appears that pit size did not change with time. The deepest pit depth observed is around 14 μm (Figure 18). This suggested that the pit did not grow with time, which means no propagation of localized corrosion occurred.

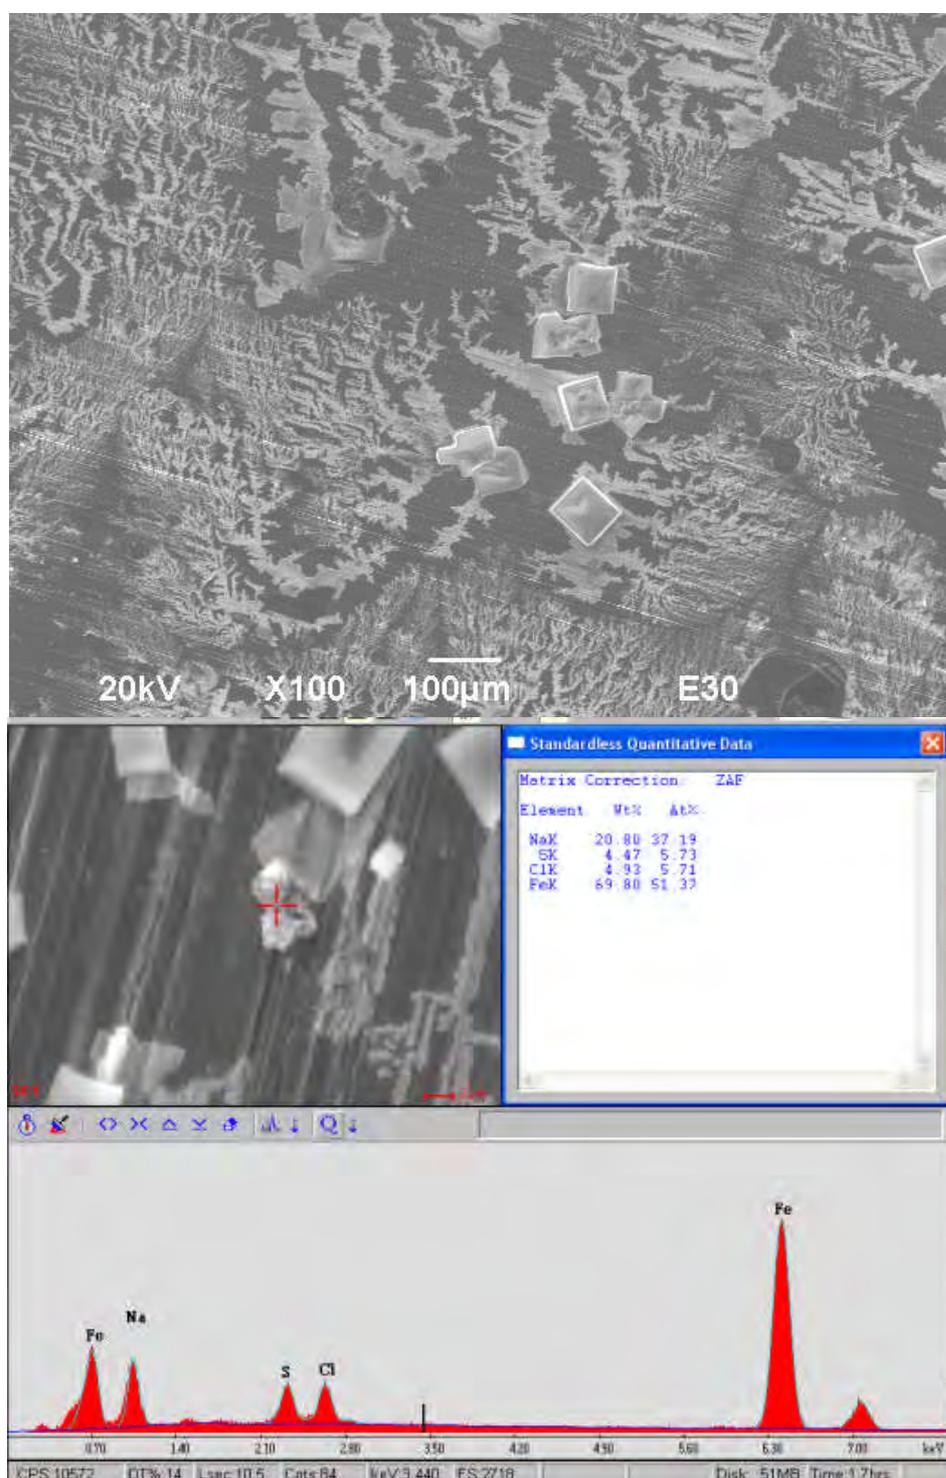
Figure 19. Corrosion specimen exposed to H_2S for 1 days at 10 wt% NaCl, 25°C, with corrosion product layer.

The SEM image of the steel specimen surface after one day exposure to H₂S is shown in Figure 19. There is barely any iron sulfide layer formed on the metal surface compared to similar observations in salt-free conditions. This suggests that the addition of a high content of salt significantly slowed down the uniform corrosion rate, which was confirmed by the weight loss measurement (Figure 20). A considerable quantity of sodium chloride is observed in the SEM image, crystallized on the metal surface due to rapid dehydration of alcohol used to dry the steel specimen after exposure. This is apparent as both cubic crystals and dendritic structures on the specimen surface.

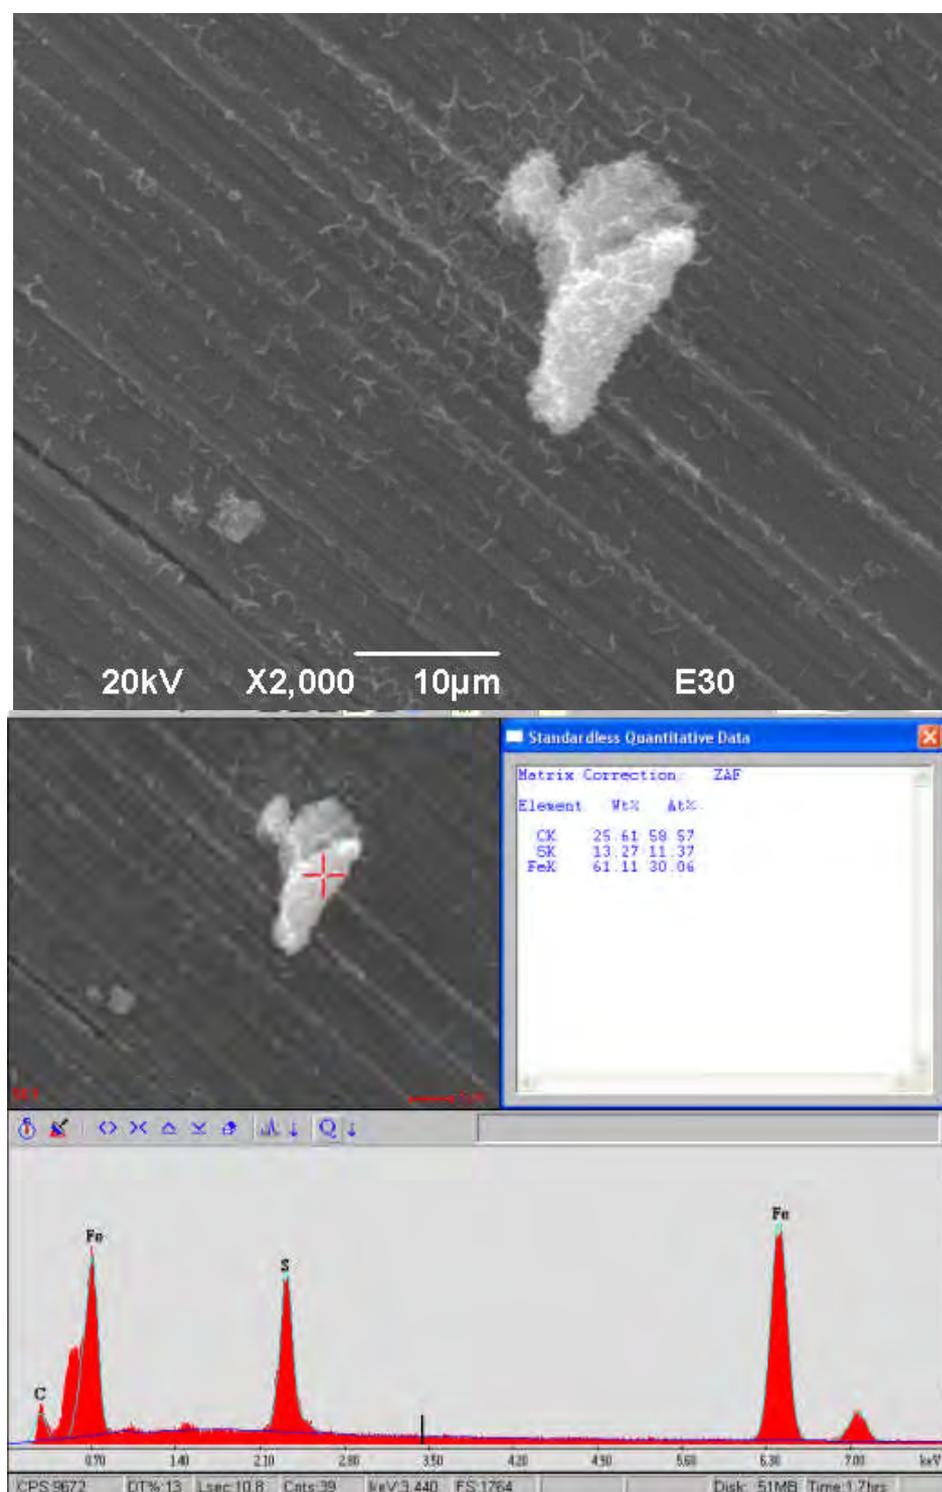
Figure 21. Corrosion specimen exposed to H₂S for 3 days at 10 wt% NaCl, 25°C, with corrosion product layer.

In this case, the corrosion specimen was first rinsed with deoxygenated deionized water to remove sodium chloride after retrieval from the glass cell. Therefore, no NaCl crystals were observed on the specimen surface. After three days exposure to H₂S, it appears that most of the specimen surface still showed little corrosion (Figure 21). Small amounts of iron sulfide layer were unevenly distributed on the steel surface. It appears that the addition of chloride ions slowed down the reaction rate between steel and H₂S instead of accelerating the reaction, as was suggested by the literature.

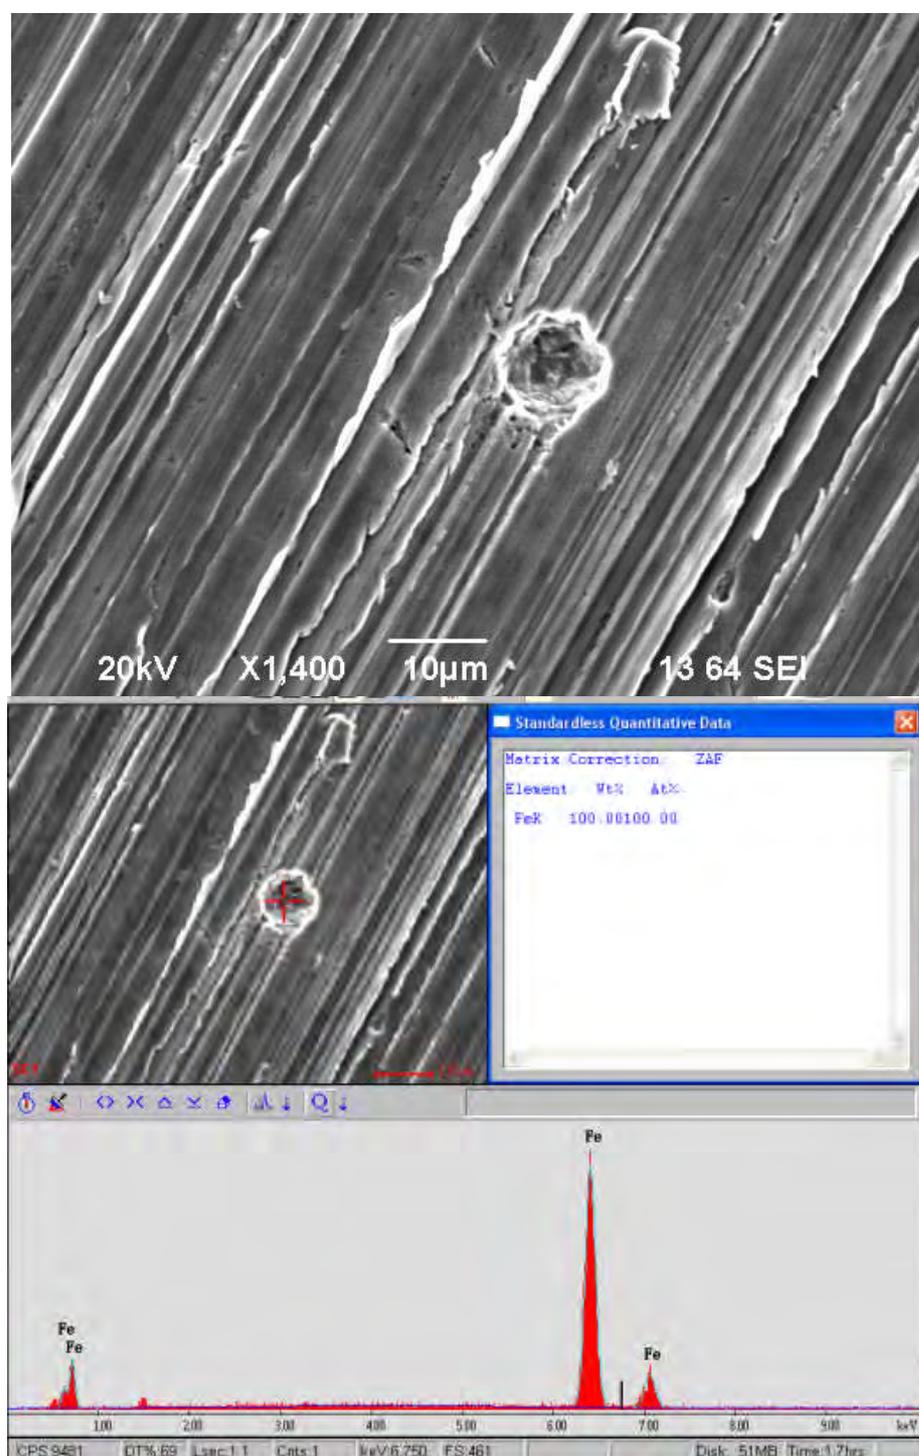
Figure 23. Corrosion specimen exposed to H₂S for 7 days at 10 wt% NaCl, 25°C, without corrosion product layer.

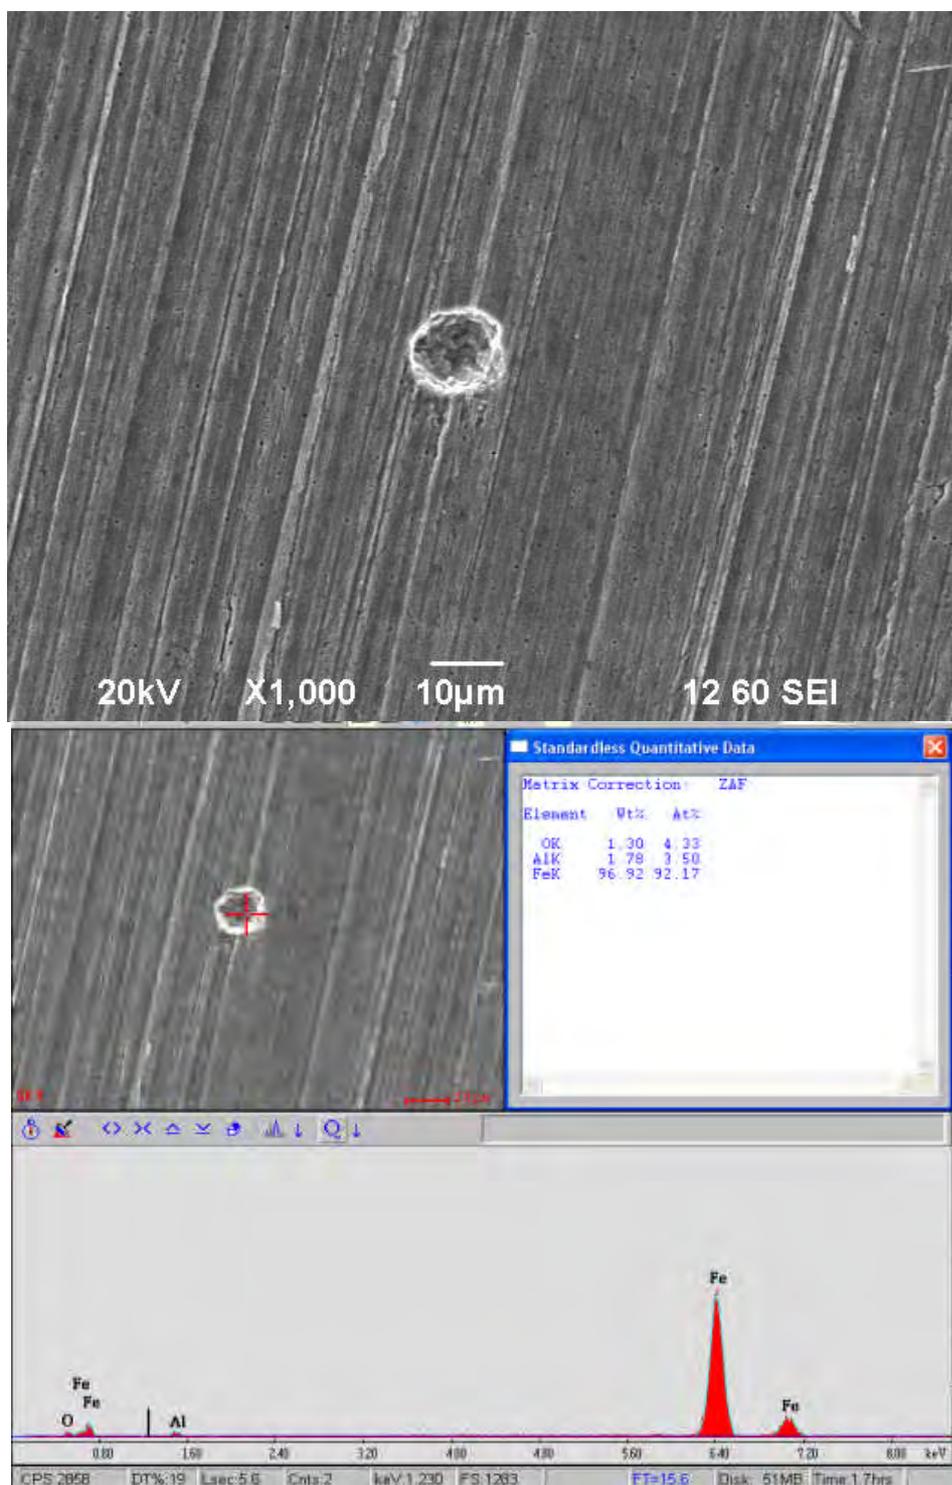
Figure 25. Corrosion specimen exposed to H_2S for 15 days at 10 wt% NaCl, 25°C, without corrosion product layer.

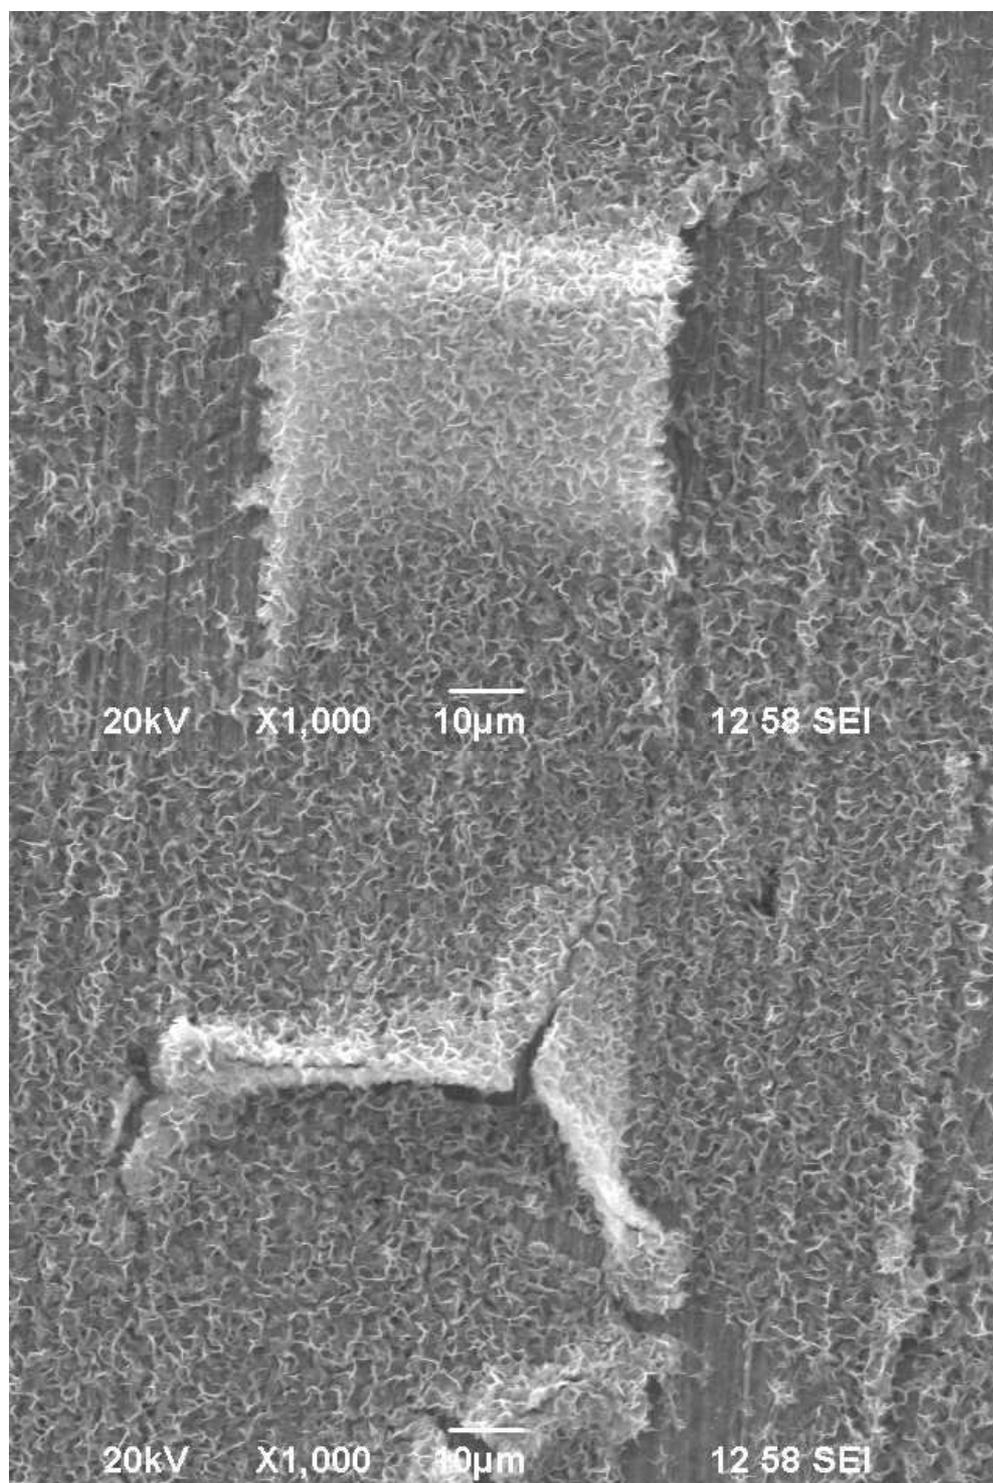
Figure 27. Corrosion specimen exposed to H₂S for 26 days at 10 wt% NaCl, 25°C, with corrosion product layer.

Figure 27 shows the iron sulfide layer morphology after the corrosion specimen was exposed to H₂S for 26 days. Some major cracks of the iron sulfide layers were observed. Large and deep pits were expected; however, no severe pitting corrosion was observed after the iron sulfide layer was removed.

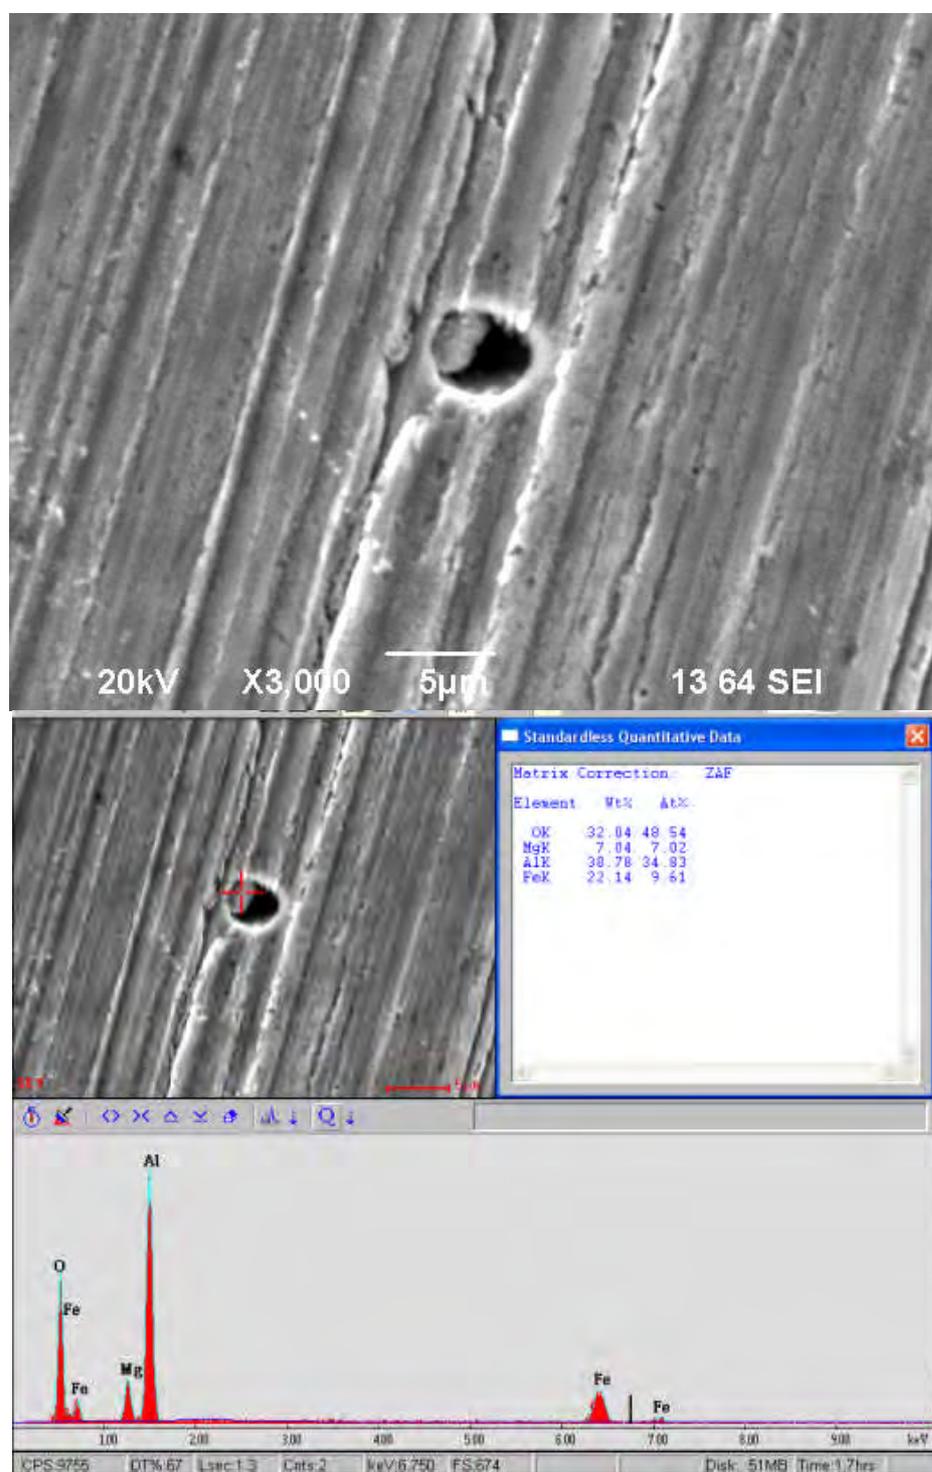
Figure 28. Corrosion specimen exposed to H₂S for 6 days at 0 wt% NaCl, 25°C, without corrosion product layer.

As stated above, some pitting (localized corrosion) was observed on the specimen surface even in the salt-free test conditions. Exposed specimens were re-examined by SEM and EDX to try to establish the cause of pitting initiation. Figure 28 shows one location of the specimen surface without the iron sulfide layer at 6 days exposure to a salt-free solution at 25°C, showing what appears to be a bead of a different material at the bottom of the pit. The same was found at several locations. EDX results confirmed the presence of aluminum and magnesium inside the pits. It is suspected that these may have been present as inclusions in the parent steel or were introduced by the surface polishing process. The feasibility of the first assumption was confirmed by looking at steel composition and consulting a metallurgist. The second assumption needed further investigation. Figure 29 shows a freshly prepared bare metal surface polished by sand paper: aluminum and magnesium were also found at a few locations. Gold sputter-coated sand paper was analyzed by EDX and the same elements were found (Figure 30) confirming that the metal inclusion in the steel may have been related to specimen preparation.

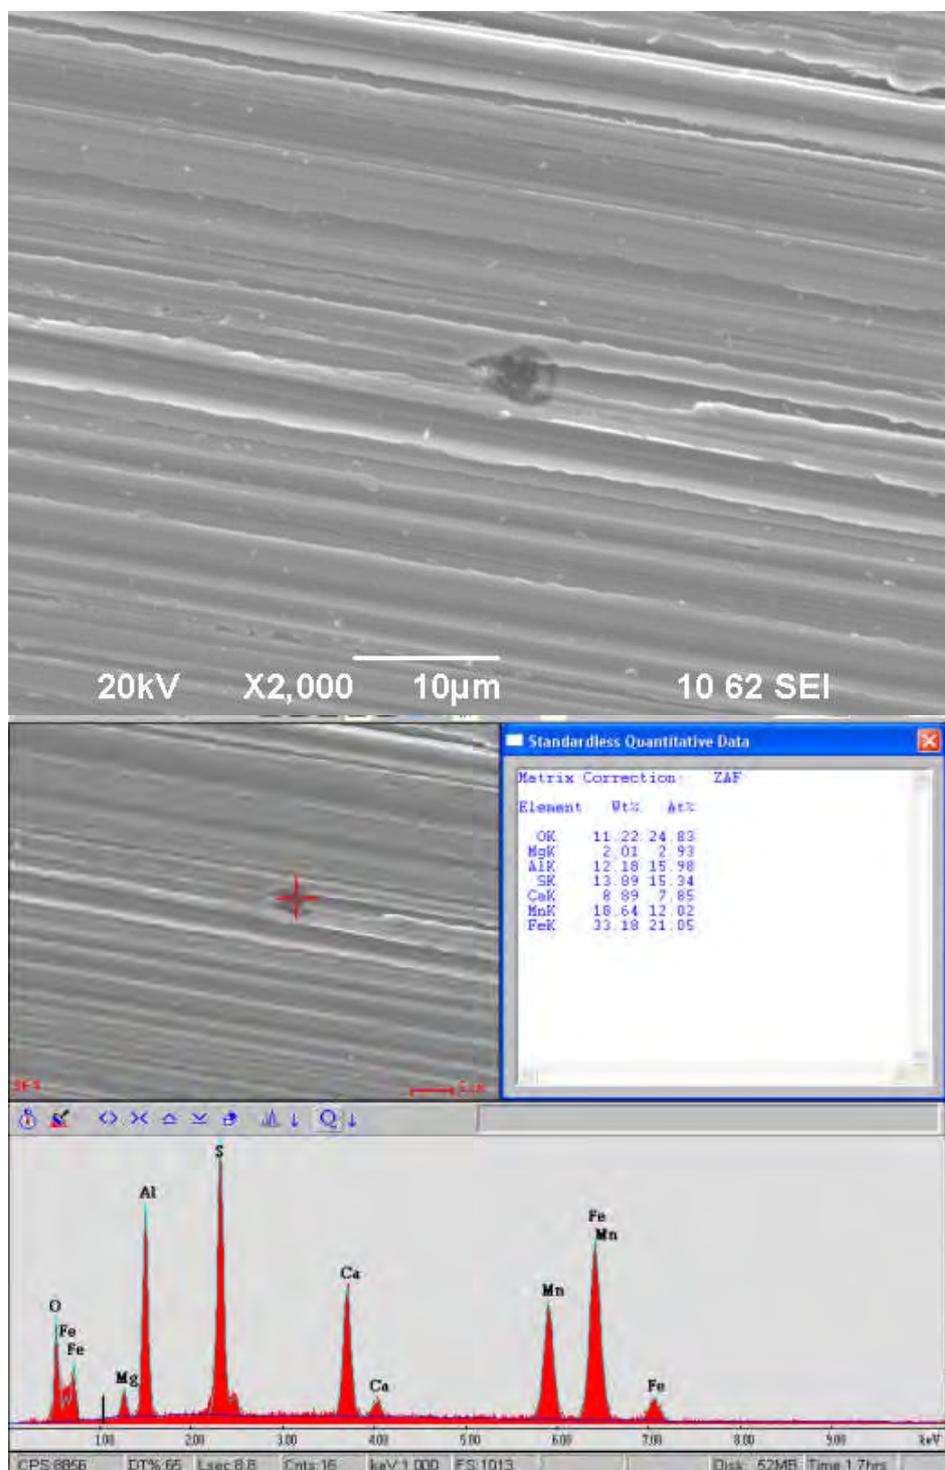
Figure 29. Freshly prepared bare corrosion specimen surface polished to 600 grit sand paper.
