Investigation of Localized Corrosion of Carbon Steel in H₂S Environments

A dissertation presented to
the faculty of
the Russ College of Engineering and Technology of Ohio University

In partial fulfillment
of the requirement for the degree
Doctor of Philosophy

Haitao Fang

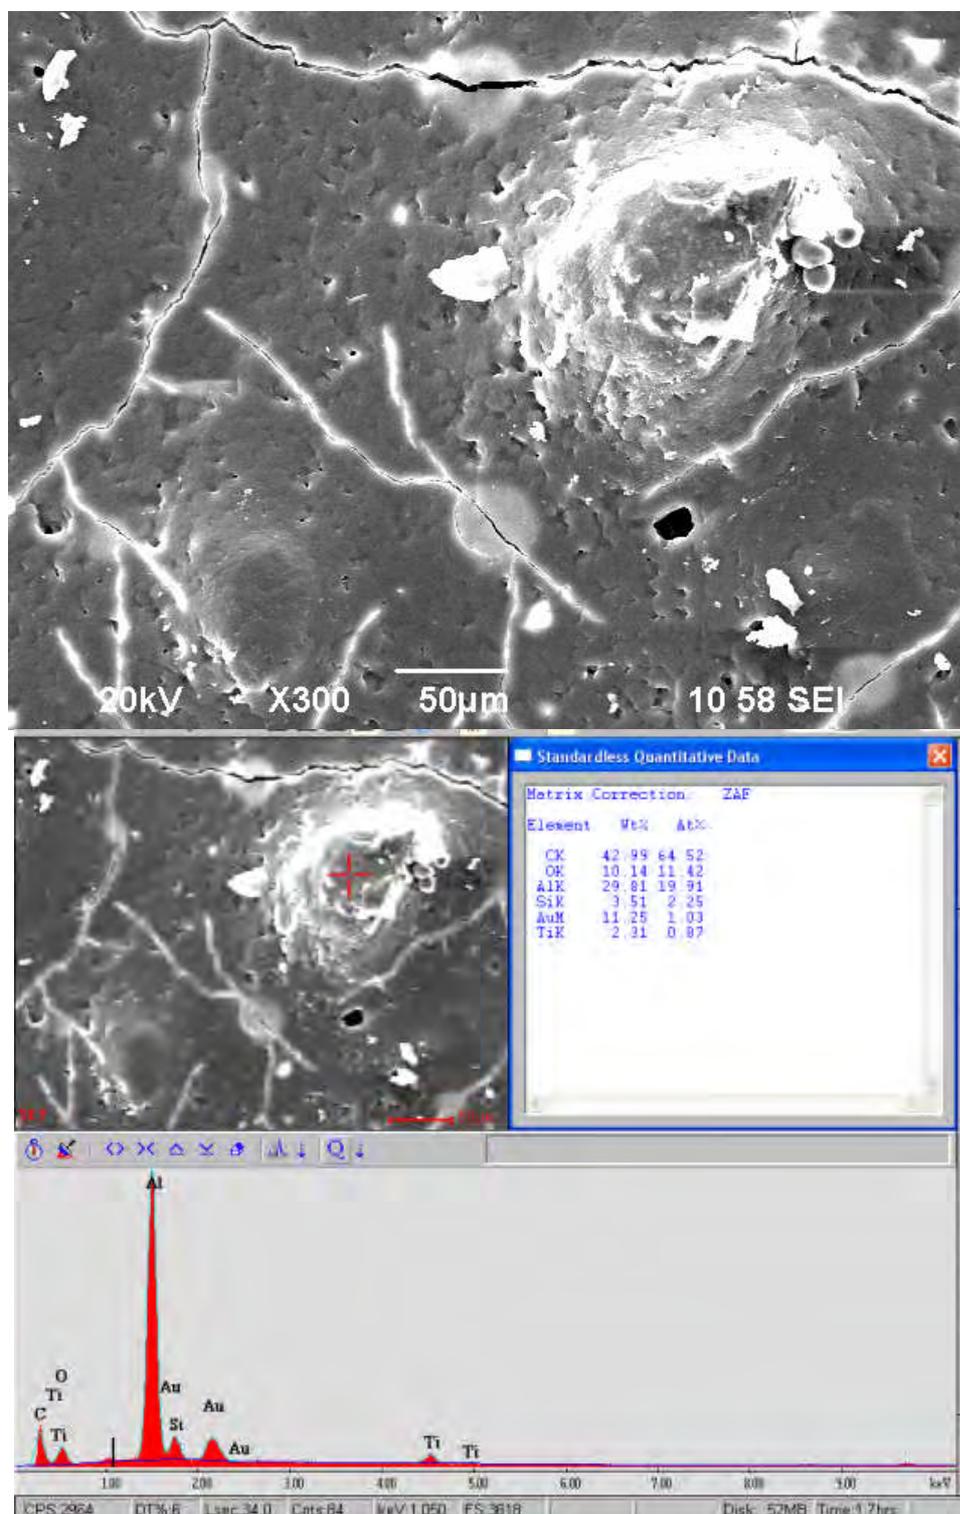
Figure 30. Analysis of gold sputter-coated sand paper.

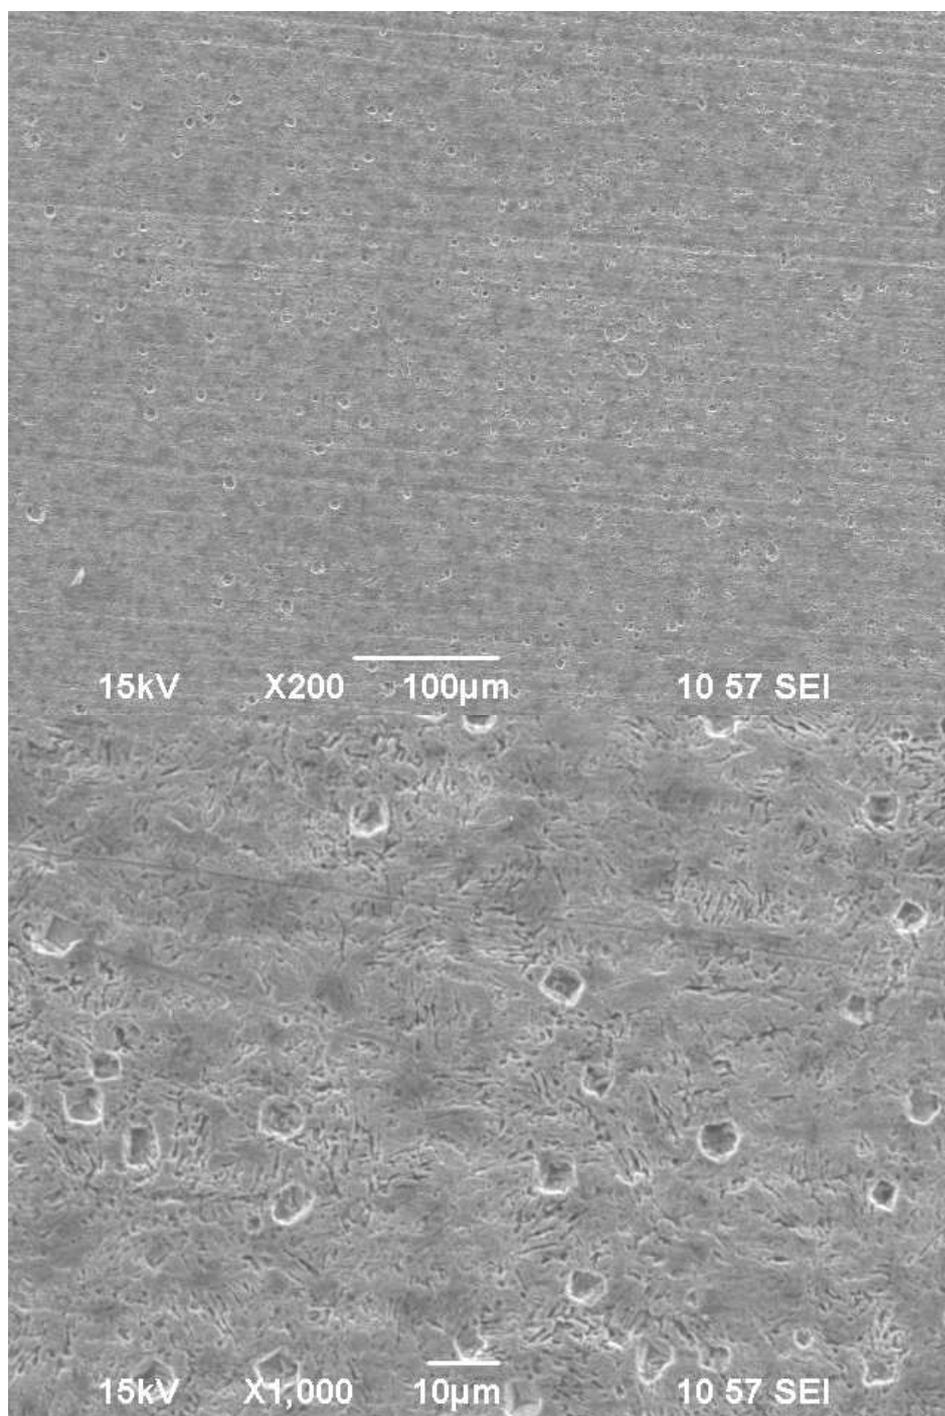
Figure 32. Corrosion specimen exposed to 0.01 bar H₂S for 7 days at 10 wt% NaCl, 80°C, without corrosion product layer.

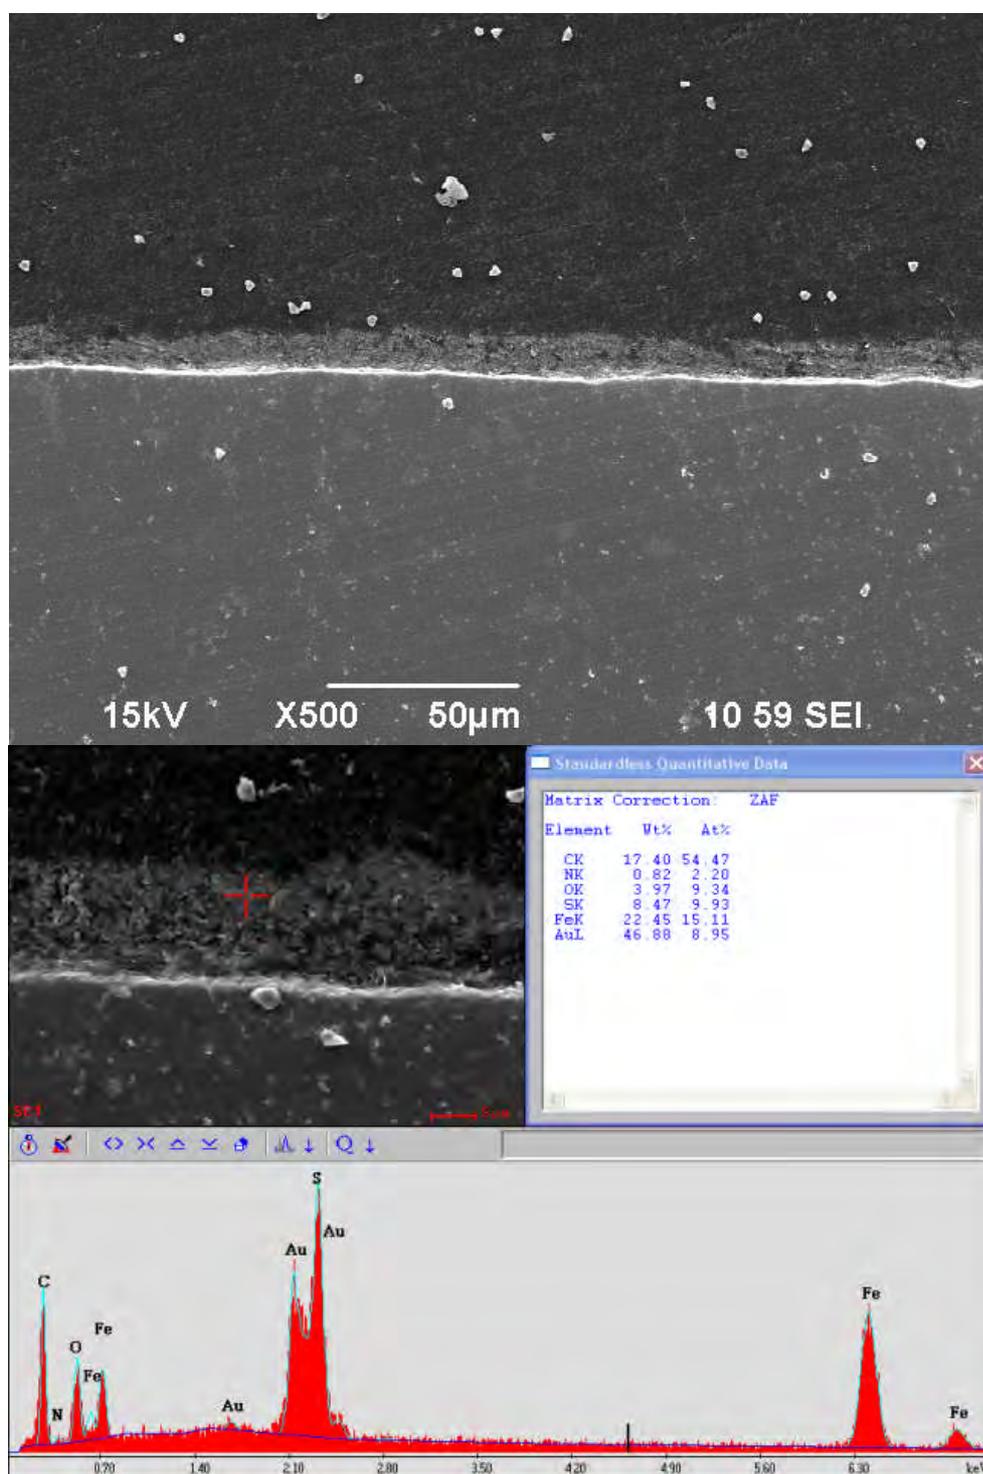
Figure 33. Cross-section of a corrosion specimen exposed to 0.01 bar H₂S for 7 days at 10 wt.% NaCl, 80°C, with corrosion product layer.

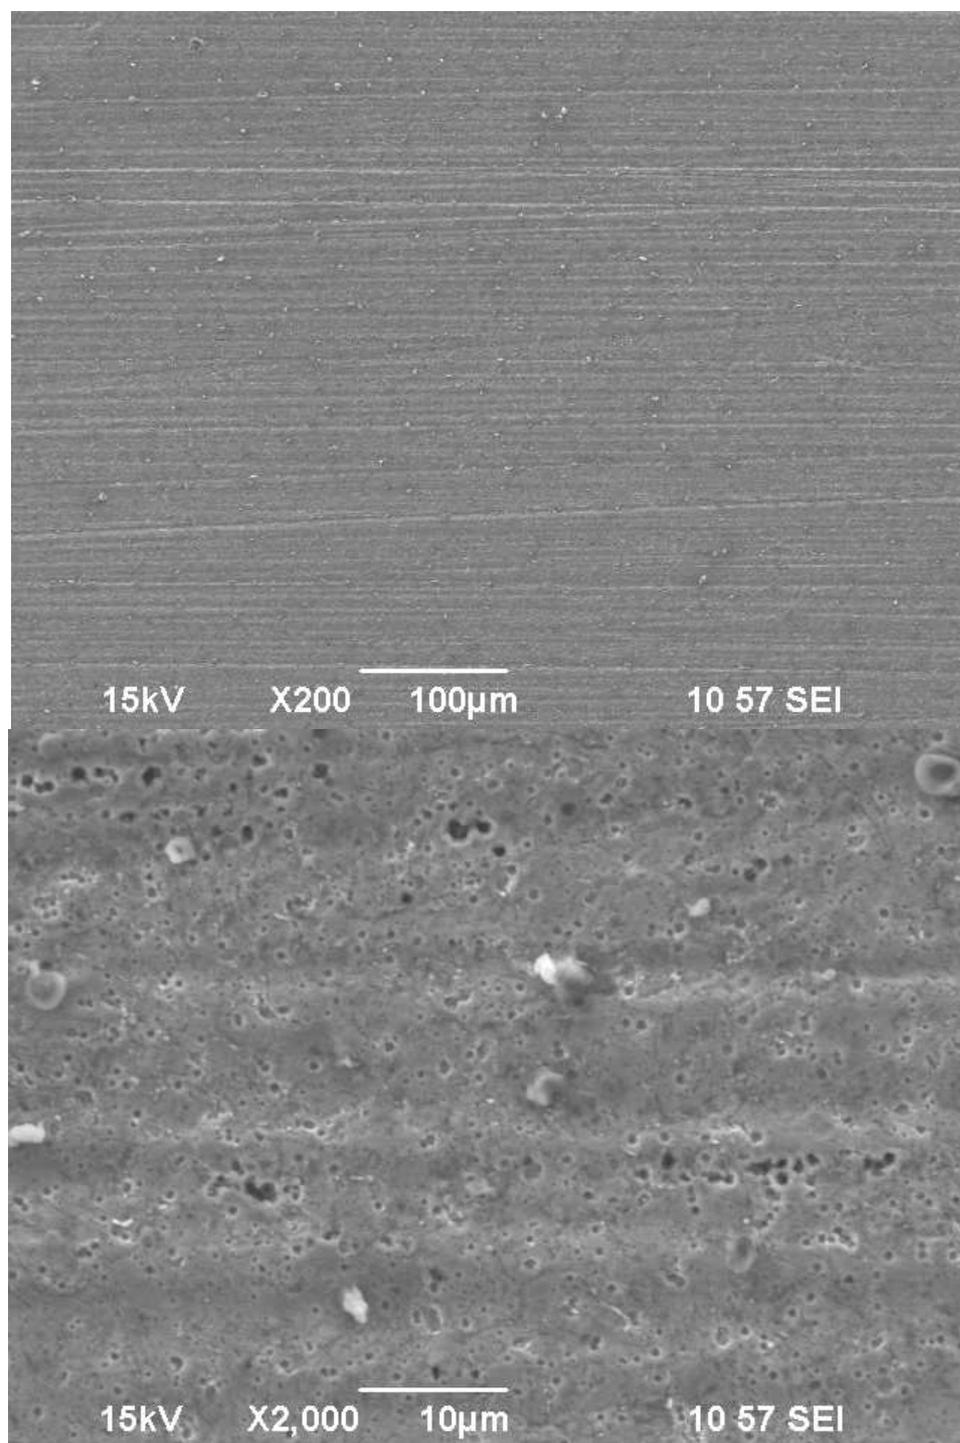
Figure 35. Corrosion specimen exposed to 0.1 bar H₂S for 7 days at 10 wt.% NaCl, 80°C, without corrosion product layer.

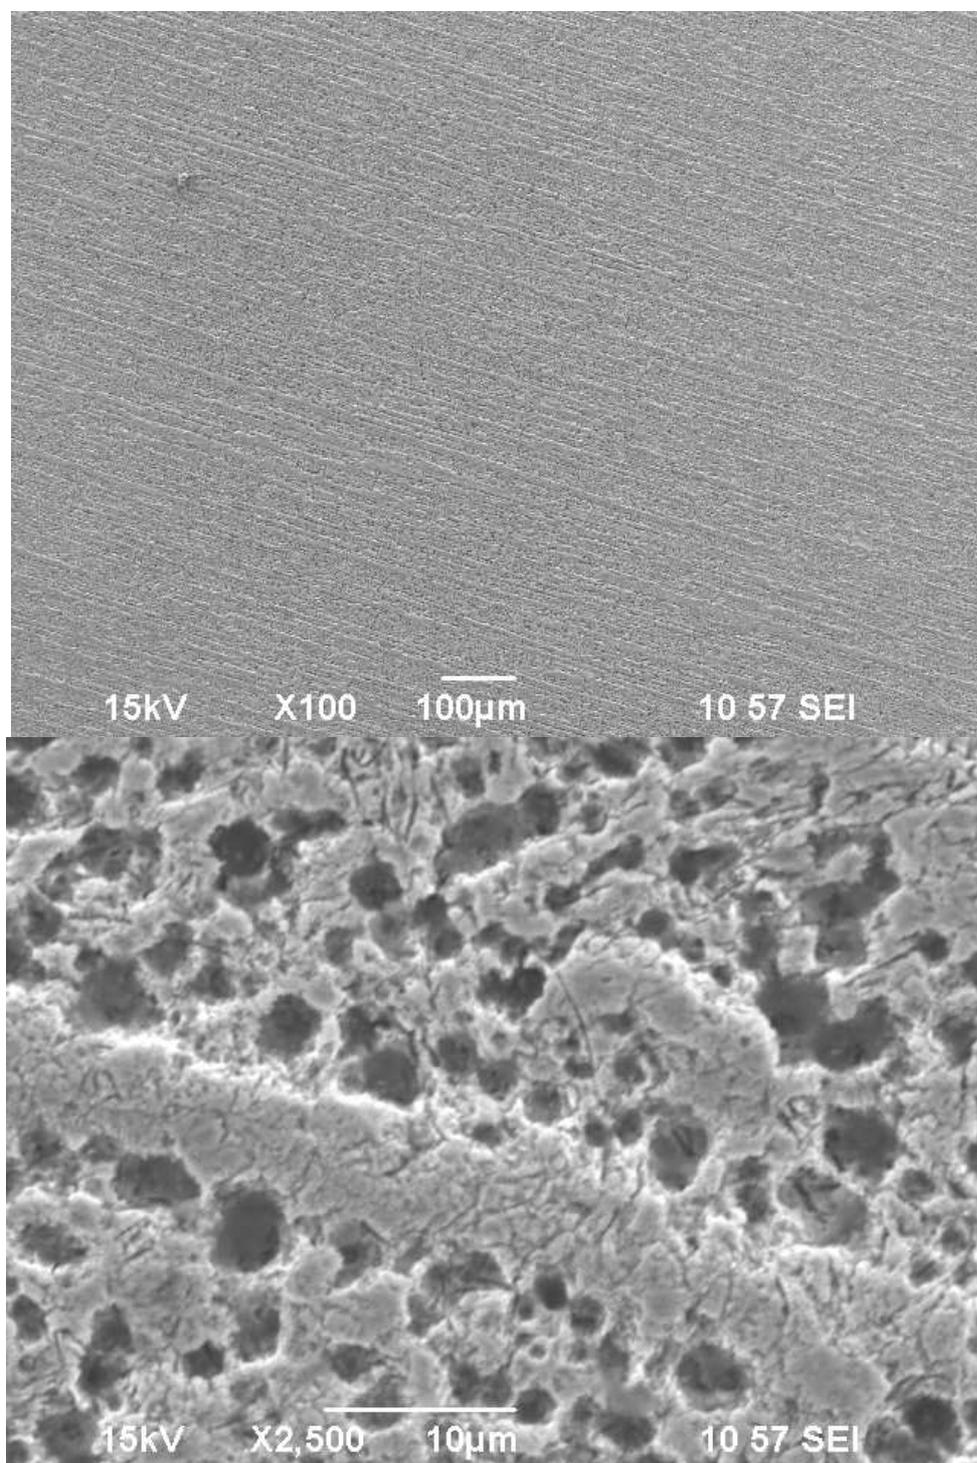
Figure 37. Corrosion specimen exposed to 1 bar H_2S for 7 days at 10 wt.% NaCl, 80°C, without corrosion product layer.

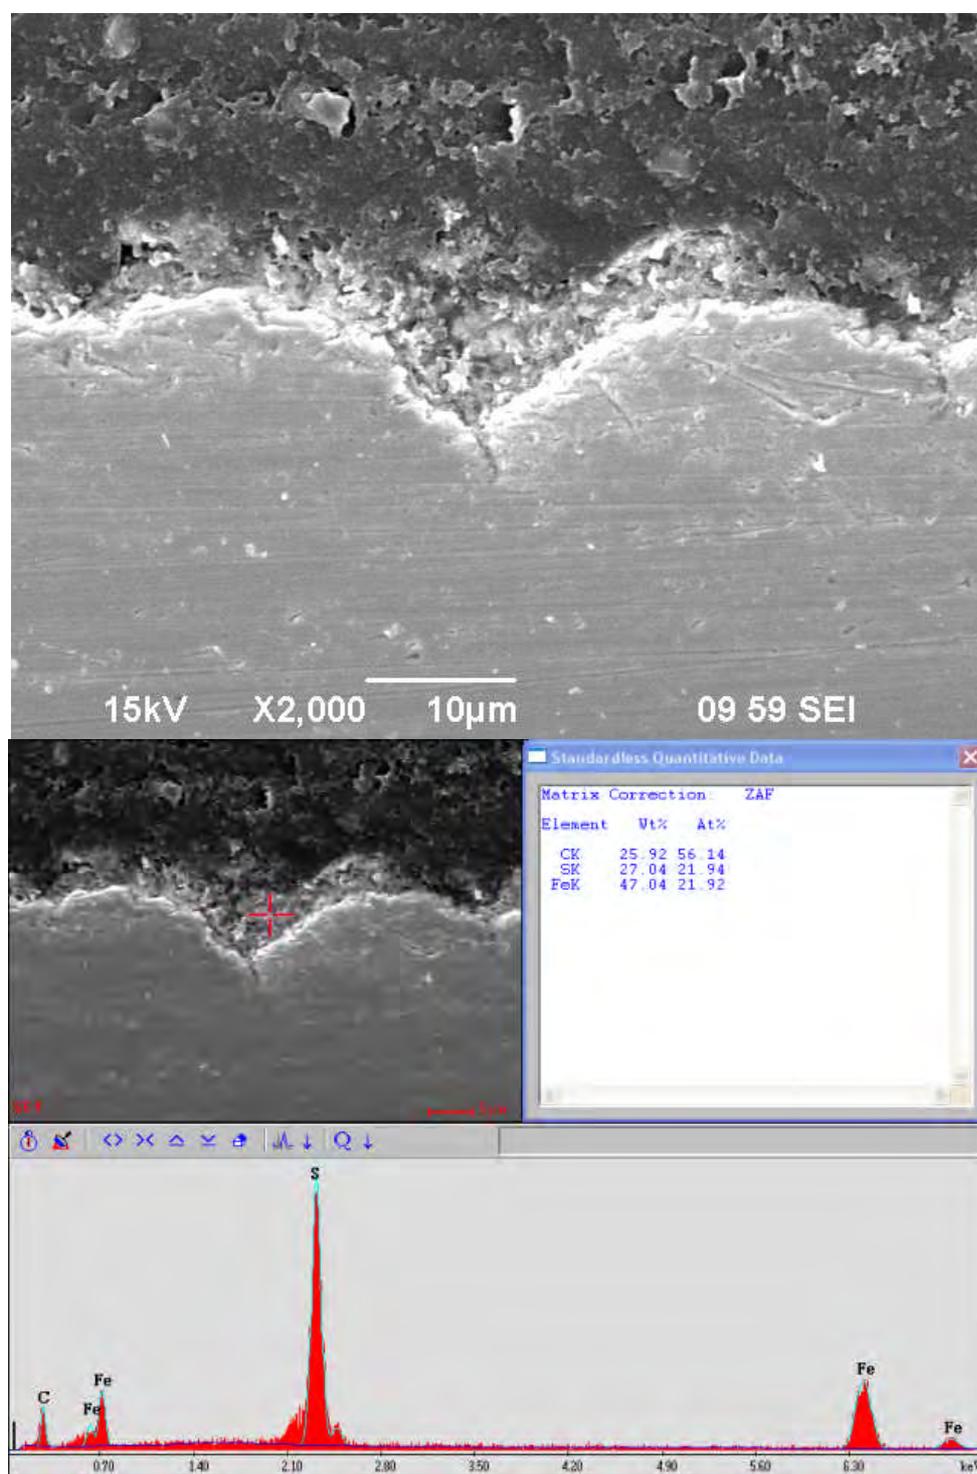
Figure 38. Cross-section of a corrosion specimen exposed to 1 bar H₂S for 7 days at 10 wt.% NaCl, 80°C, with corrosion product layer.

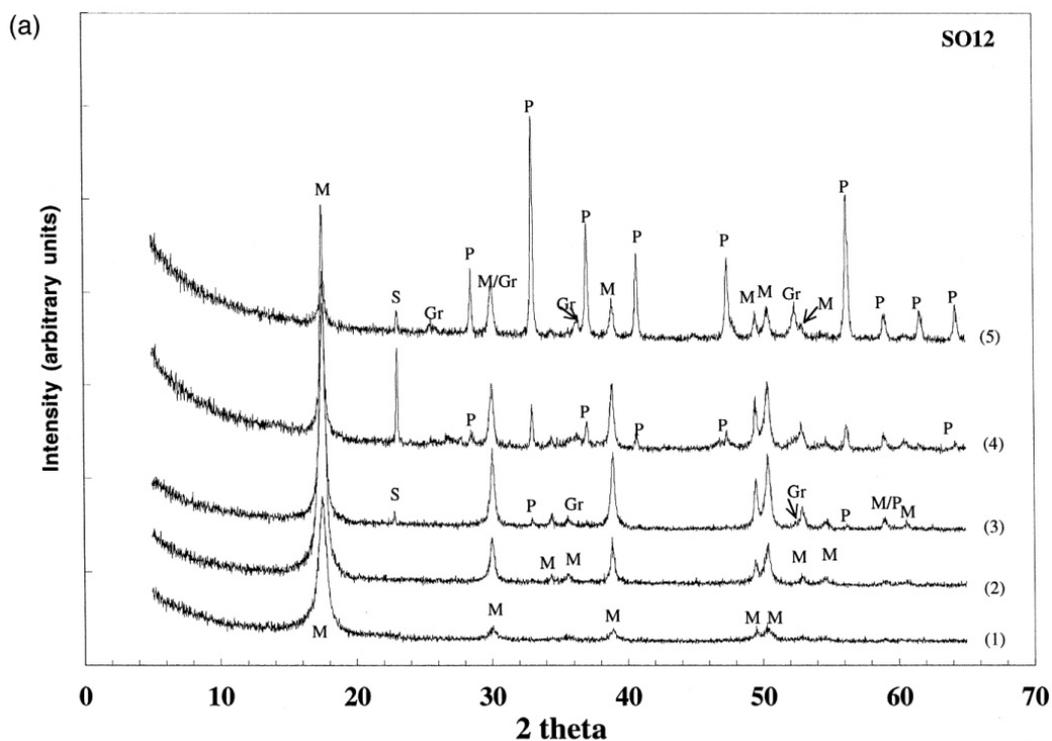
Figure 55. X-ray diffraction data for mackinawite oxidation in aqueous solution (S: sulfur [S_8]; M: mackinawite [FeS]; G: greigite [Fe_3S_4]; P: pyrite [FeS_2]).¹⁰³

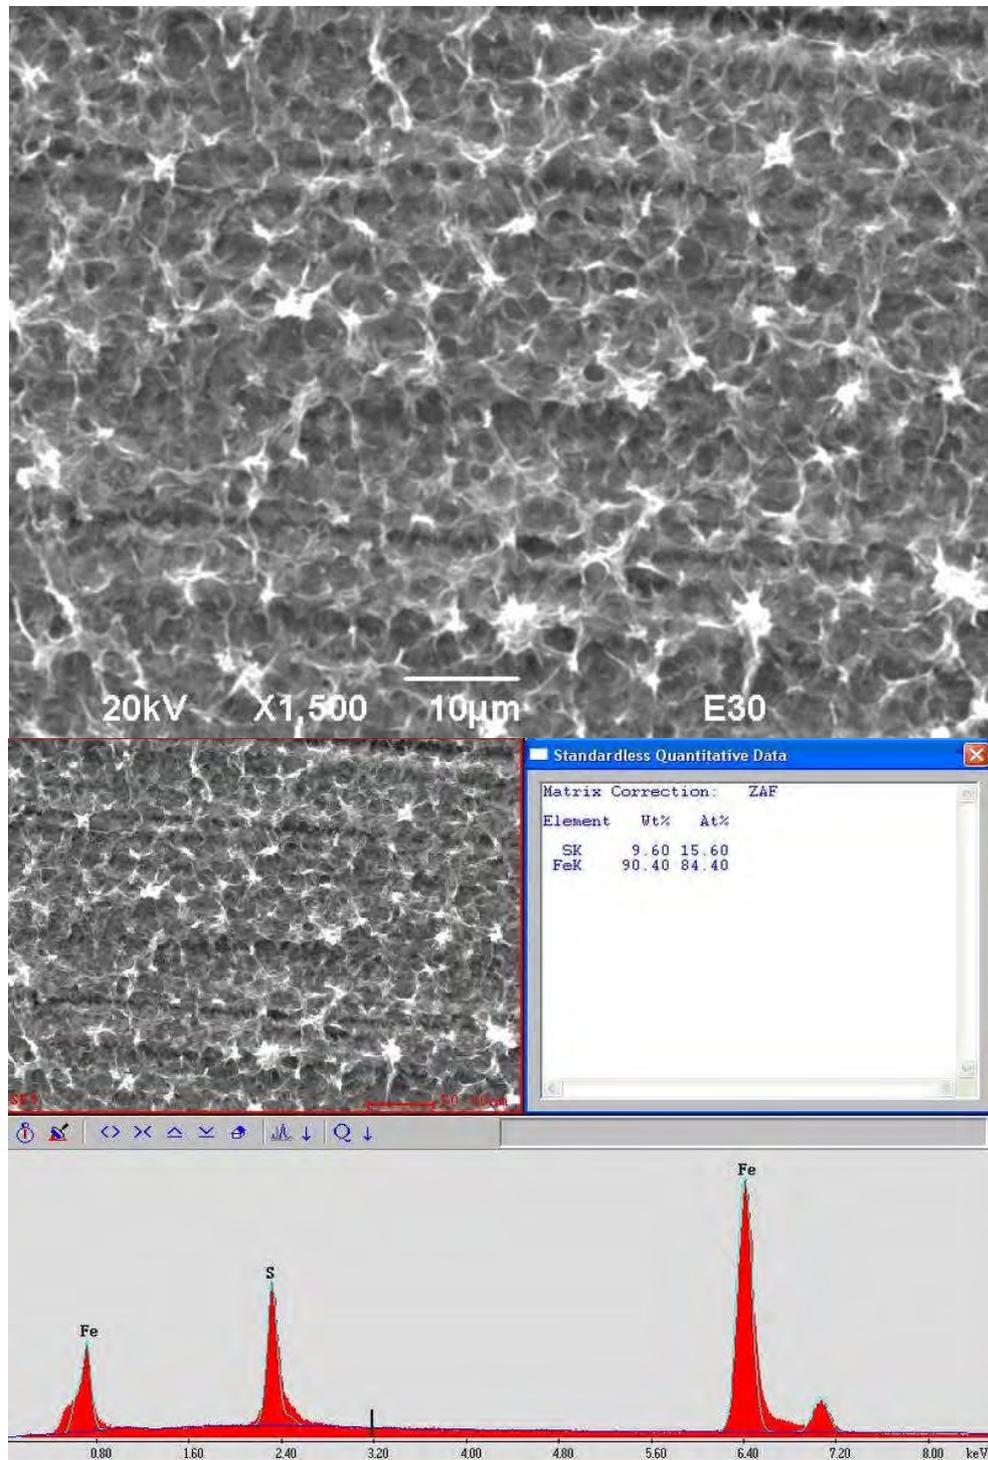
Figure 59. SEM image and EDX spectrum of a specimen surface after a 1 day exposure to 100 ppm H₂S.

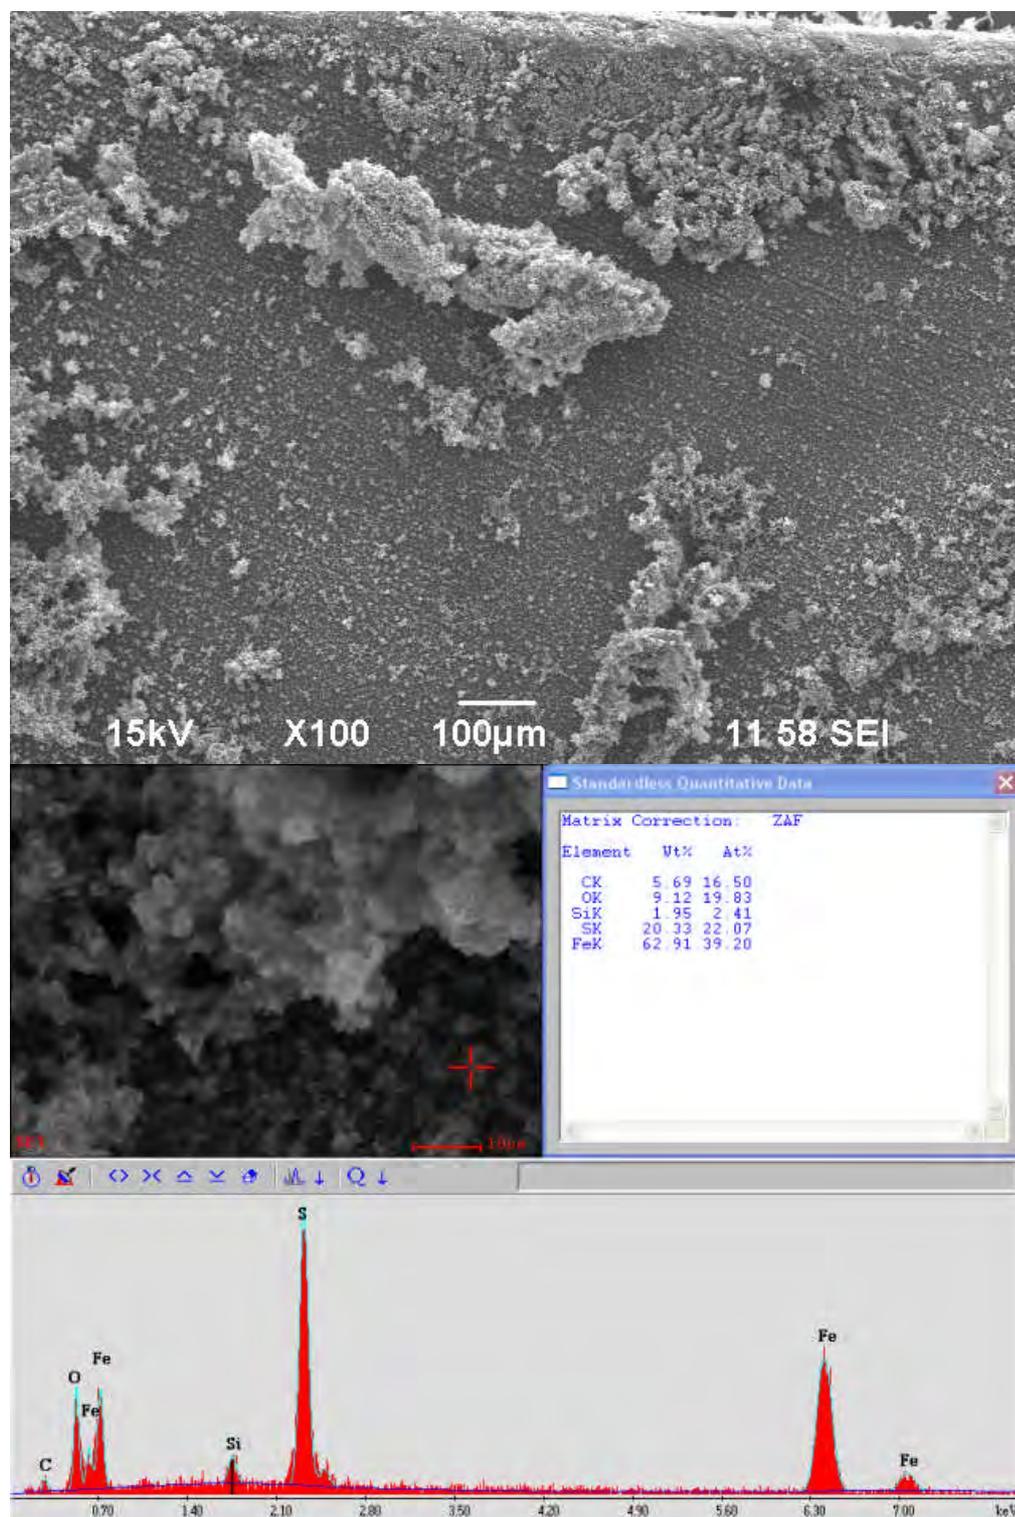
Figure 60. SEM image and EDX spectrum of a specimen surface after a 1 day exposure to air (H_2S was stopped purging)

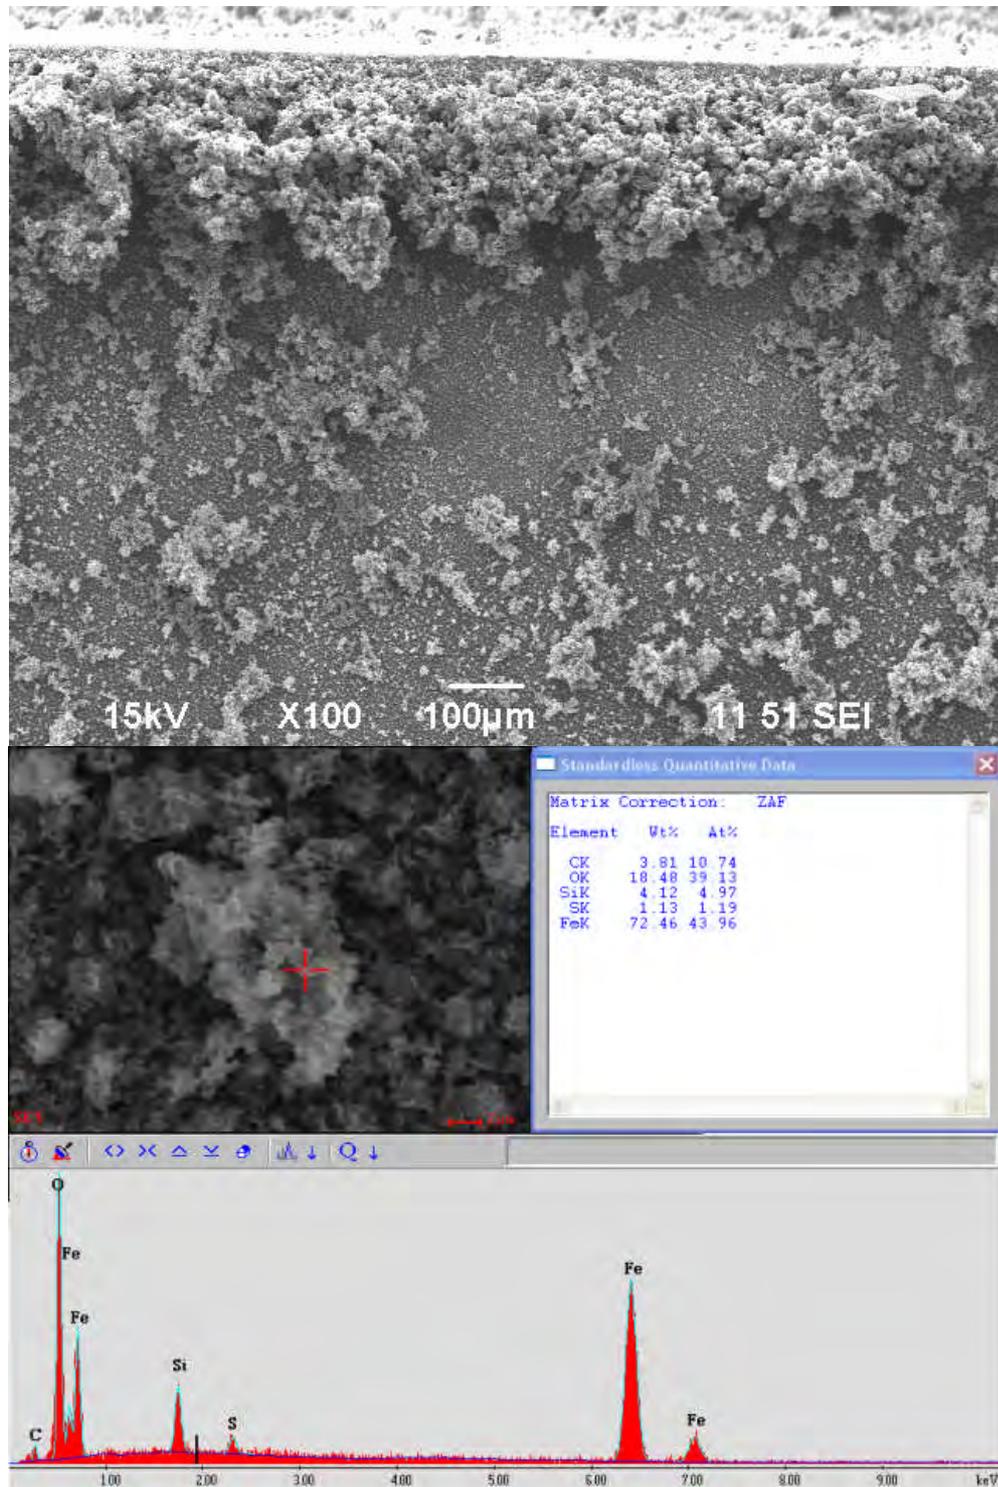
Figure 61. SEM image and EDX spectrum of a specimen surface after a 5 days exposure to Certified Breathing Air (H_2S was stopped purging)

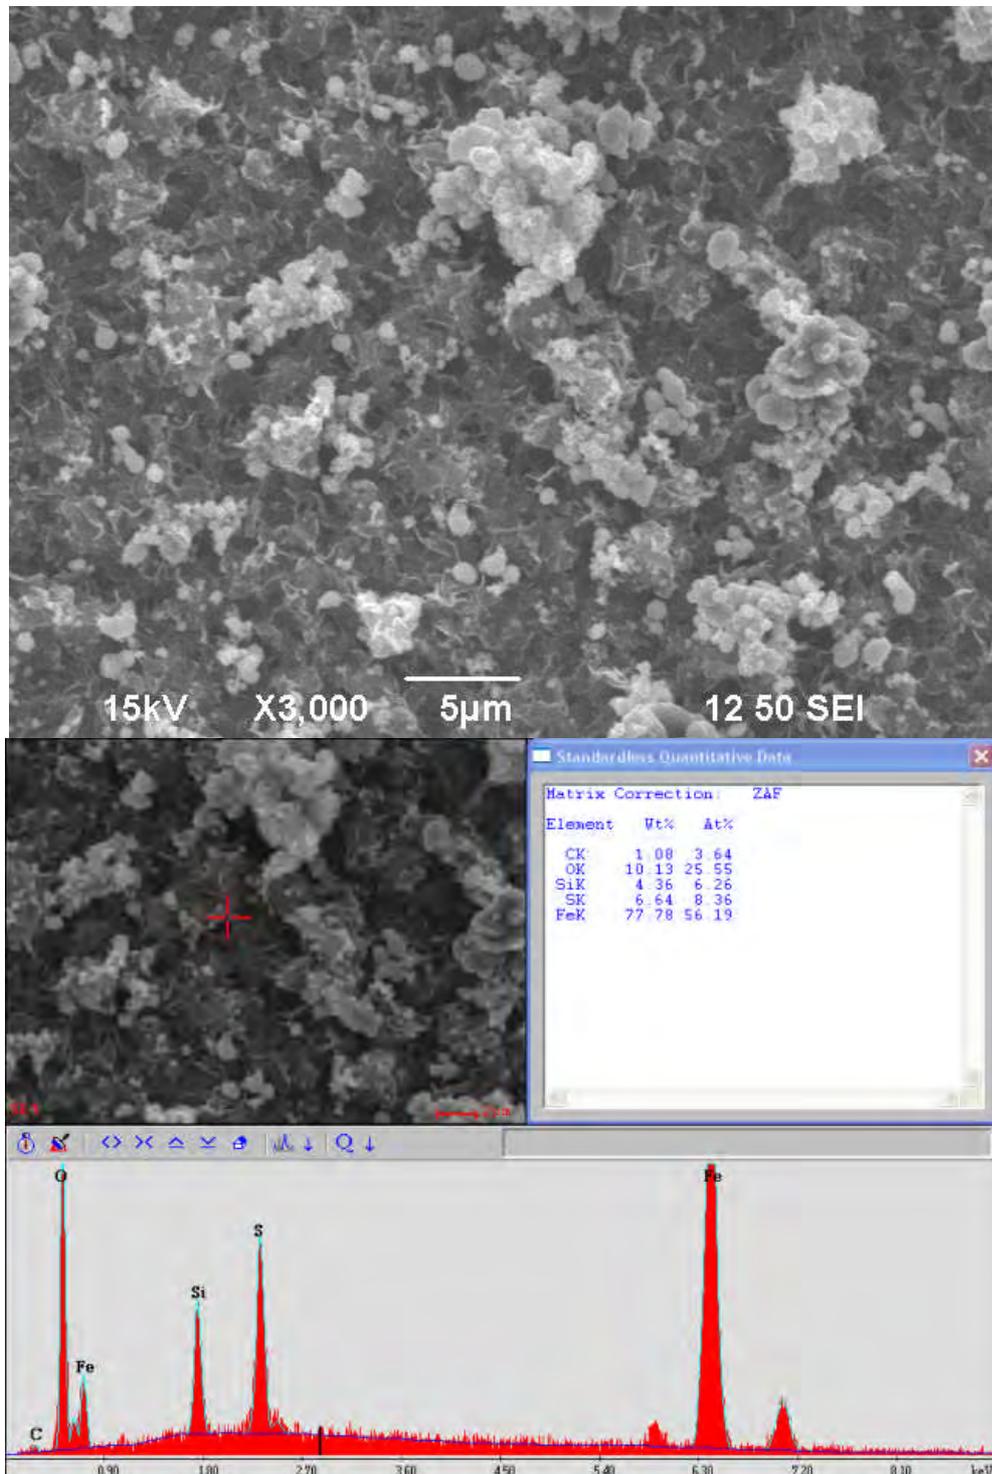
Figure 63. SEM image and EDX spectrum of a specimen surface after a 16 days exposure to Certified Breathing Air (H_2S was stopped purging)

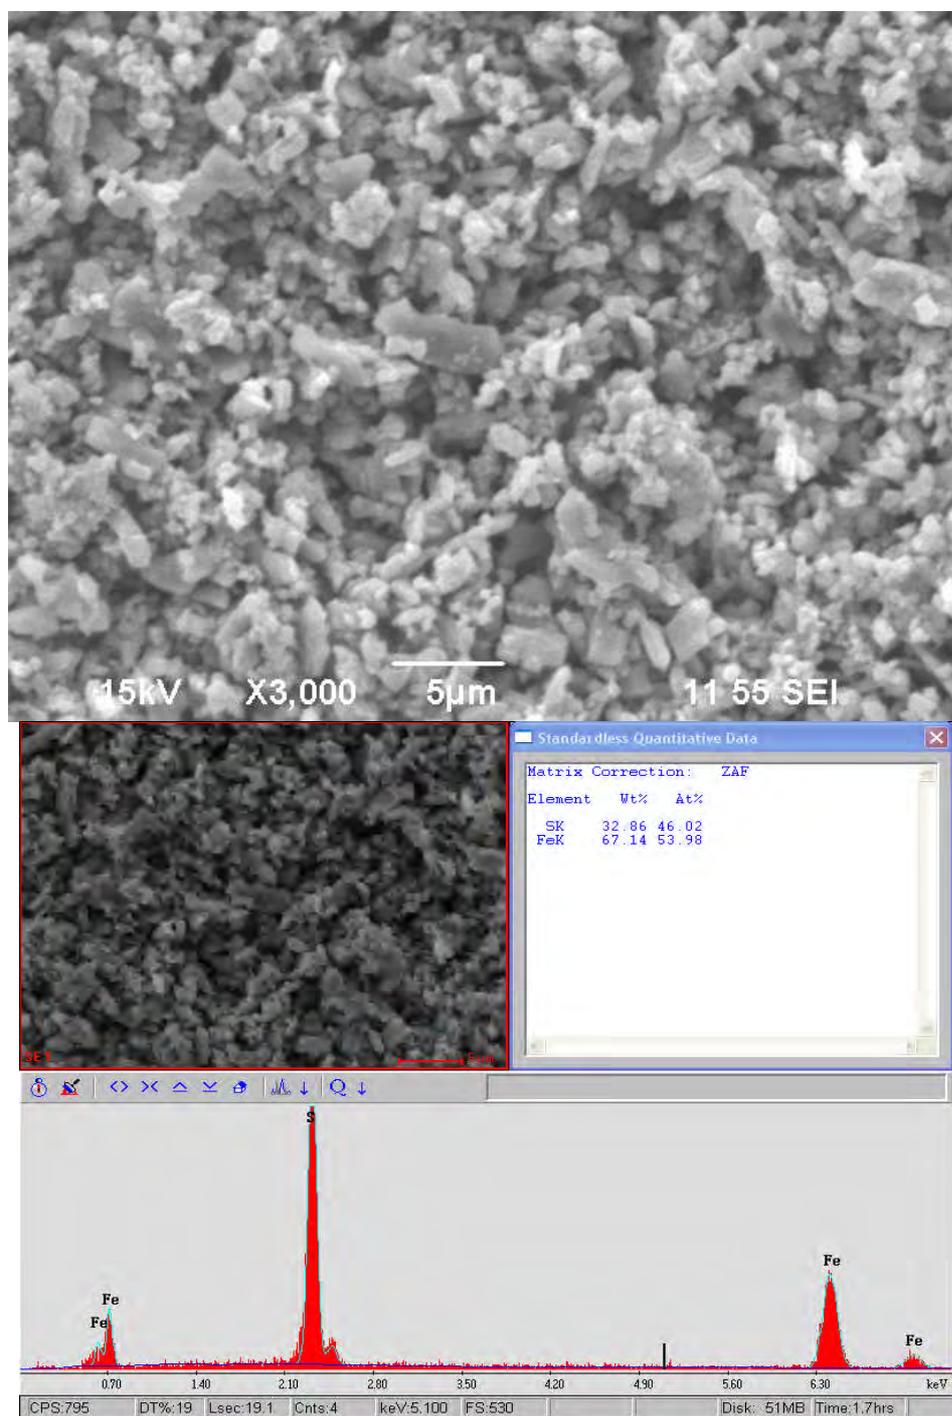
Figure 67. SEM image and EDX spectrum of a specimen surface after a 2 days exposure to 10,000 ppm H₂S.

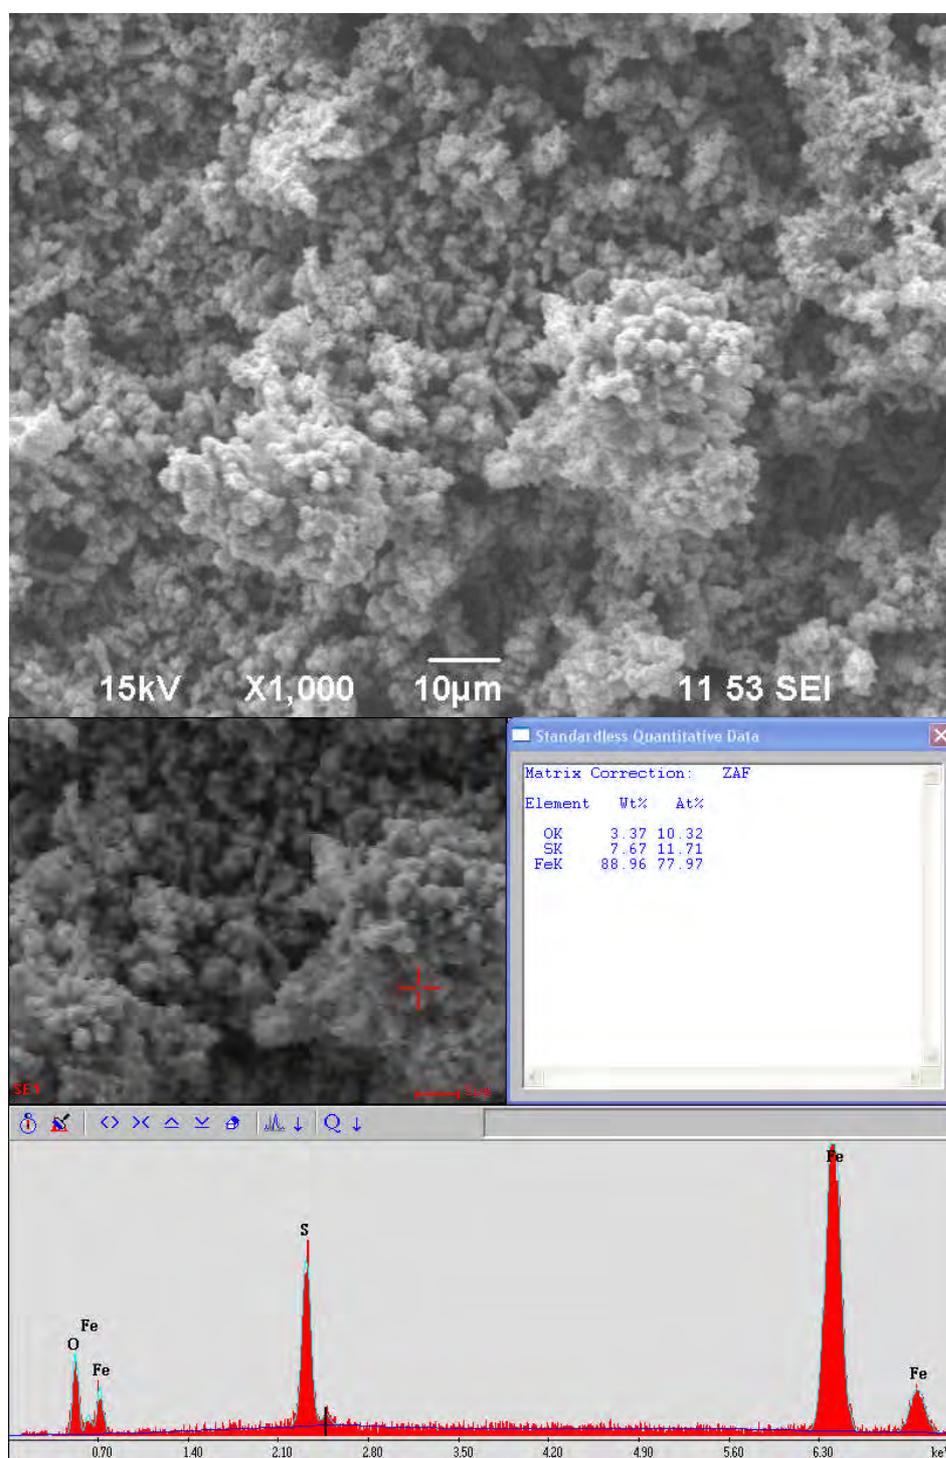
Figure 68. SEM image and EDX spectrum of a specimen surface after a 1 day exposure to air. (H_2S was stopped purging)

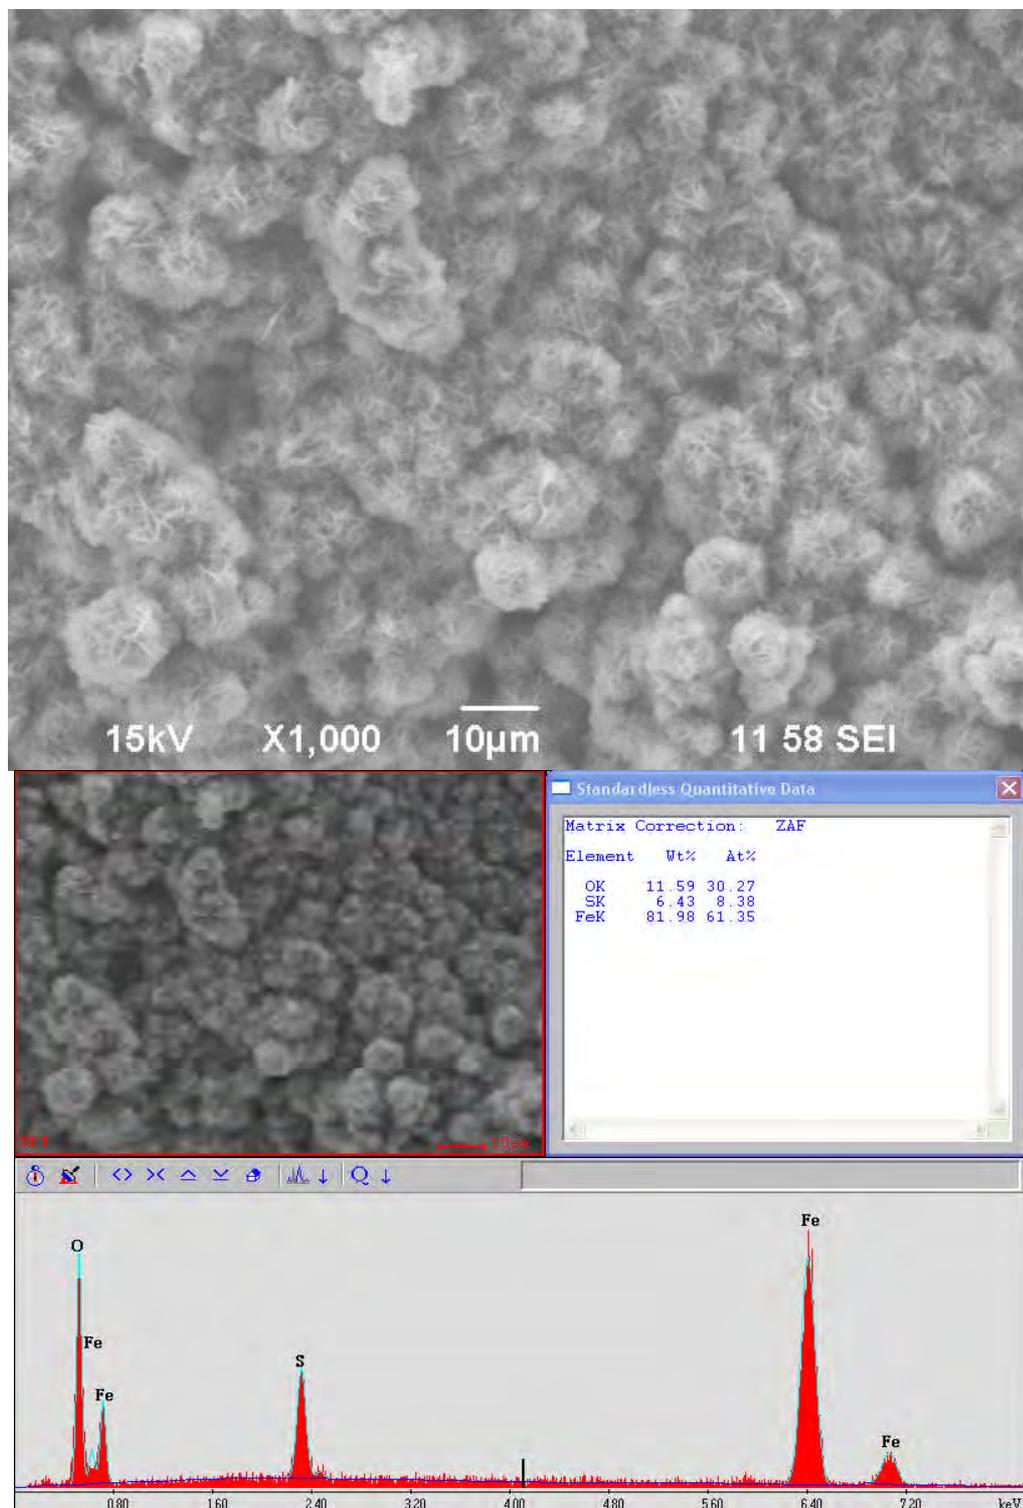
Figure 69. SEM image and EDX spectrum of a specimen surface after a 5 days exposure to Certified Breathing Air. (H_2S was stopped purging)

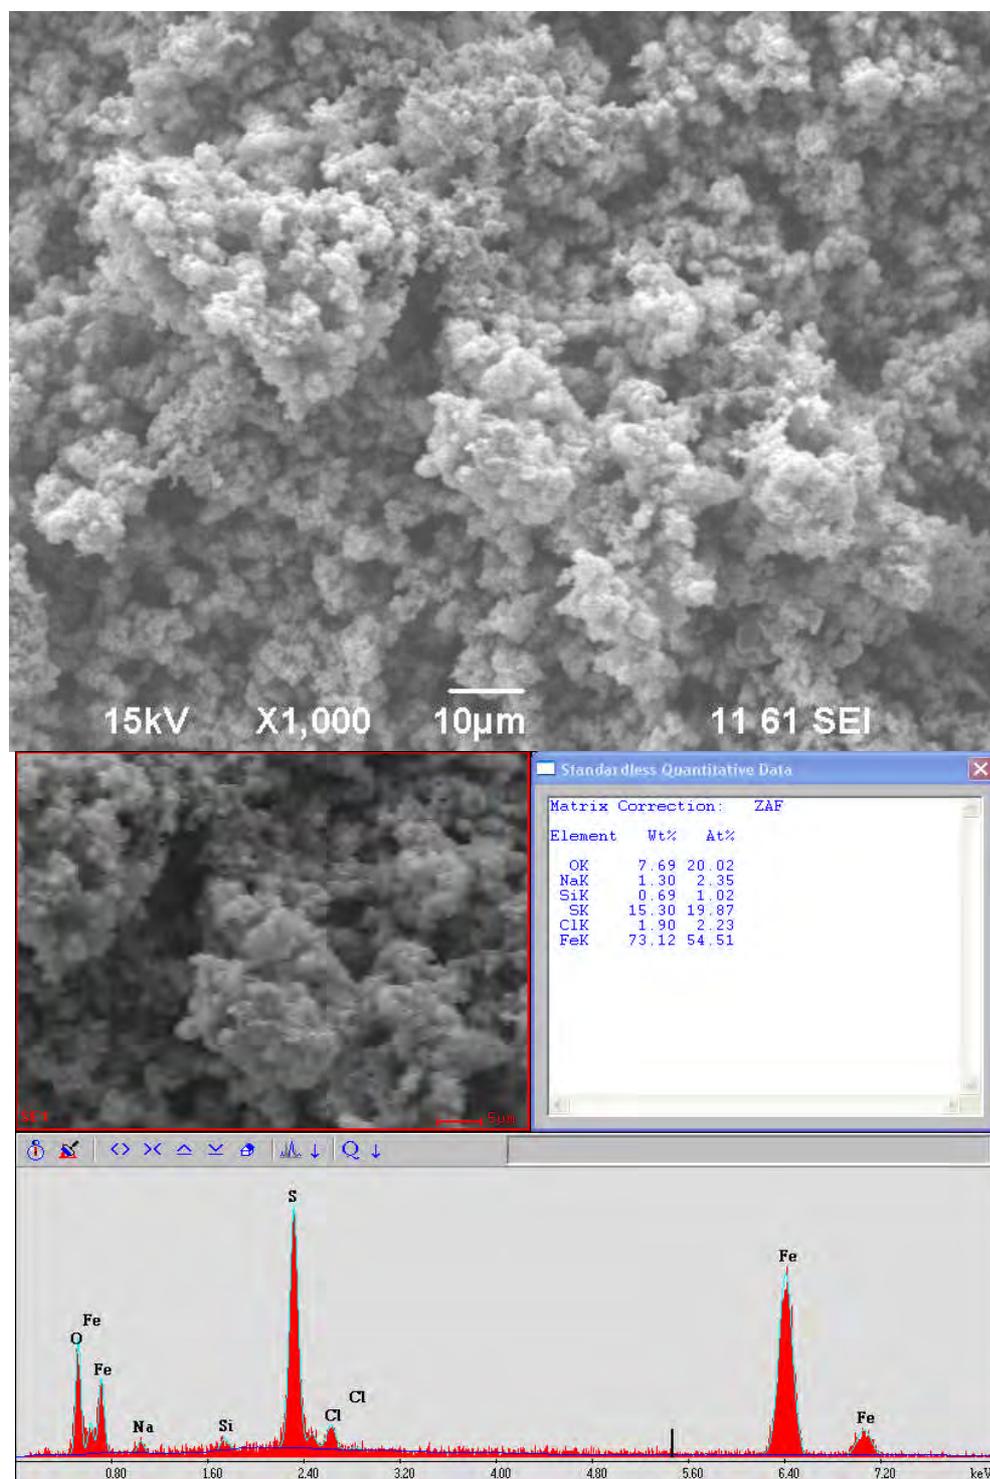
Figure 70. SEM image and EDX spectrum of a specimen surface after a 10 days exposure to air. (H_2S was stopped purging)

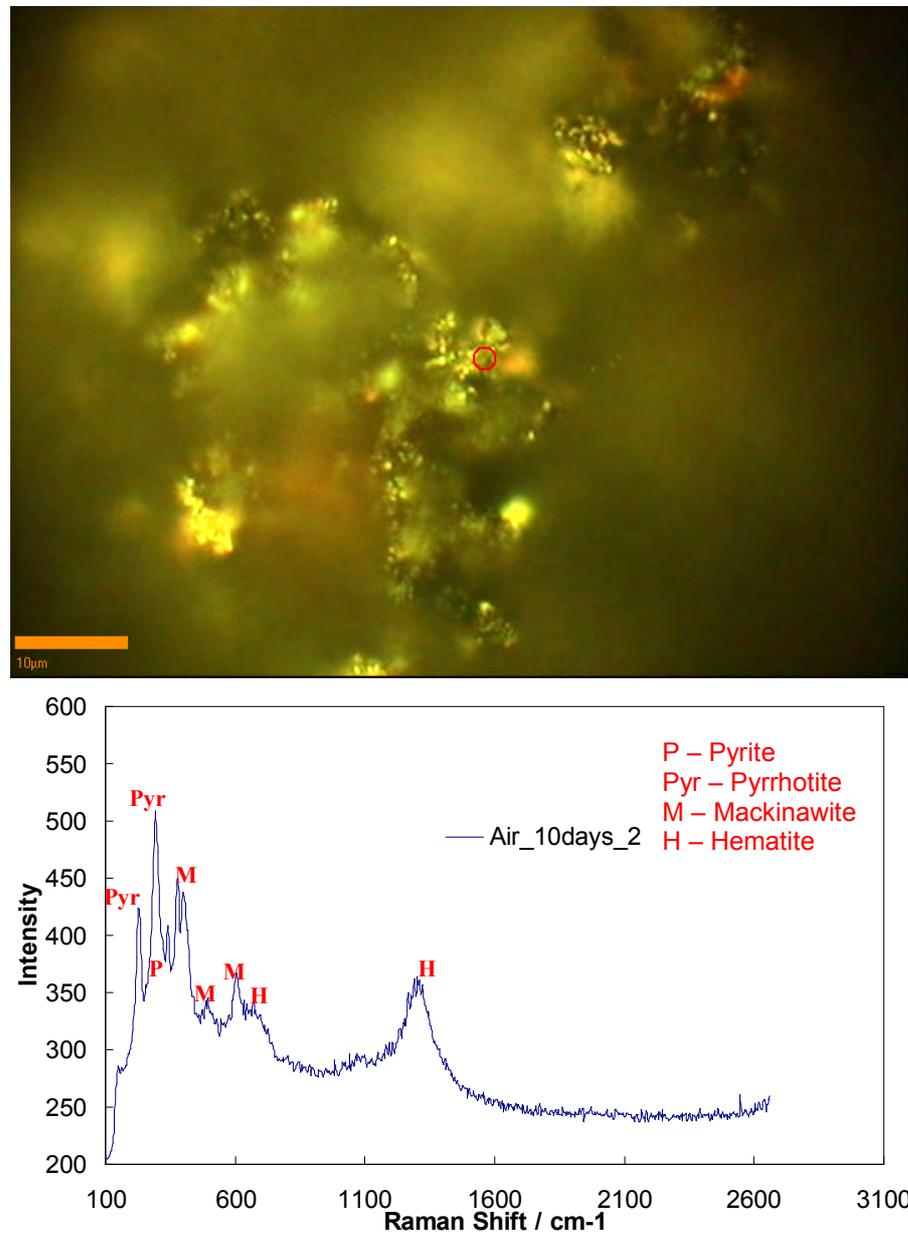
Figure 73. Raman data of corrosion products (10 days exposure to air).
