Investigation of Localized Corrosion of Carbon Steel in H₂S Environments

A dissertation presented to
the faculty of
the Russ College of Engineering and Technology of Ohio University

In partial fulfillment
of the requirement for the degree
Doctor of Philosophy

Haitao Fang

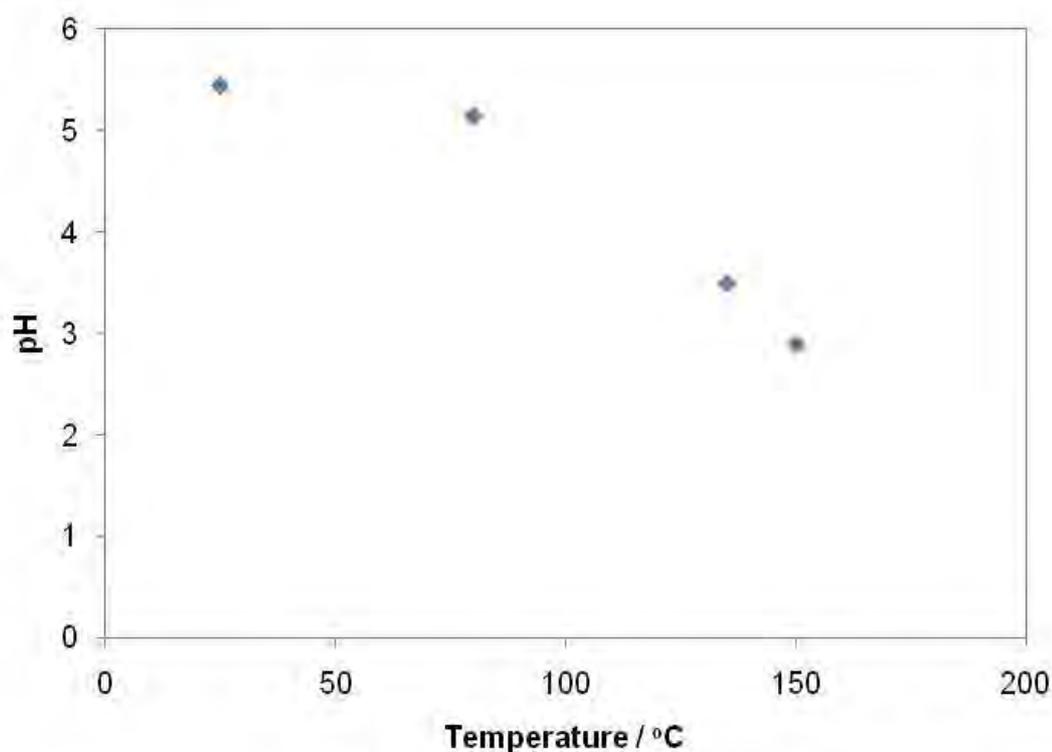
Figure 80. pH of the test solution after degassing for the studied temperatures.

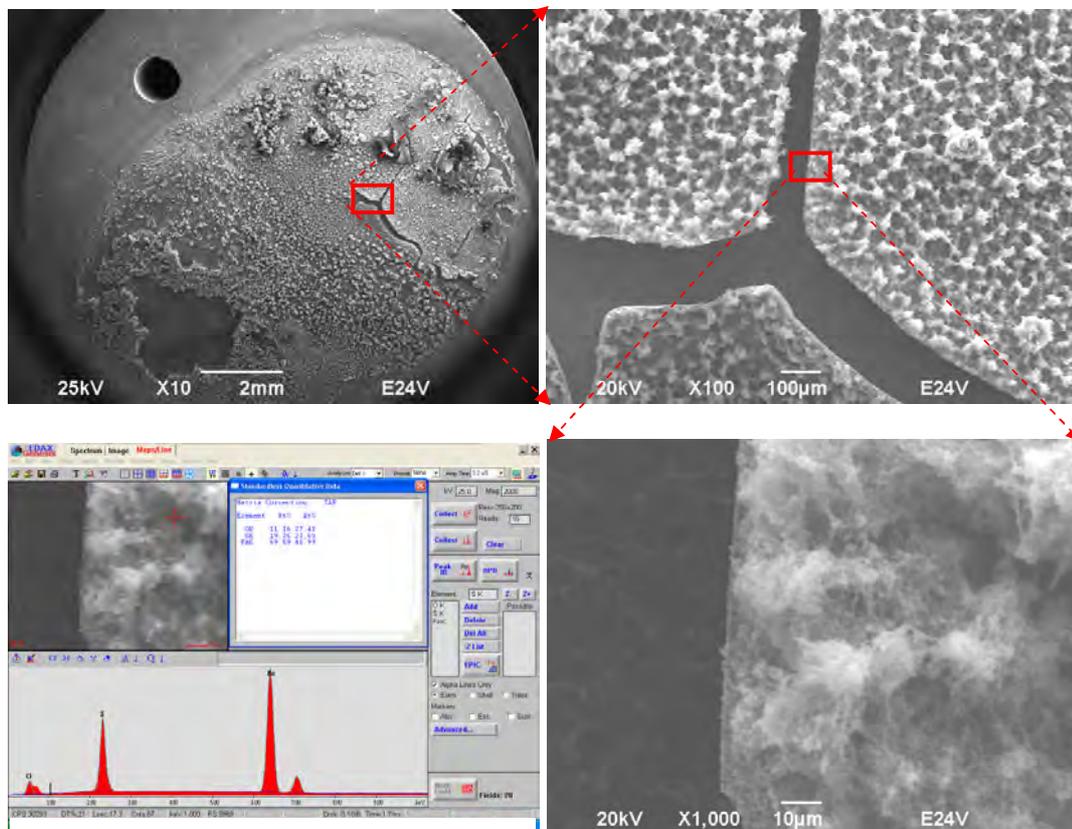
Figure 83. Corrosion specimen contacted with elemental sulfur for 1 day at 25°C, with corrosion product layer.

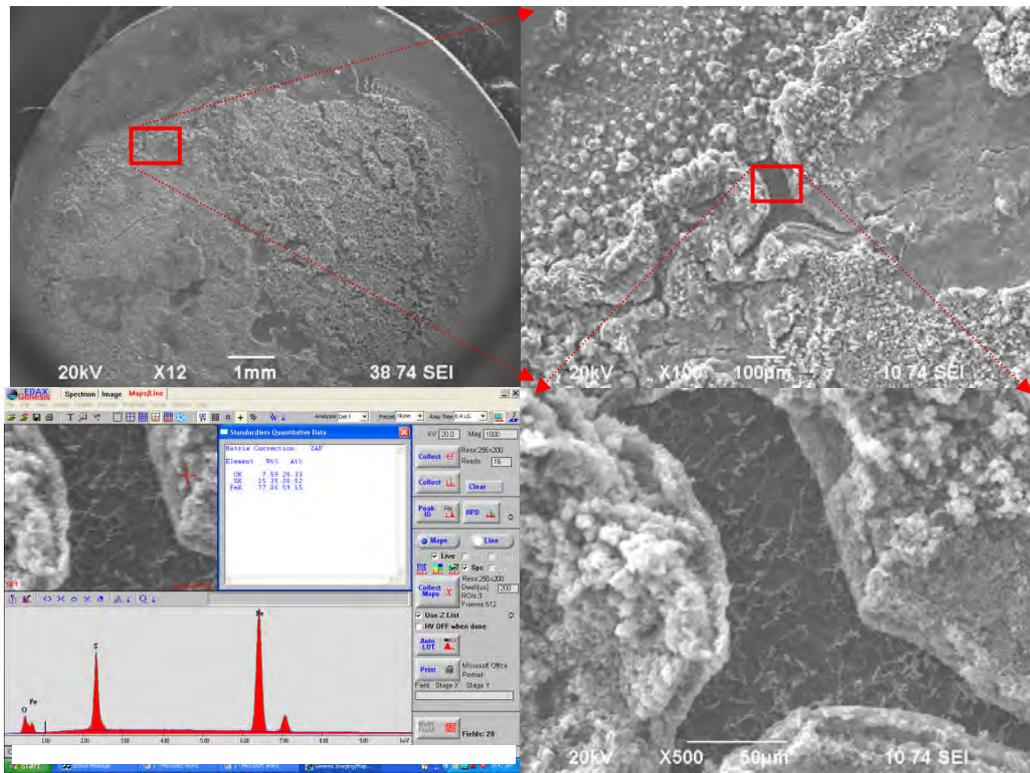
Figure 87. Corrosion specimen contacted with elemental sulfur for 5 days at 25°C, with corrosion product layer.

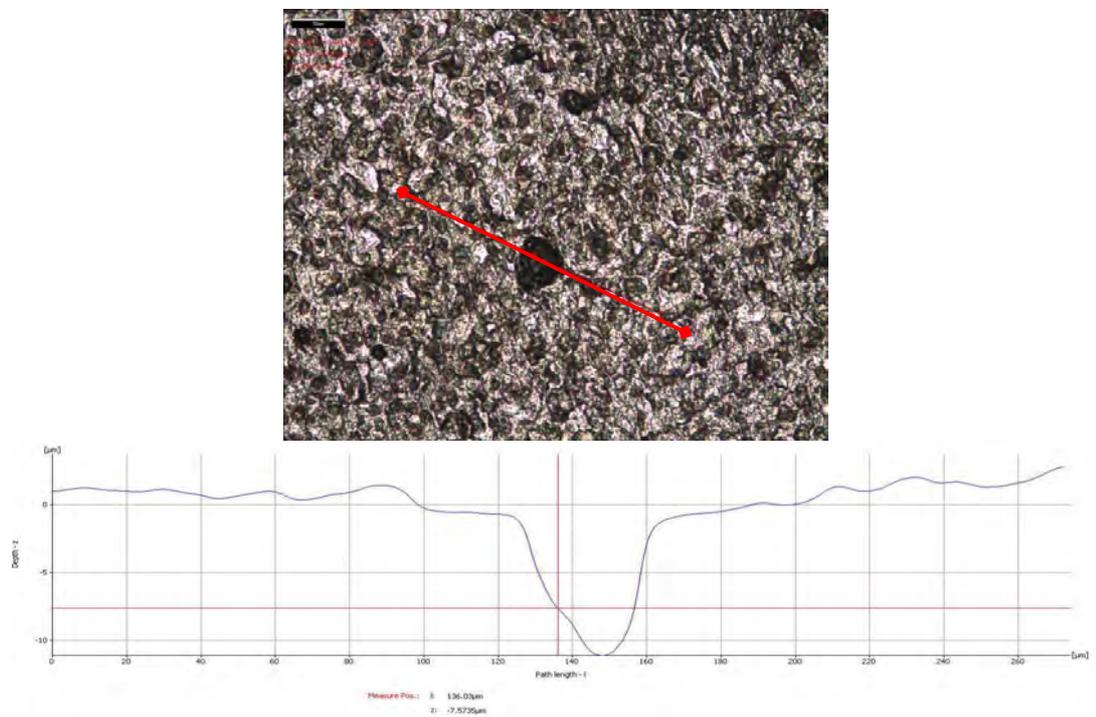
Figure 90. IFM data for specimen contacted with sulfur for 1 day at 80°C, without corrosion product layer.

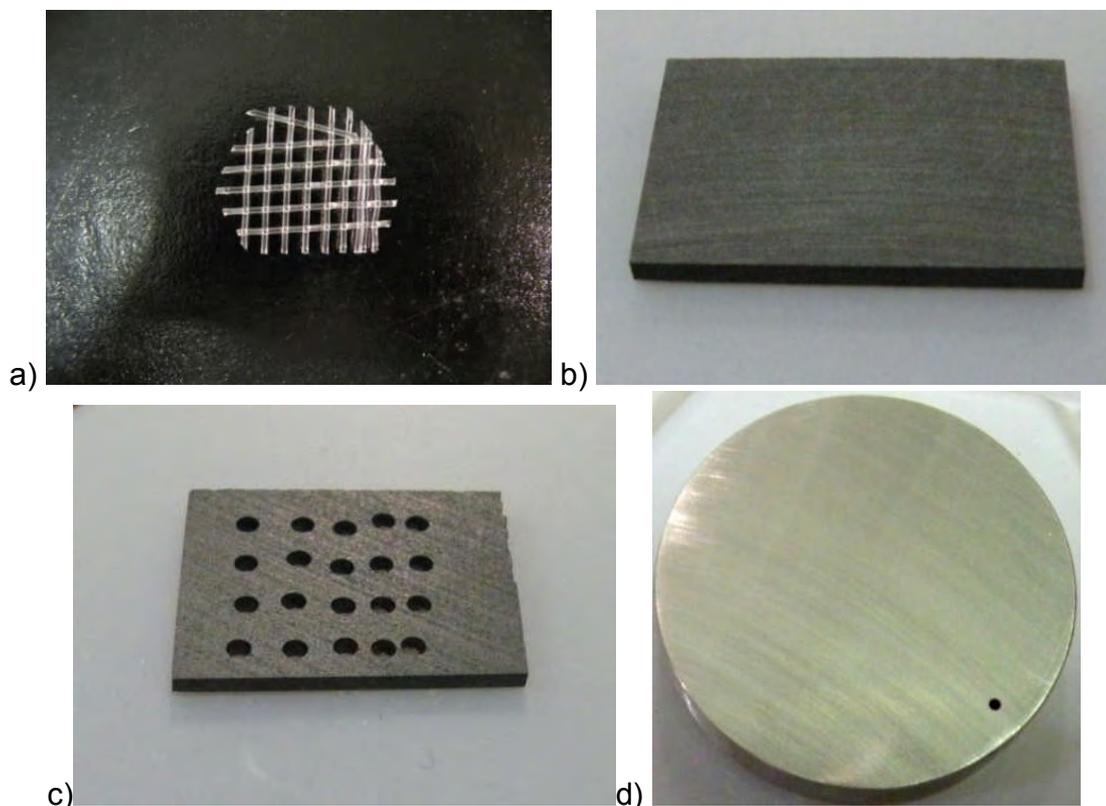
Figure 101. Materials used for the physical separation of sulfur and iron: a) plastic mesh, b) graphite sheet, c) graphite sheet with 0.043" ID holes, d) X65 steel sample.

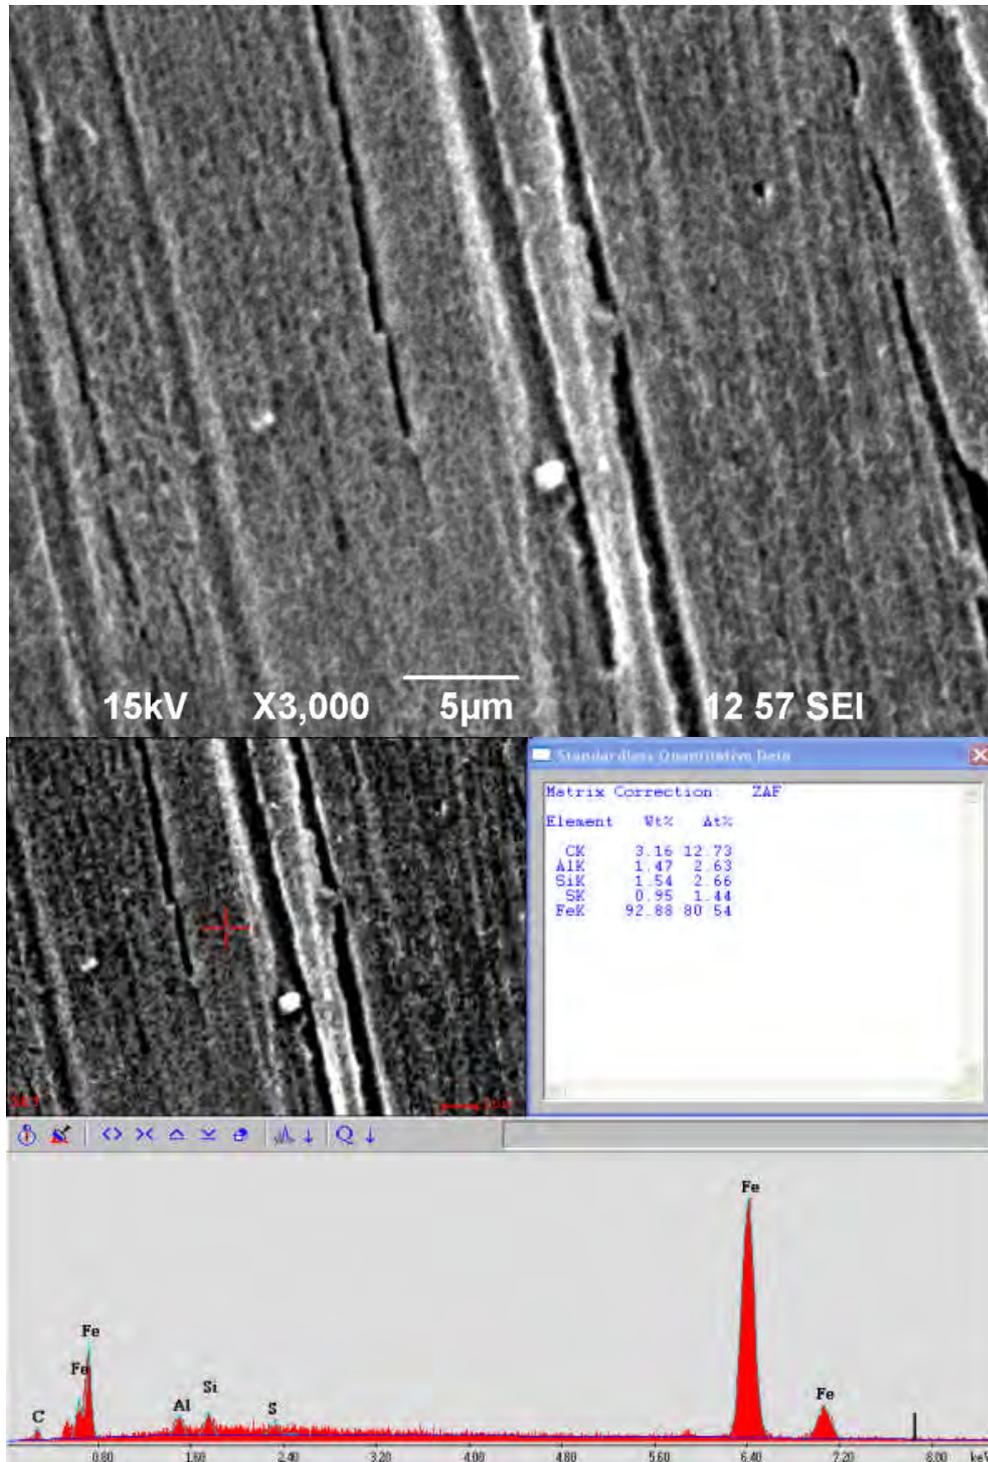
Figure 104. SEM/EDX data for the typical corroded steel surface after exposure in the sulfur/plastic-mesh/steel test where it was in close proximity to sulfur but electrically insulated from each other.

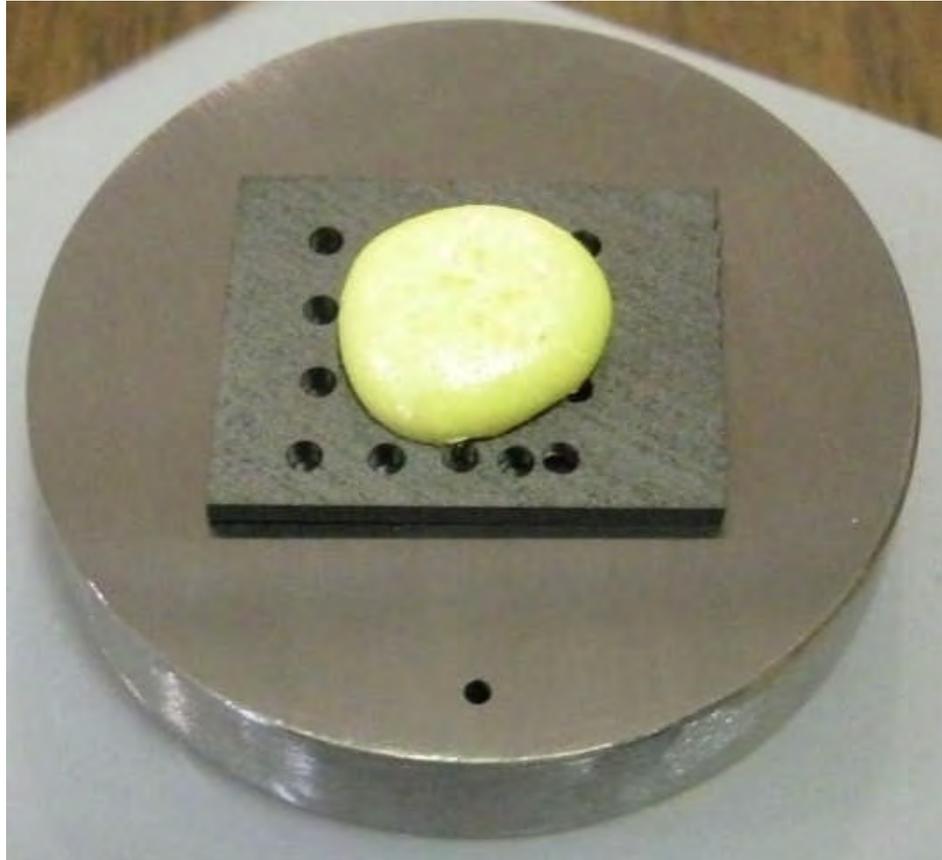
Figure 108. Sample arrangement for sulfur/carbon-sheet-with-holes/steel test where the steel was in physical proximity to the sulfur and electrically connected.

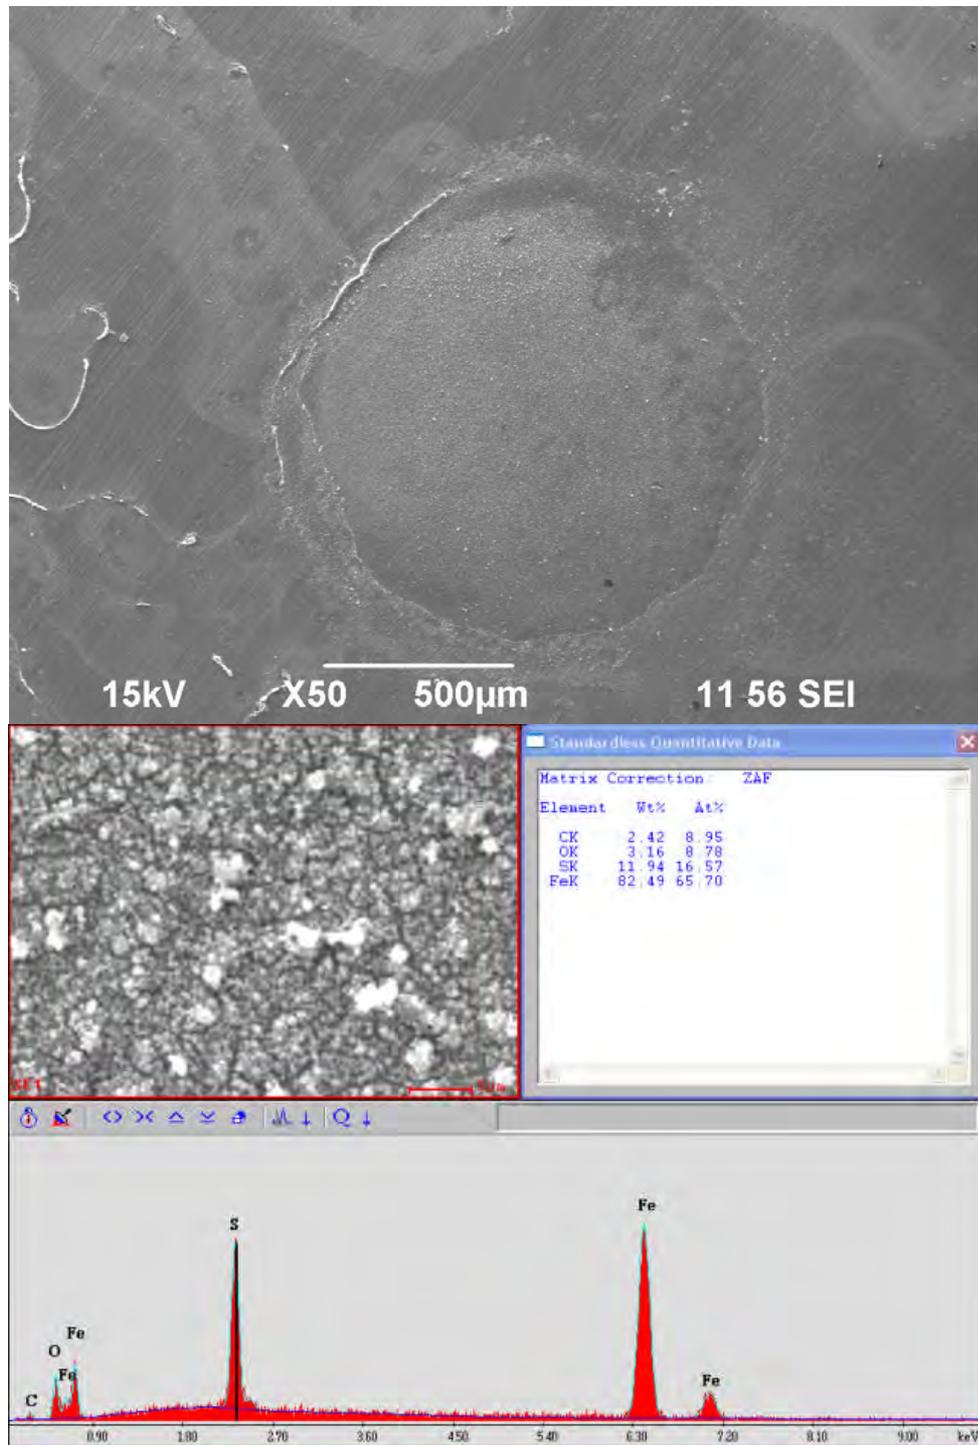
Figure 109. SEM/EDX data for the sample surface underneath the hole from the experiment where the steel was in physical proximity to the sulfur and electrically connected.

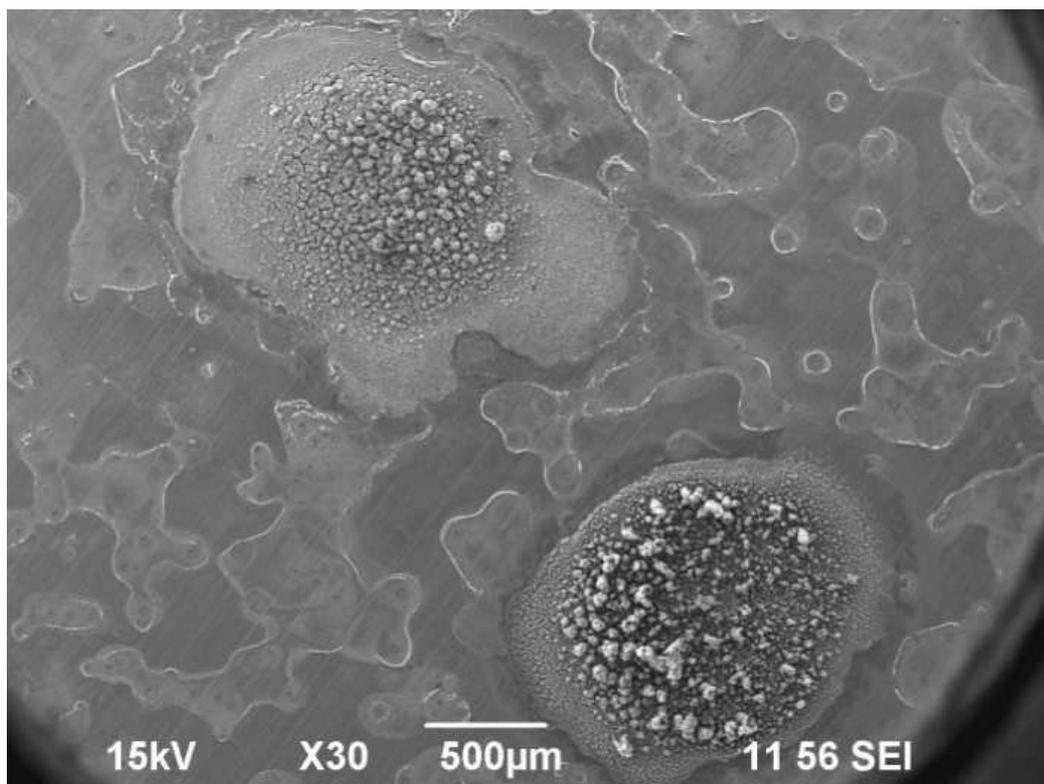
Figure 110. SEM data for the sample surface underneath the hole, from the experiment where the steel was in physical proximity to the sulfur and electrically connected.

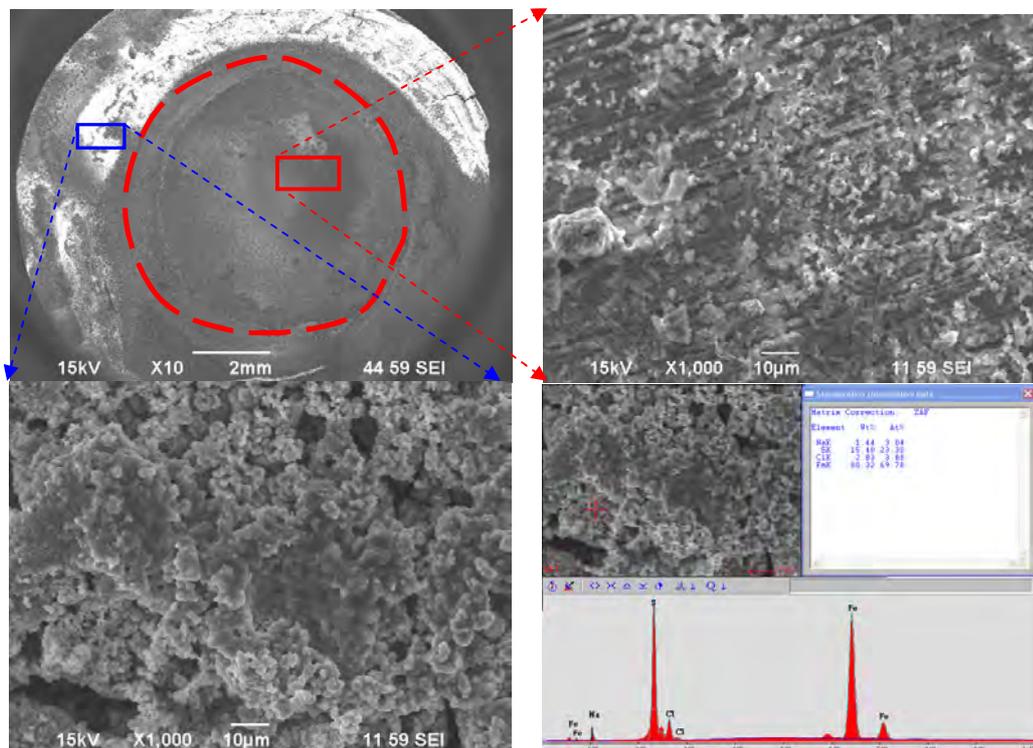
Figure 115. Corrosion specimen contacted with elemental sulfur for 1 day at 25°C, with corrosion product layer.

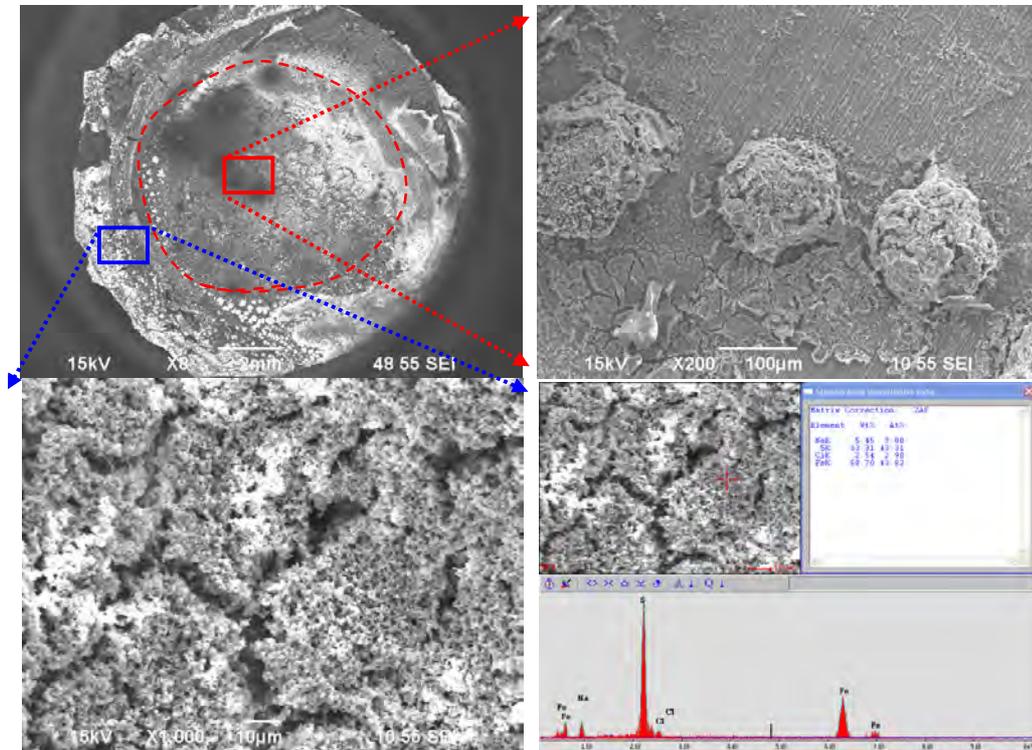
Figure 119. Corrosion specimen contacted with elemental sulfur for 5 days at 25°C, with corrosion product layer.

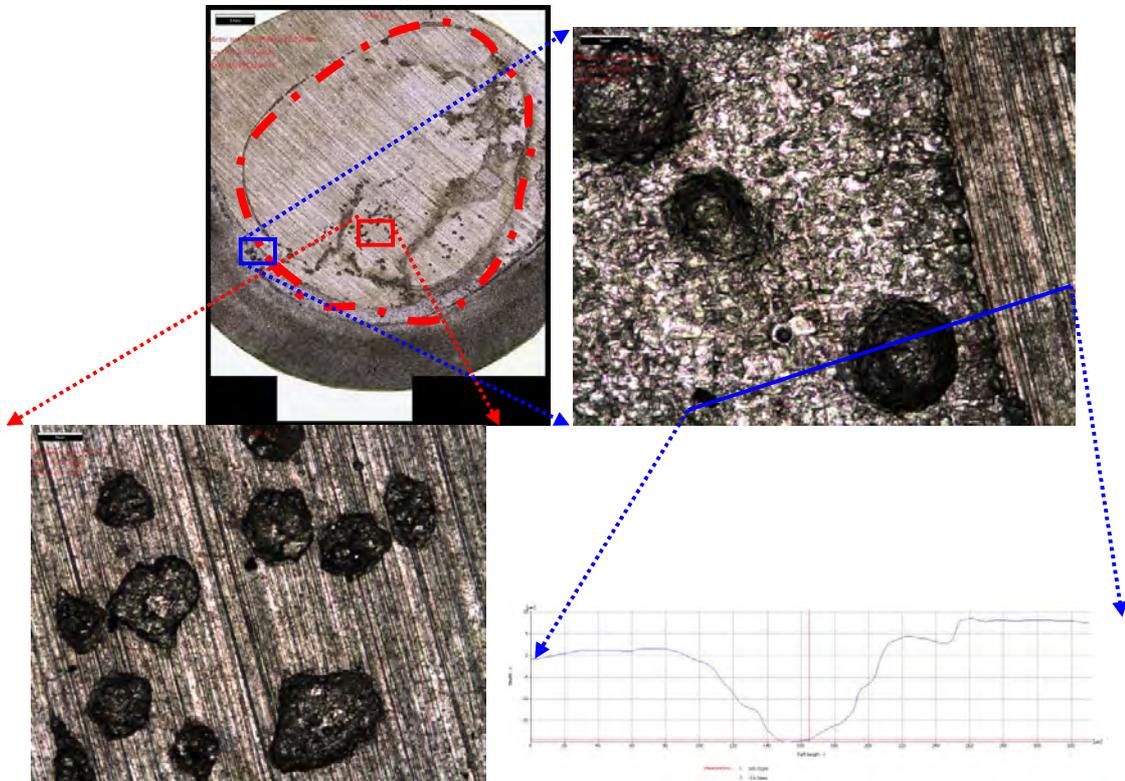
Figure 120. IFM data for specimen contacted with sulfur for 5 days at 25°C, without corrosion product layer.

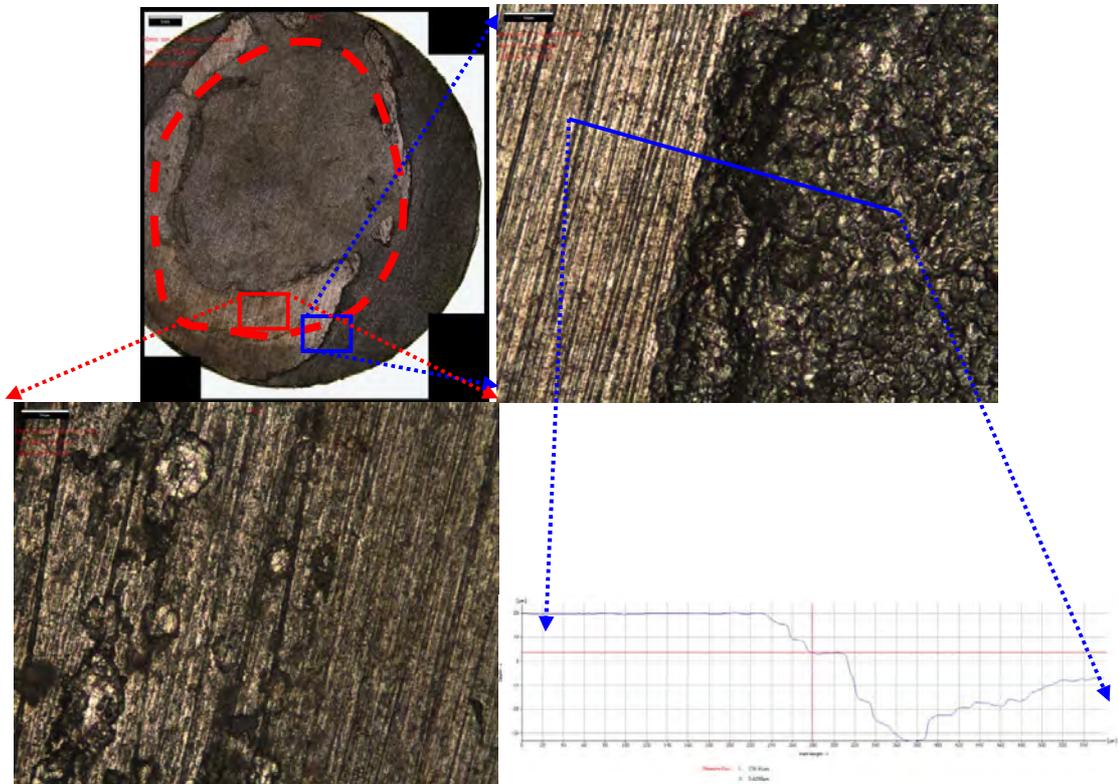
Figure 125. IFM data for specimen contacted with sulfur for 1 day at 80°C, without corrosion product layer.

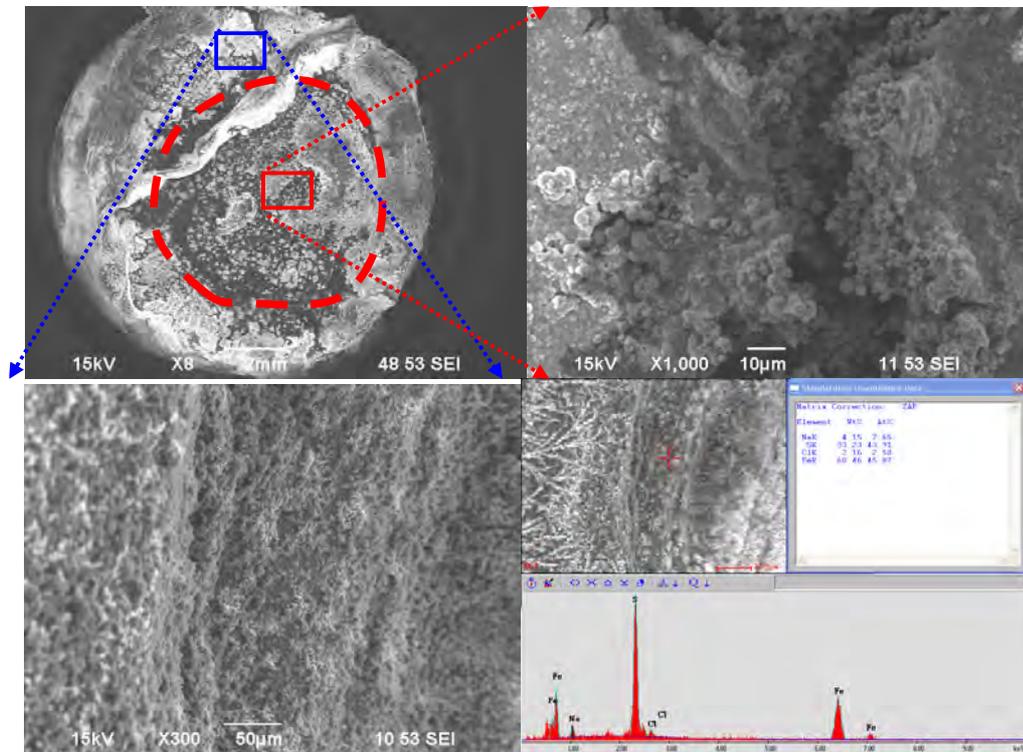
Figure 126. Corrosion specimen contacted with elemental sulfur for 4 days at 80°C, with corrosion product layer.

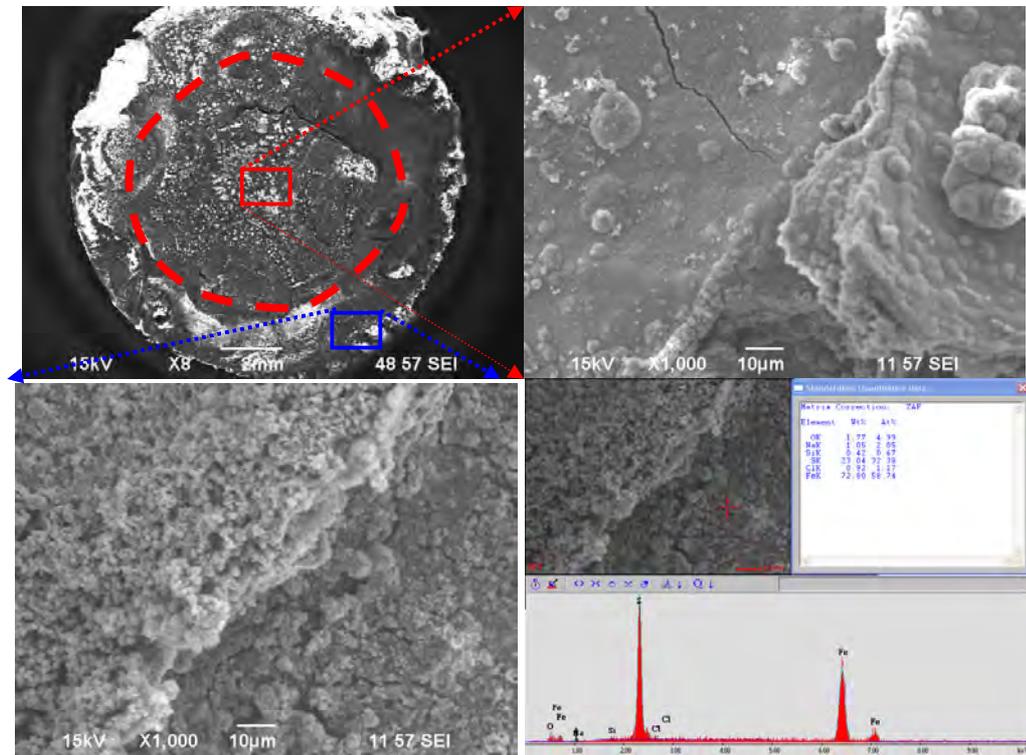
Figure 127. Corrosion specimen contacted with elemental sulfur for 5 days at 80°C, with corrosion product layer.

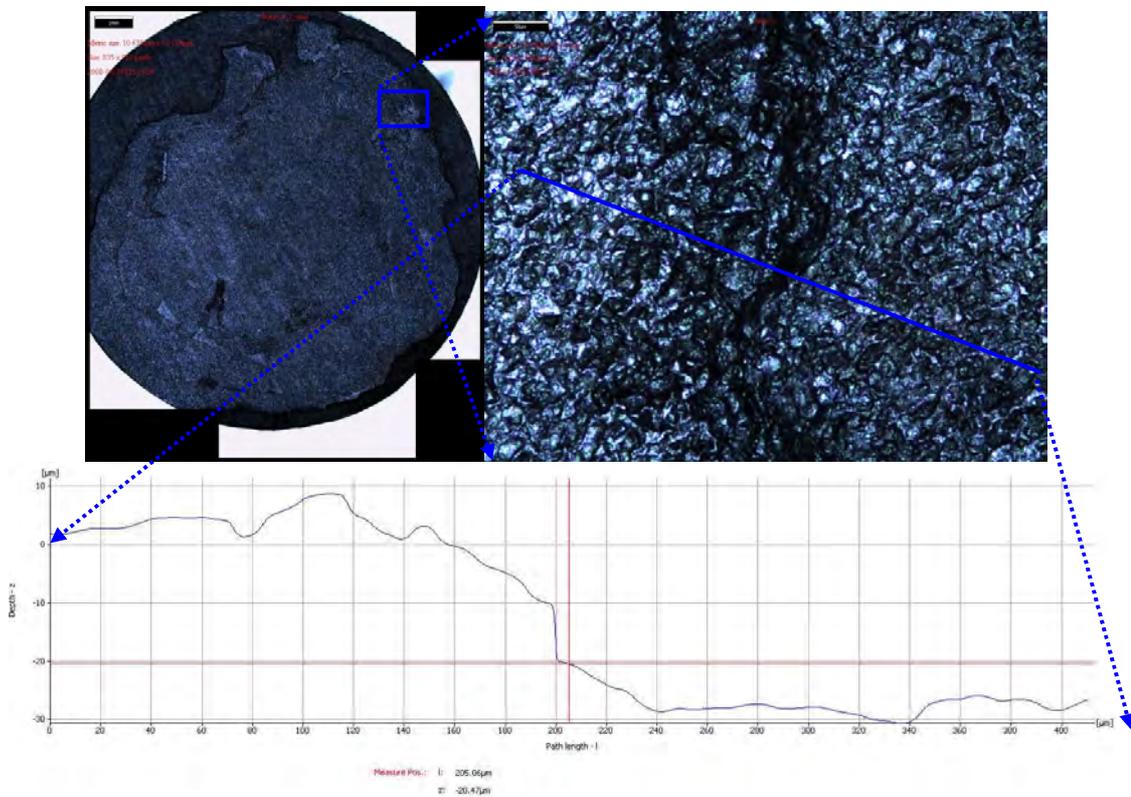
Figure 128. IFM data for specimen contacted with sulfur for 5 days at 80°C, without corrosion product layer.

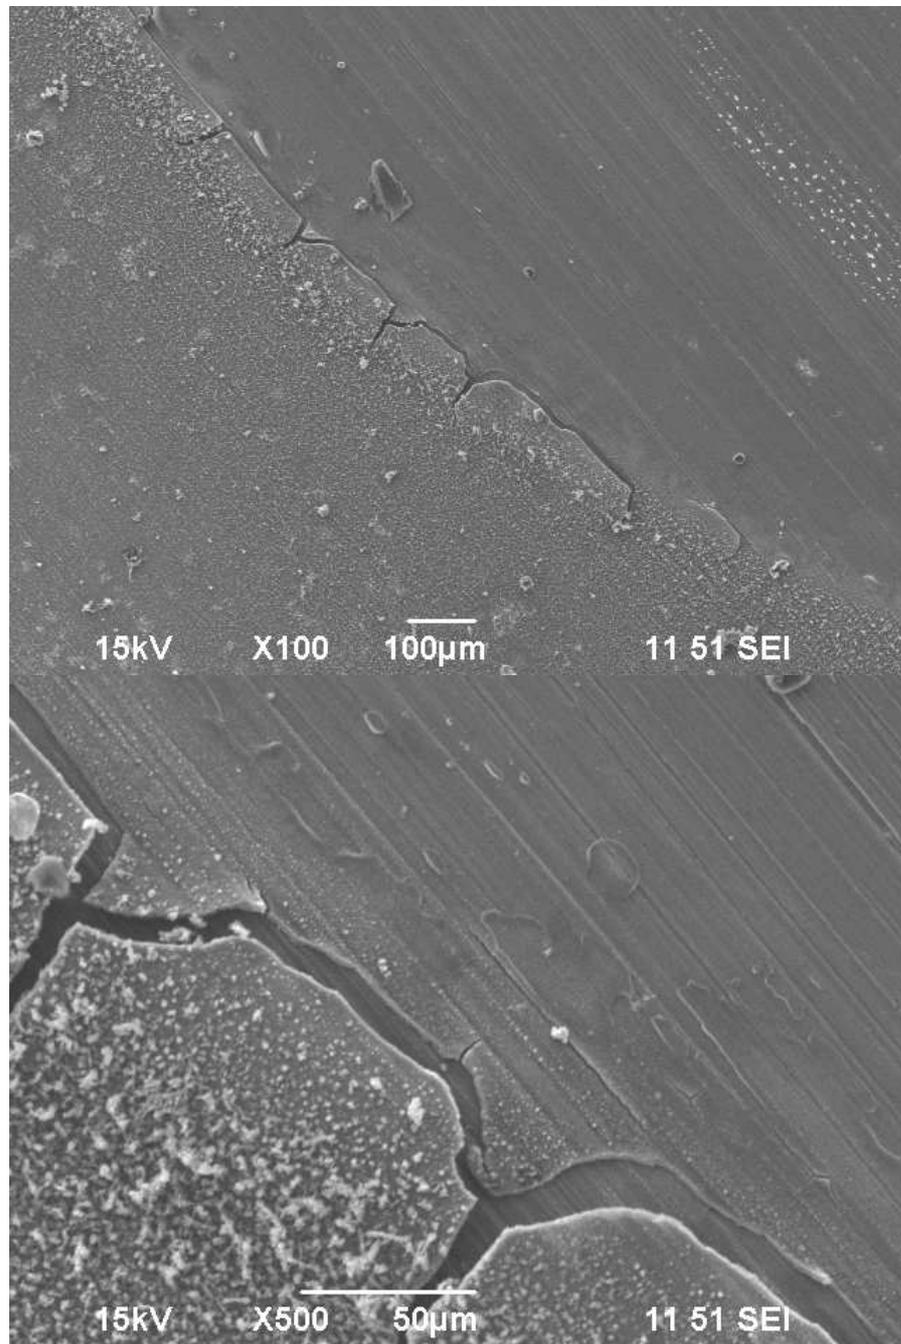
Figure 135. SEM image of specimen surface after 1 day exposure to sulfur at 25°C, 0.175 M NaCl.

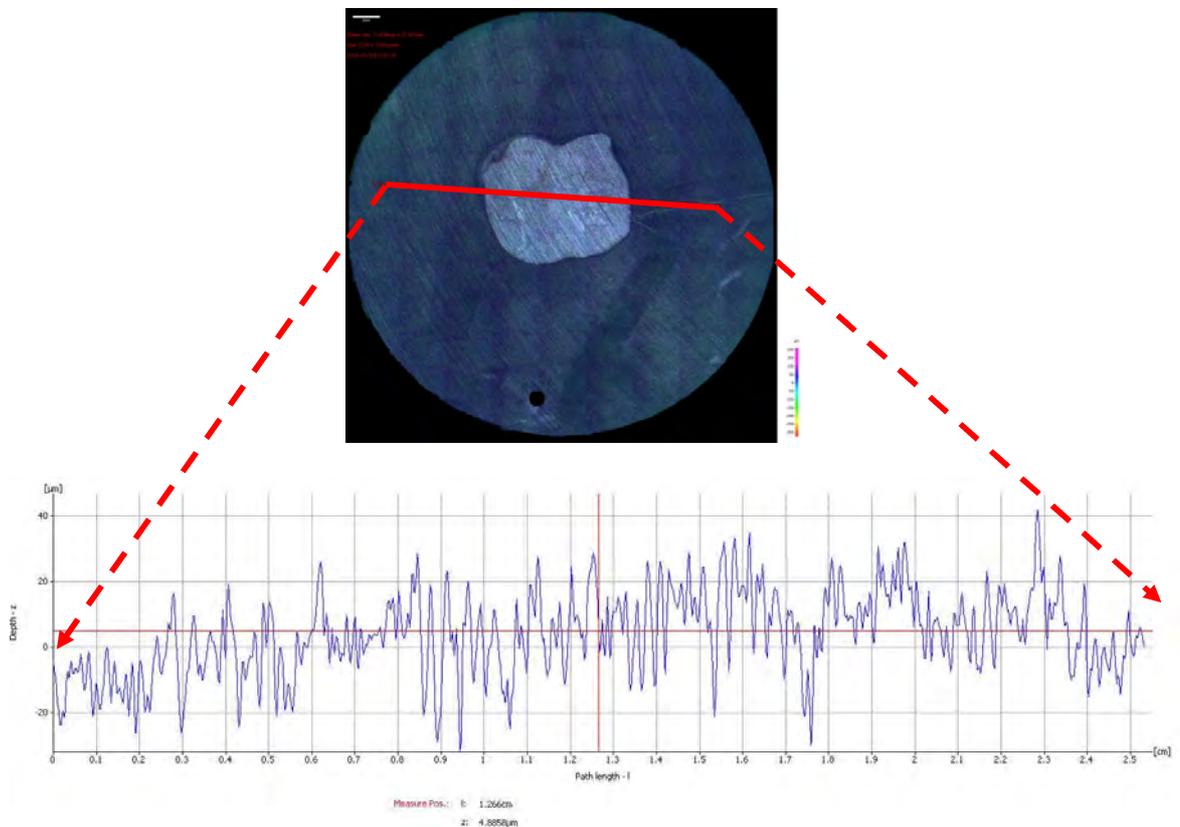
Figure 136. IFM data for corrosion specimen for 1 day at 25°C, 0.175 M NaCl, without film, appearance of the surface and surface profile.

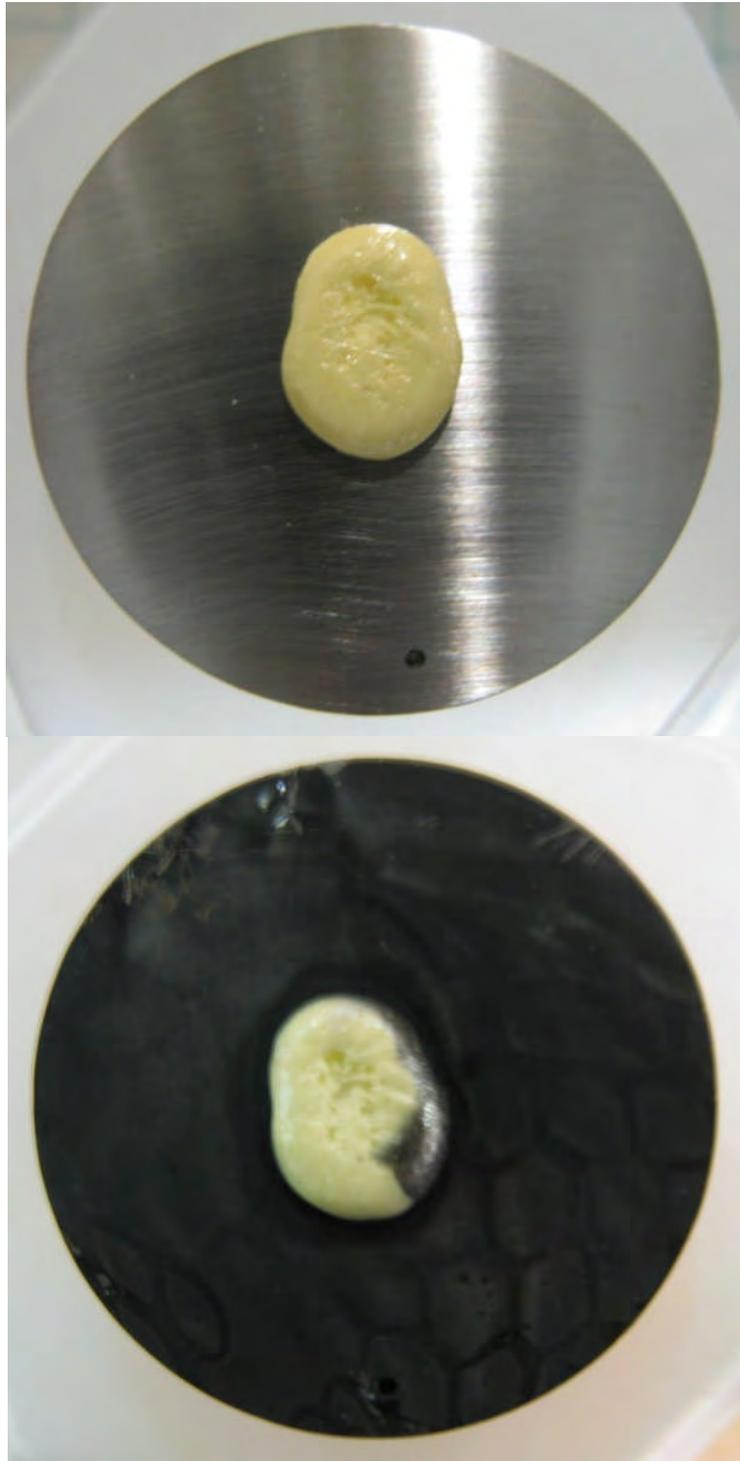
Figure 137. Corrosion specimen before and after 1 day exposure to sulfur at 25°C, 0.175 M NaClO₄.

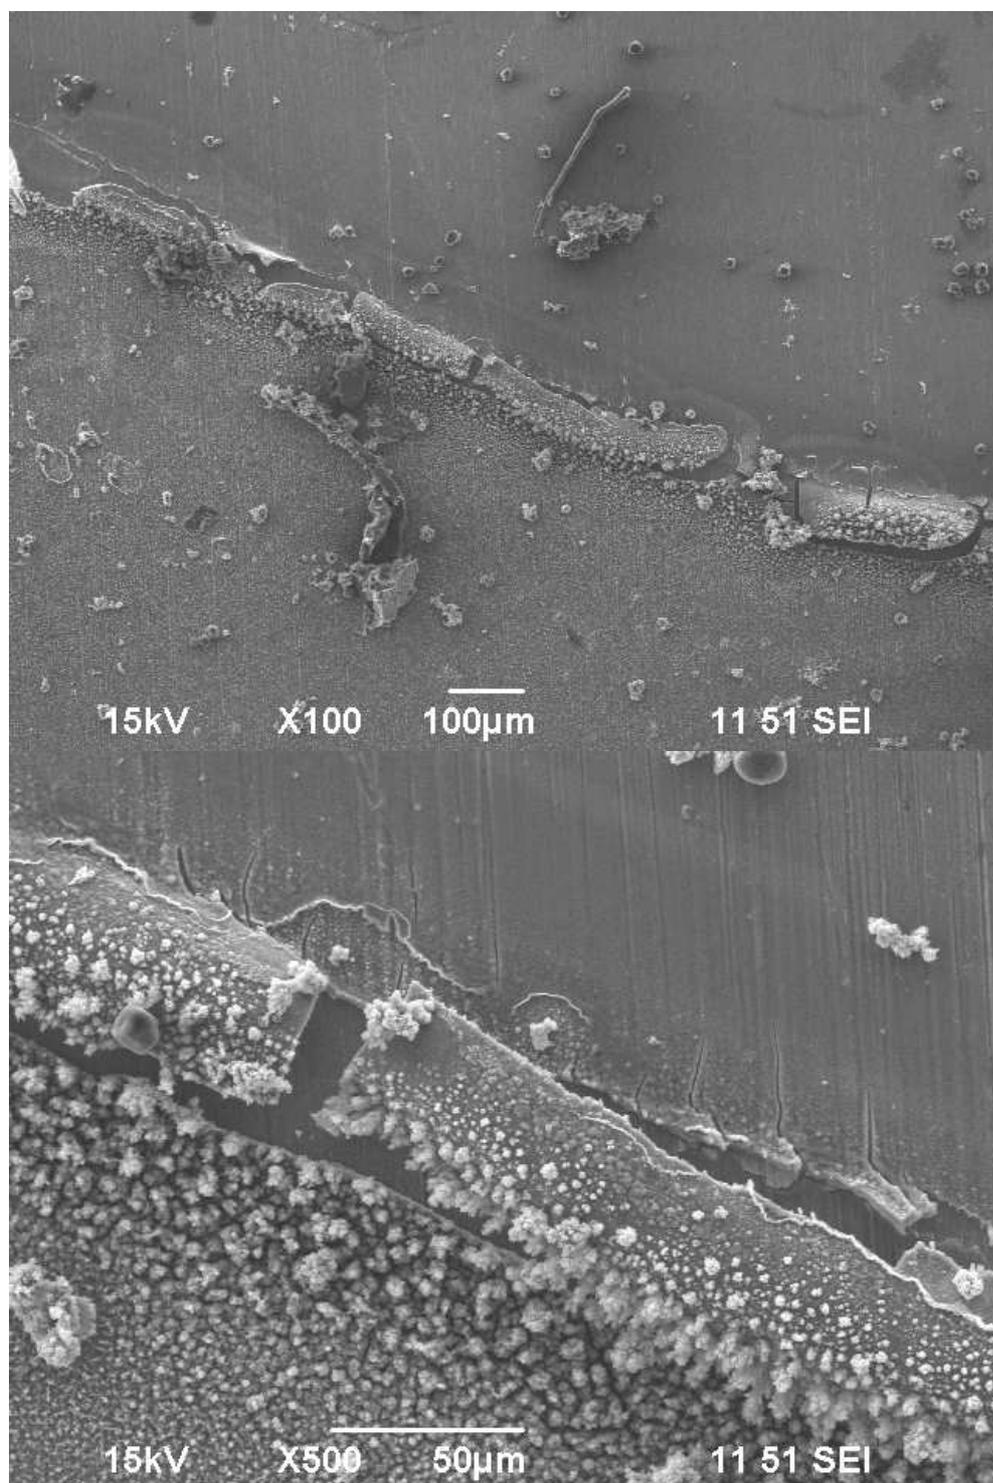
Figure 138. SEM image of specimen surface after 1 day exposure to sulfur at 25°C, 0.175 M NaClO₄.

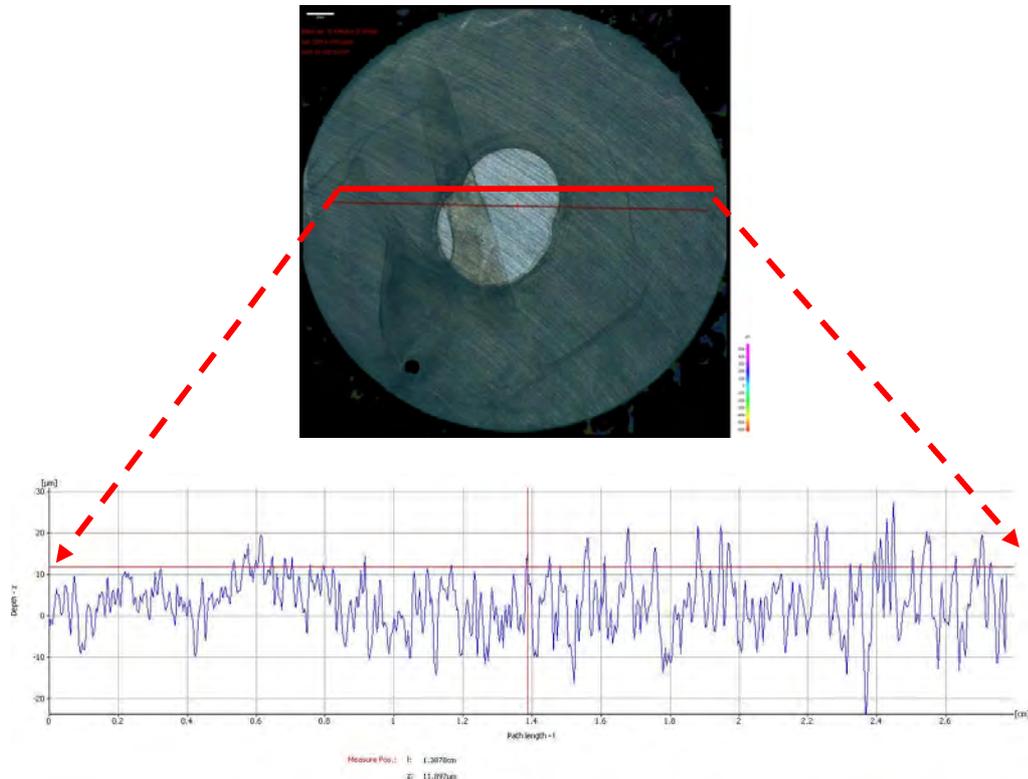
Figure 139. IFM data for corrosion specimen for 1 day at 25°C, 0.175 M NaClO₄, without film, appearance of the surface and surface profile.

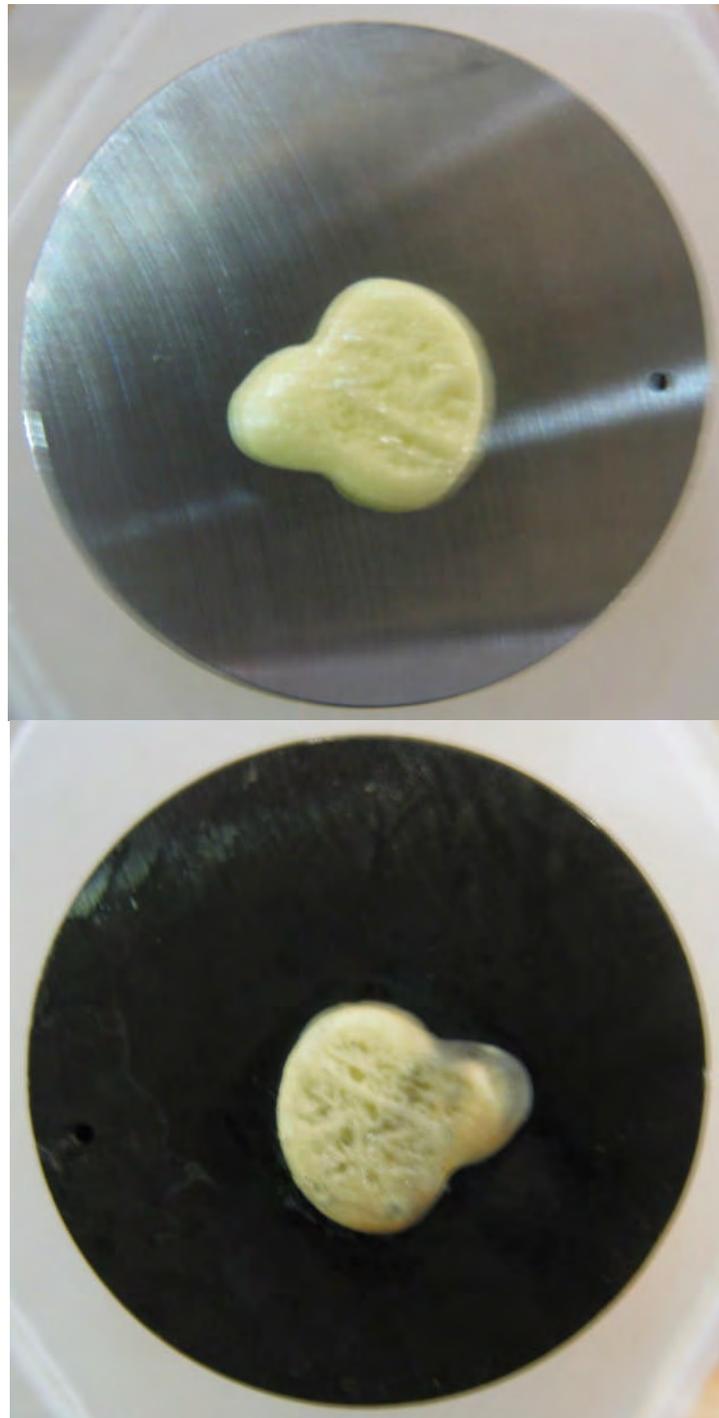
Figure 140. Corrosion specimen before and after 1 day exposure to sulfur at 80°C, salt free condition.

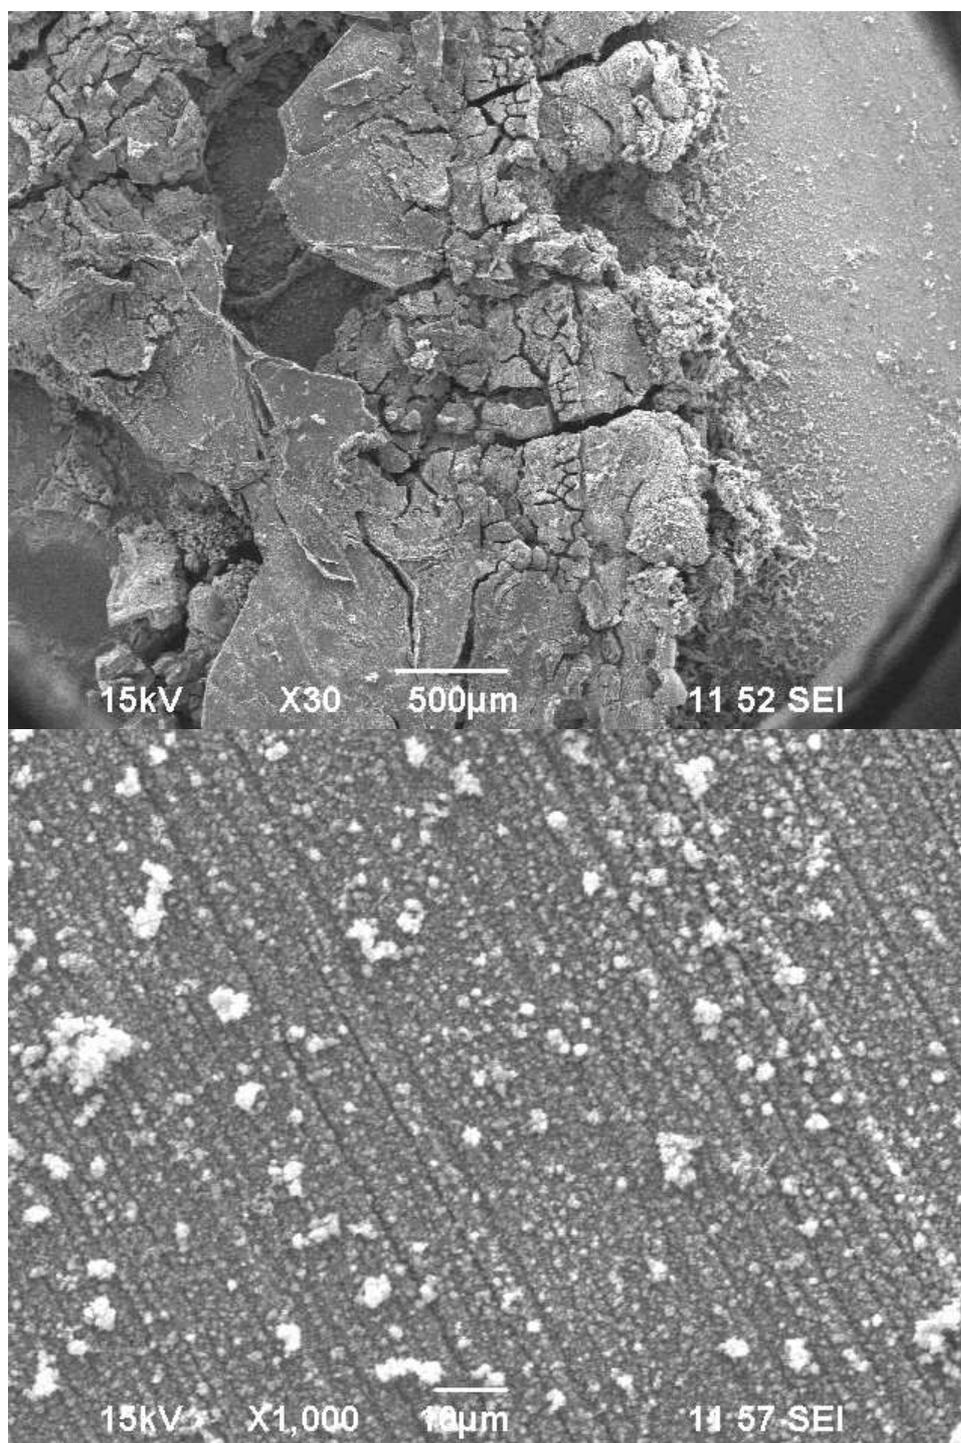
Figure 141. SEM image of specimen surface after 1 day exposure to sulfur at 80°C, salt free condition.
