Investigation of Localized Corrosion of Carbon Steel in H₂S Environments

A dissertation presented to
the faculty of
the Russ College of Engineering and Technology of Ohio University

In partial fulfillment
of the requirement for the degree
Doctor of Philosophy

Haitao Fang

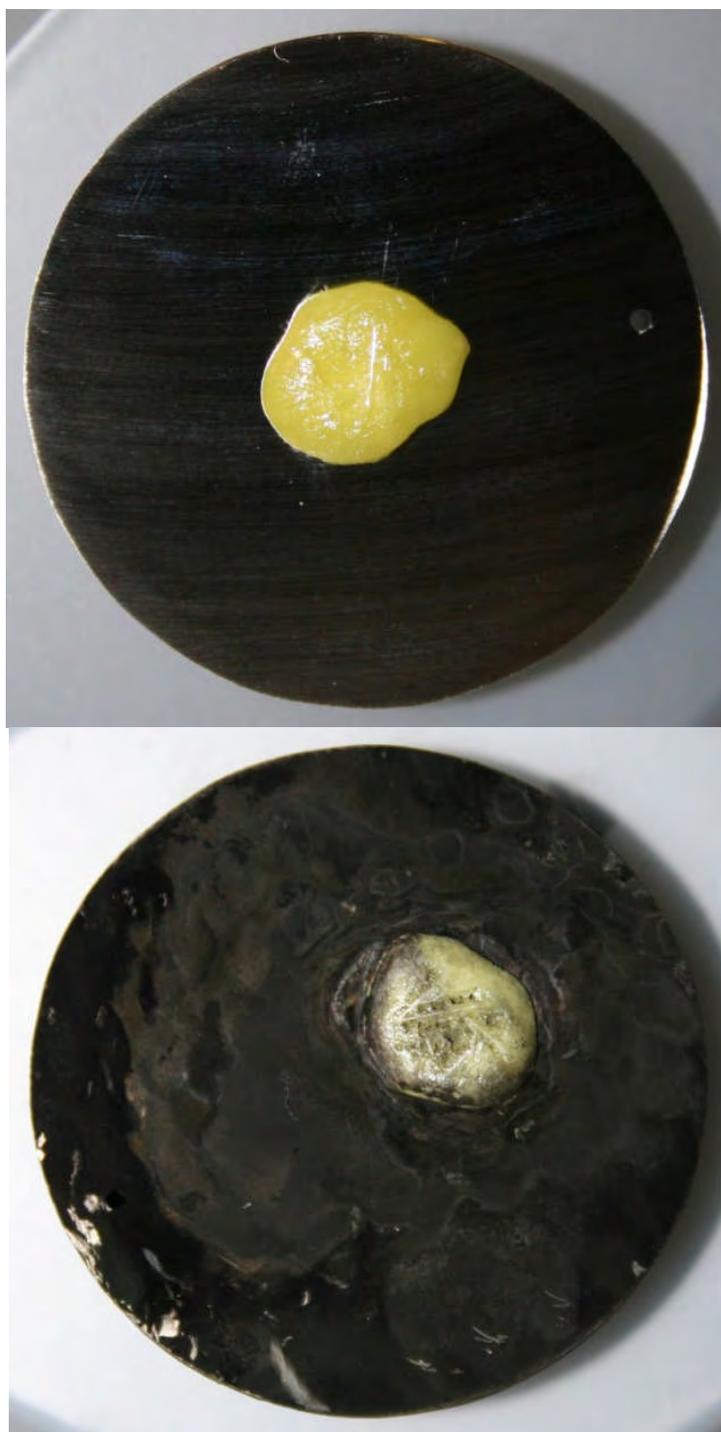
Figure 142. Corrosion specimen before and after 1 day exposure to sulfur at 80°C, 1.5 M NaCl.

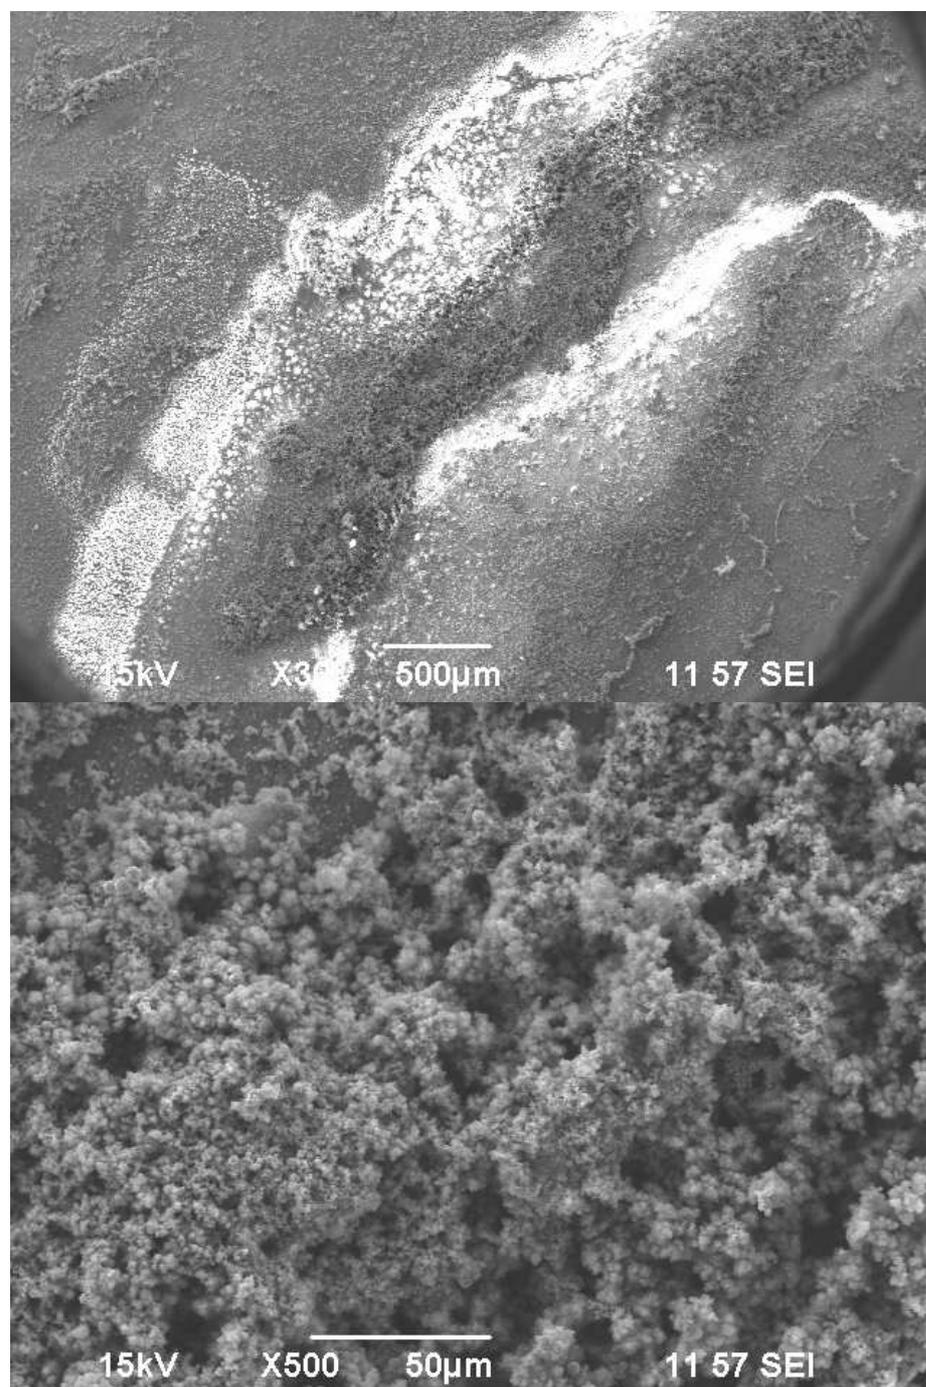
Figure 143. SEM image of specimen surface after 1 day exposure to sulfur at 80°C, 1.5 M NaCl.

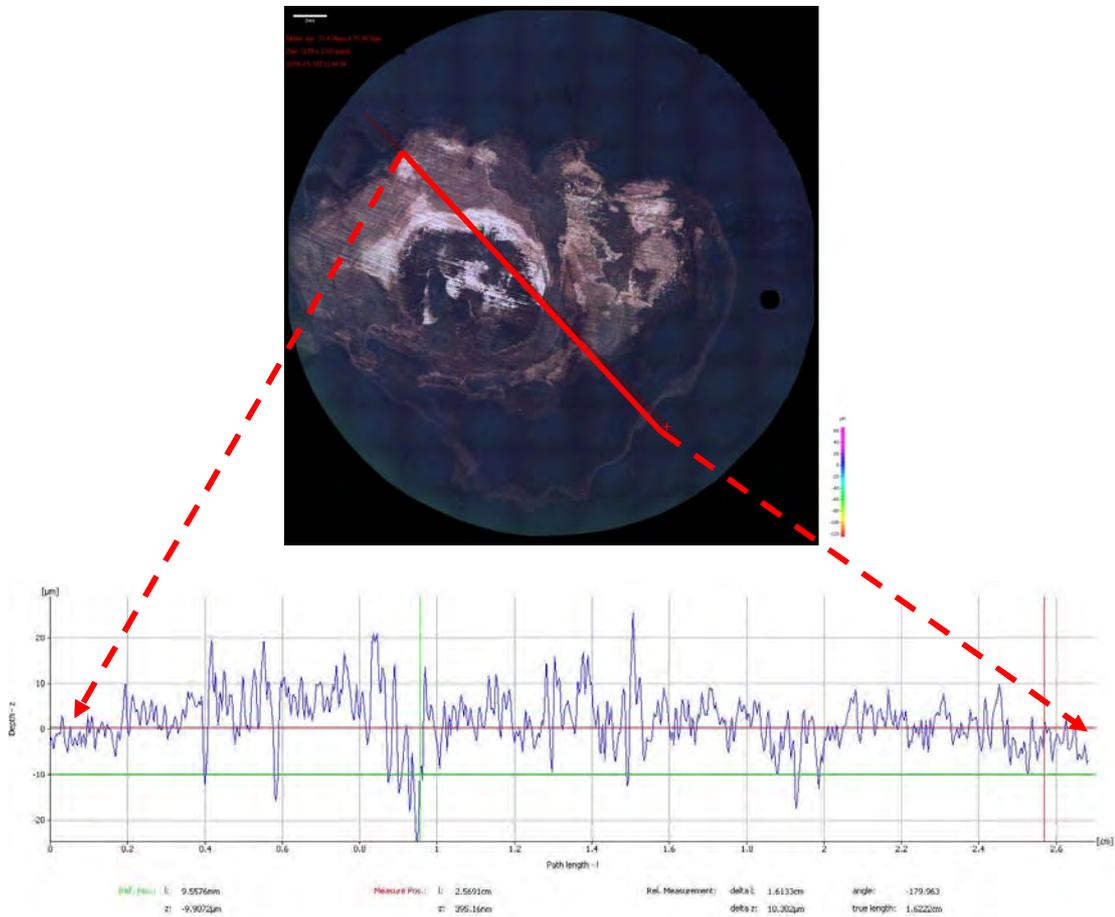
Figure 144. IFM data for corrosion specimen for 1 day at 25°C, 1.5 M NaCl, without film, appearance of the surface and surface profile.

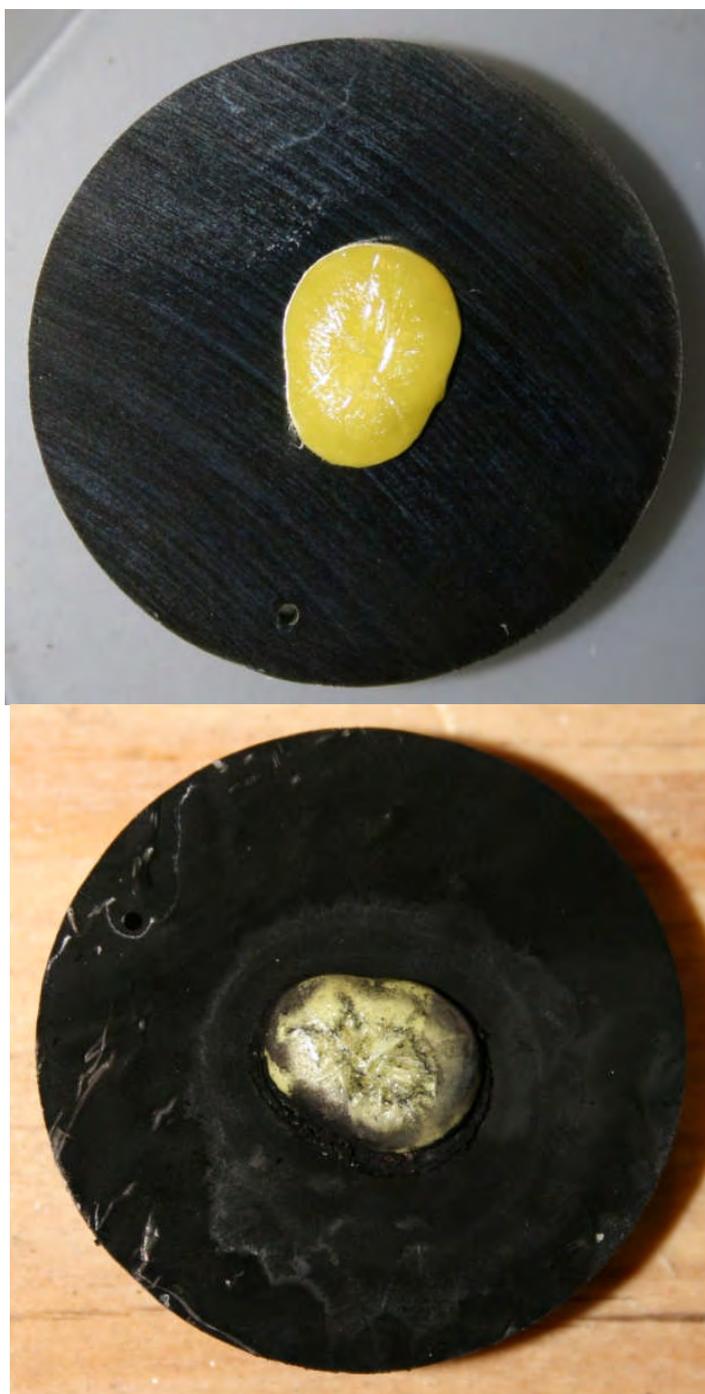
Figure 145. Corrosion specimen before and after 1 day exposure to sulfur at 80°C, 1.5 M NaClO₄.

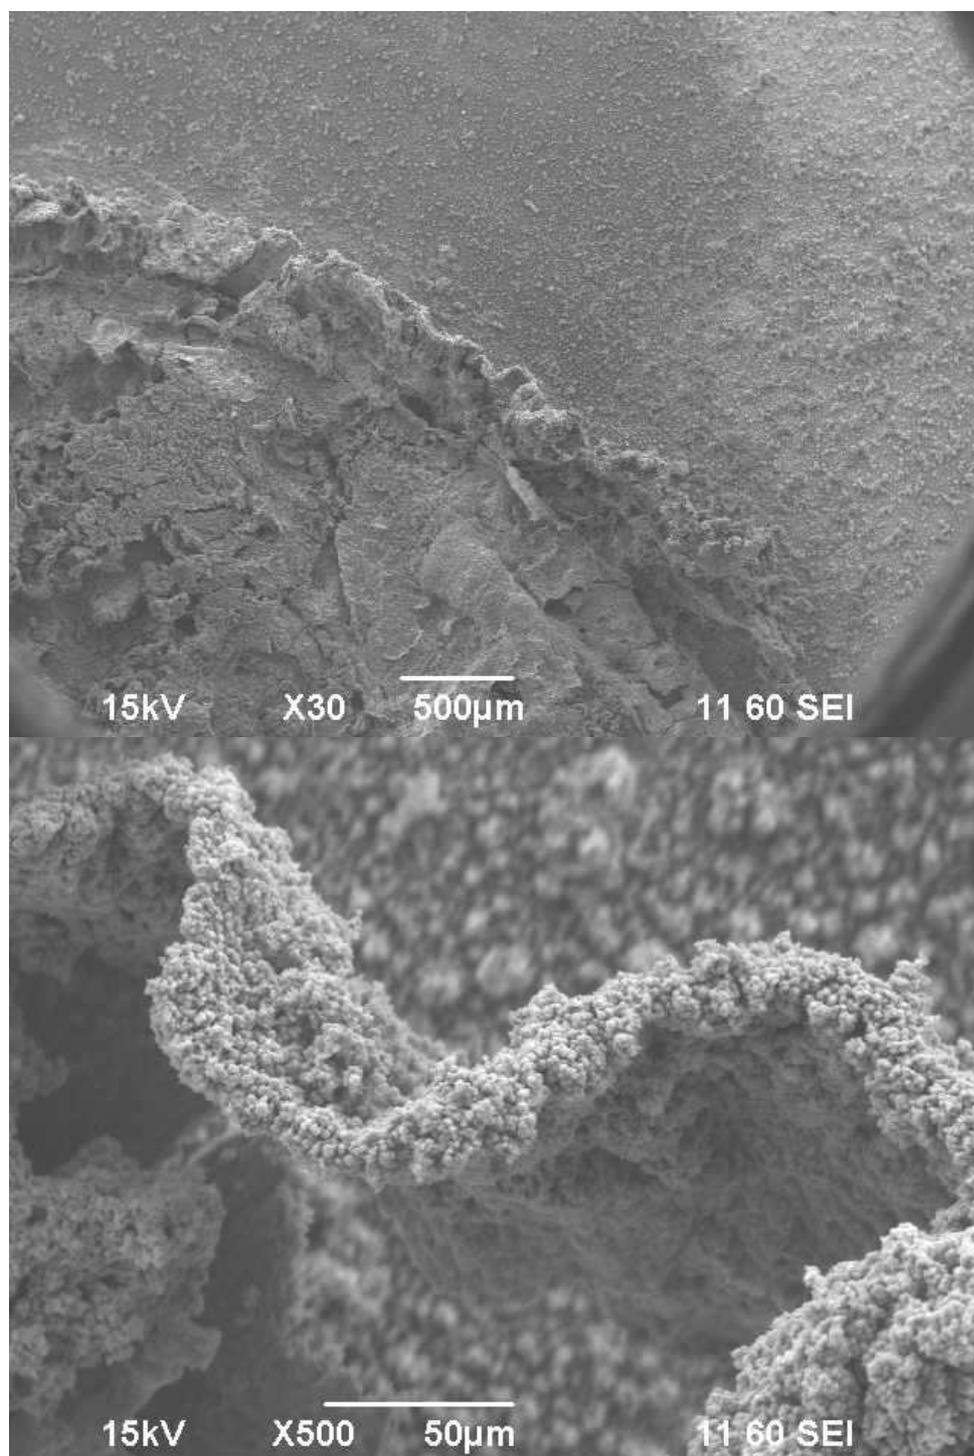
Figure 146. SEM image of specimen surface after 1 day exposure to sulfur at 80°C, 1.5 M NaClO₄.

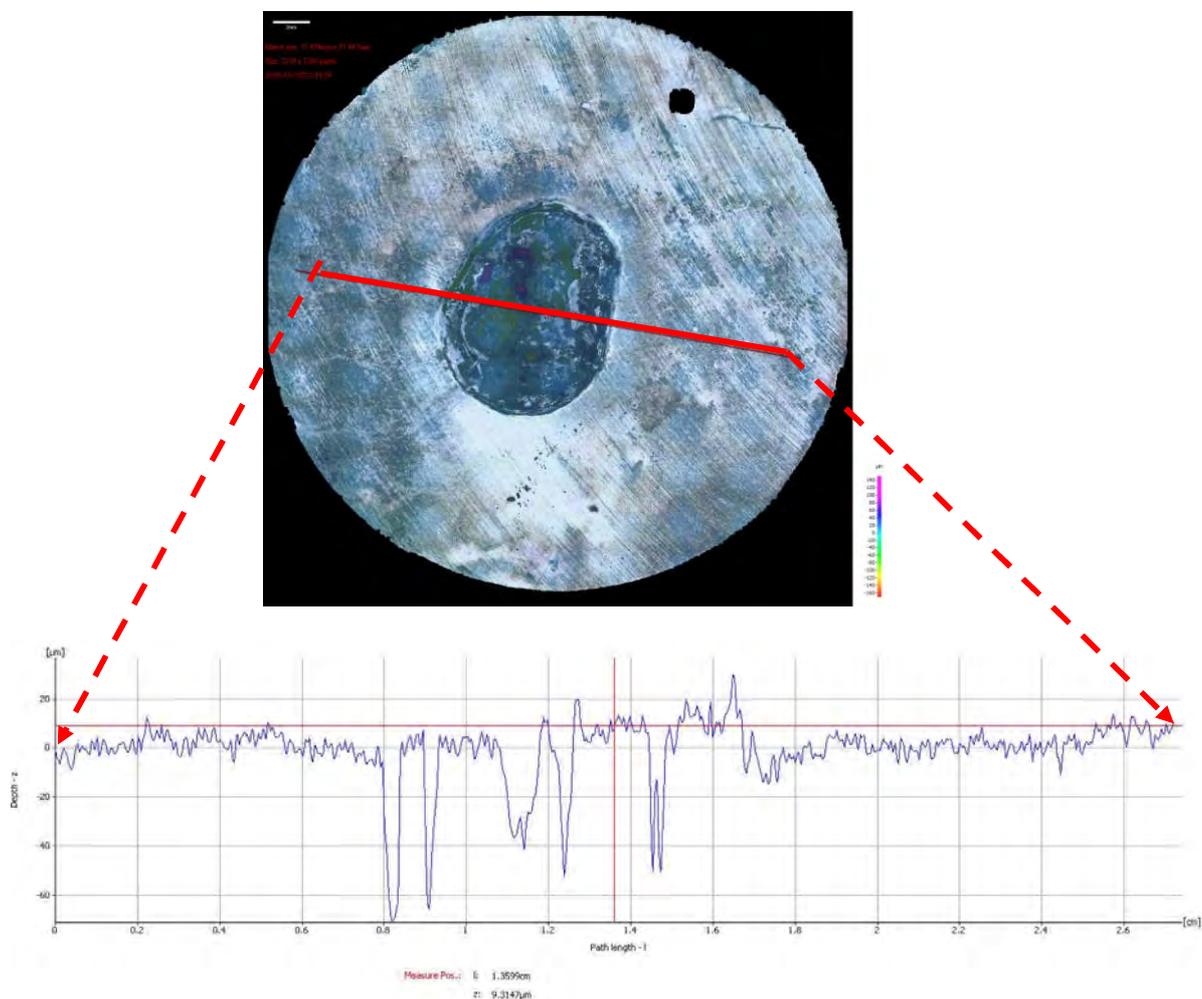
Figure 147. IFM data for corrosion specimen for 1 day at 25°C, 1.5 M NaClO₄, without film, appearance of the surface and surface profile.

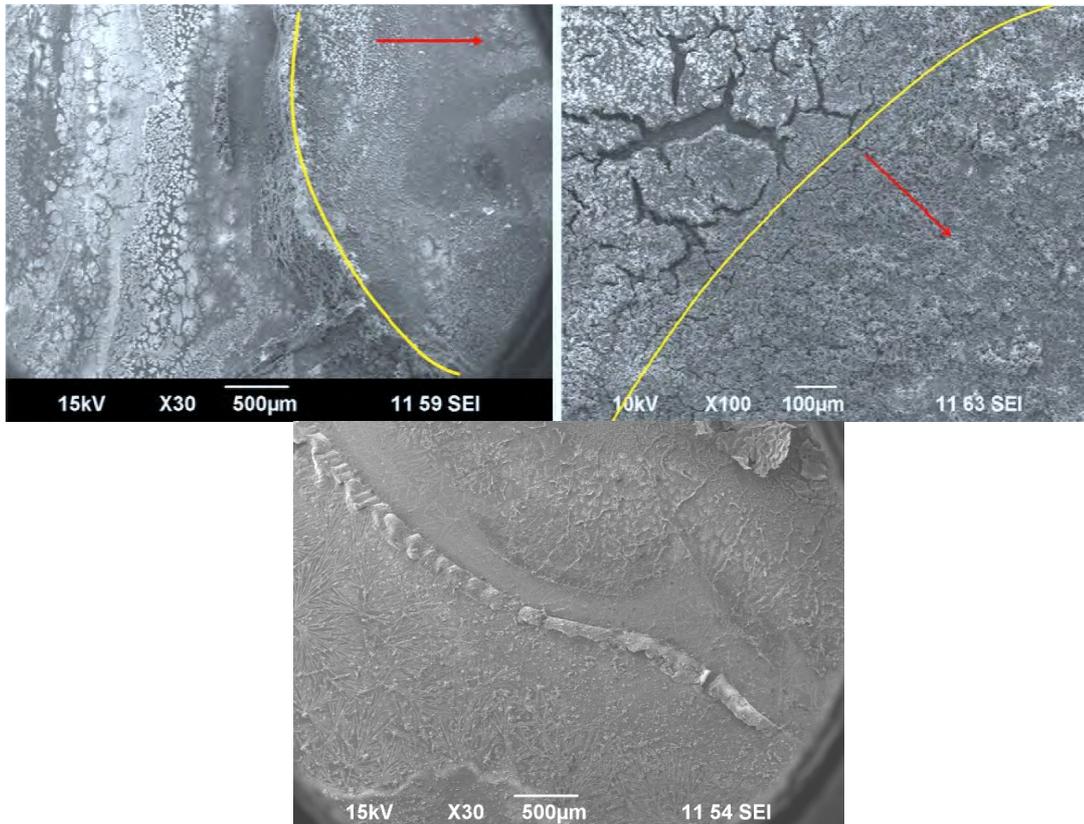
Figure 150. SEM images of specimen surface on the sulfur edge.

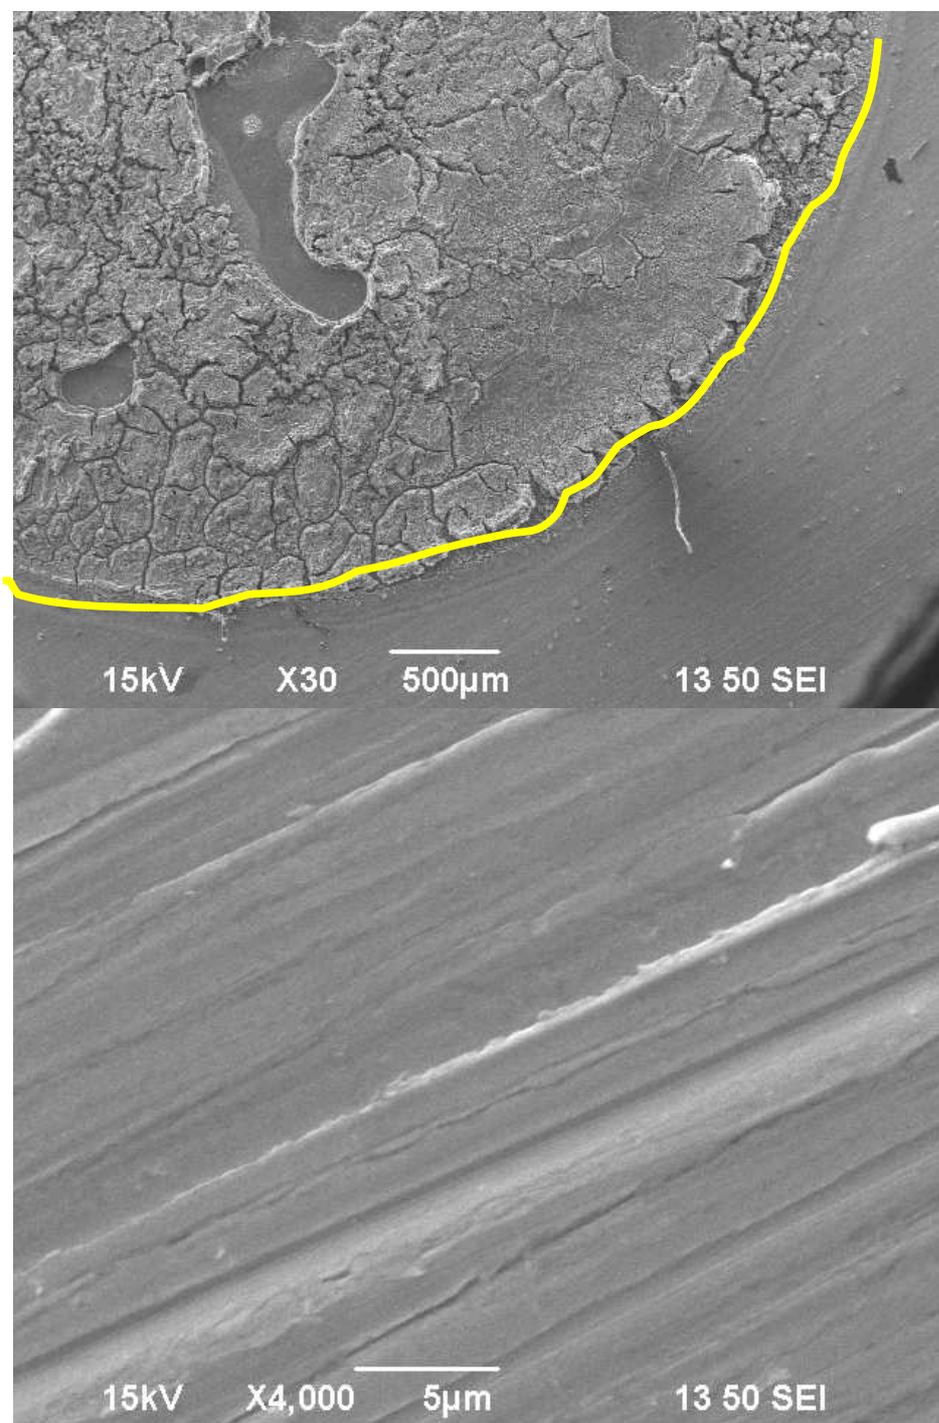
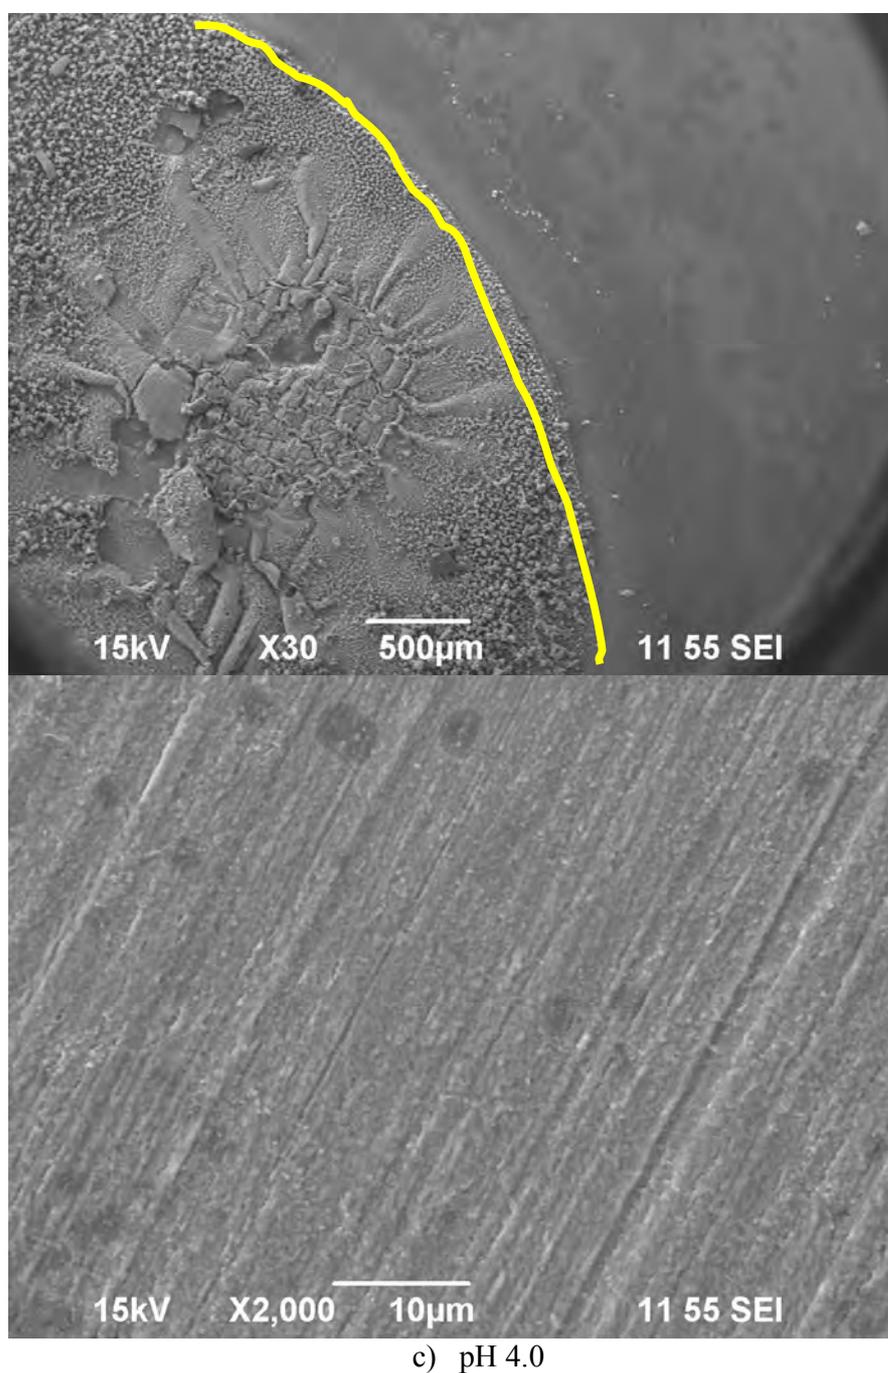
a) pH 7.0

b) pH 6.0

Figure 151. pH effect on film formation underneath (upper pictures) and outside the sulfur droplet (25°C, N₂ purged).

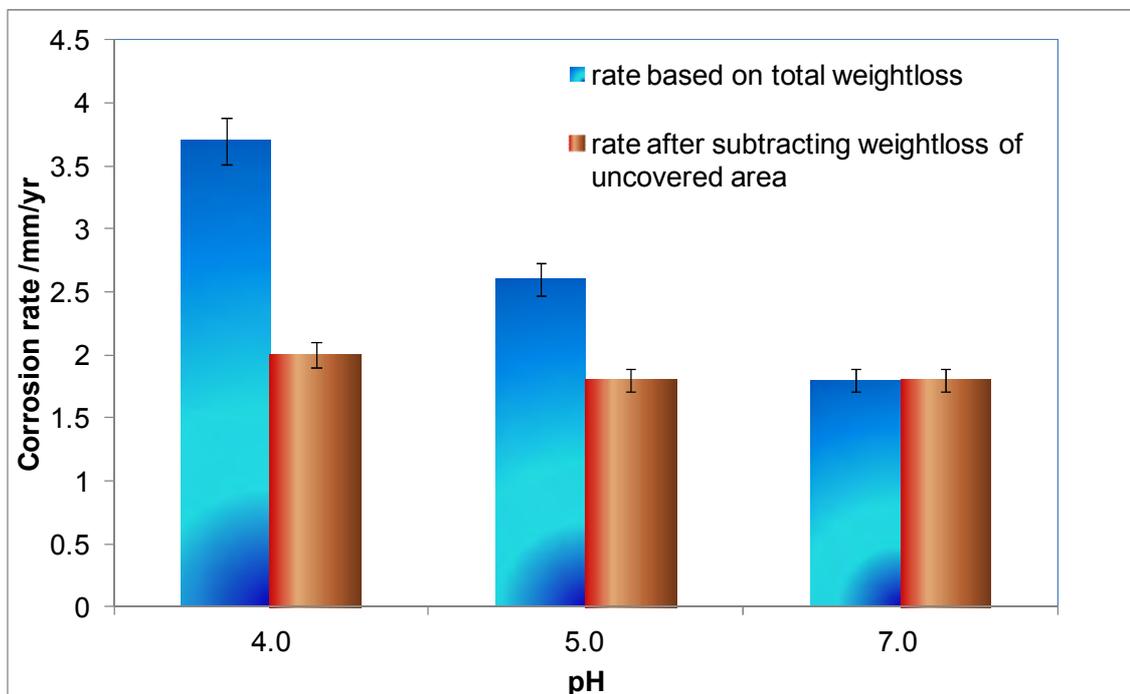
Figure 152. pH effect on sulfur/iron reaction rate(25°C, N₂ purged).

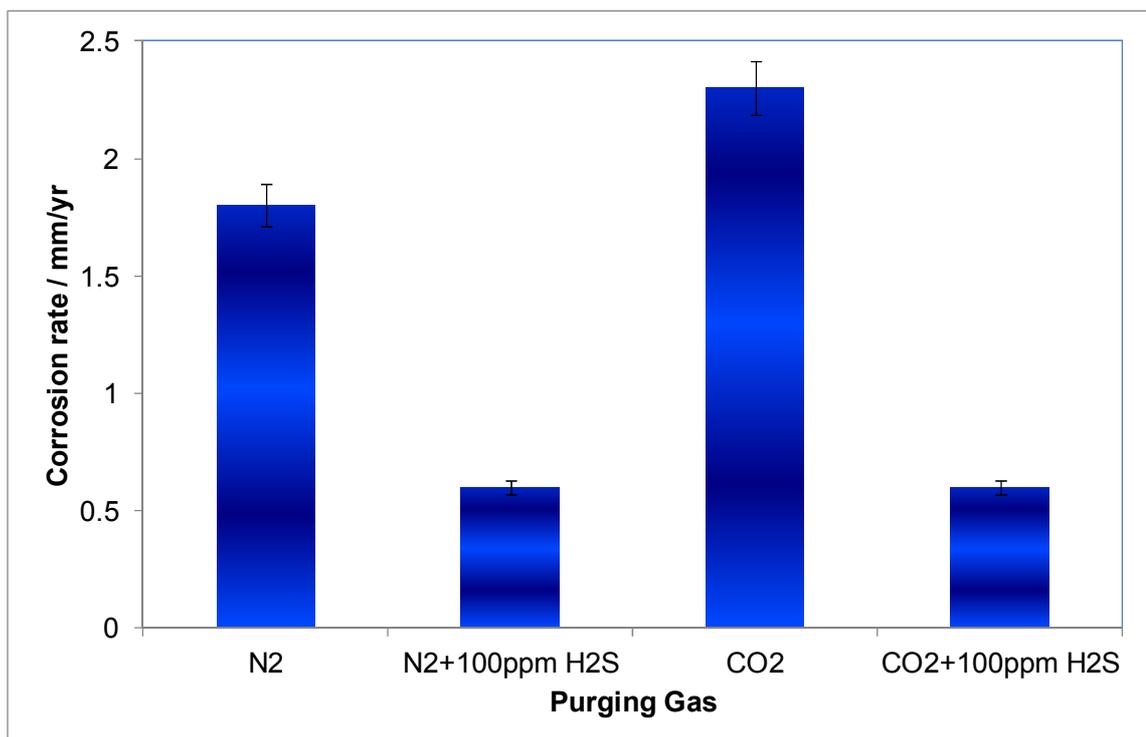
Figure 156. Corrosion rate underneath the sulfur droplet at different systems.

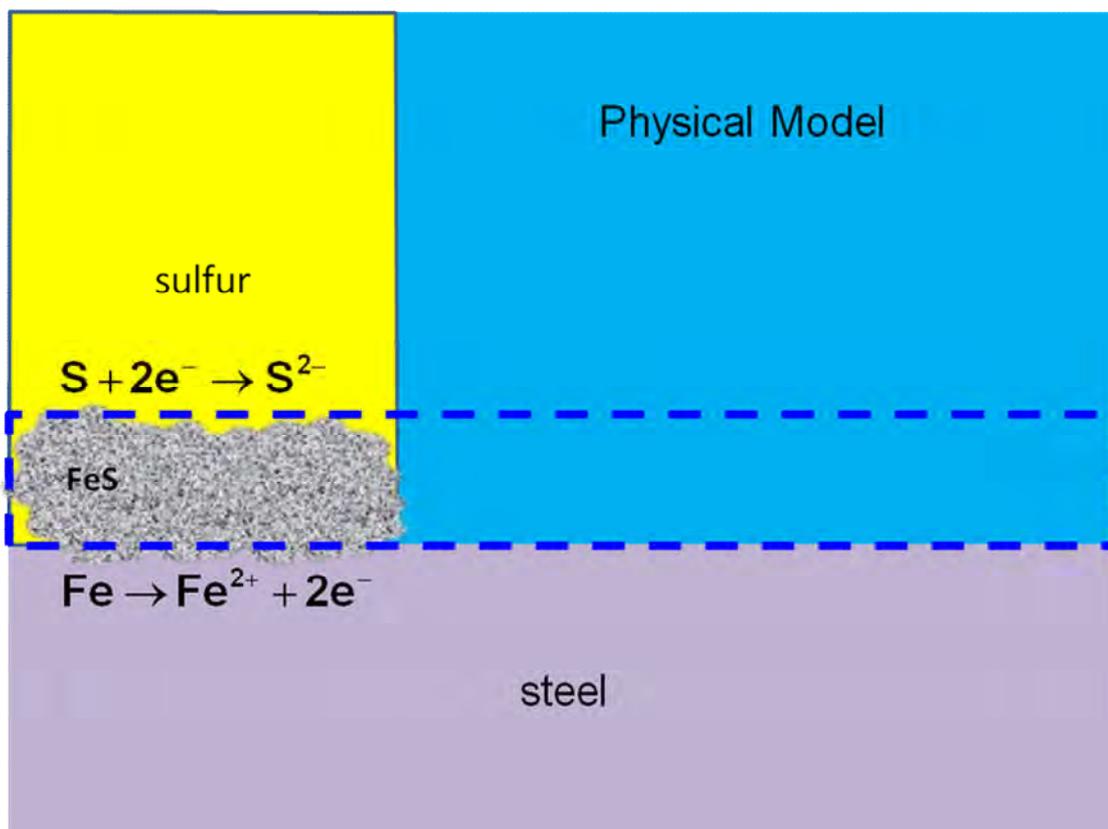
Figure 159. Schematic of the modeled electrochemical system in elemental sulfur corrosion.

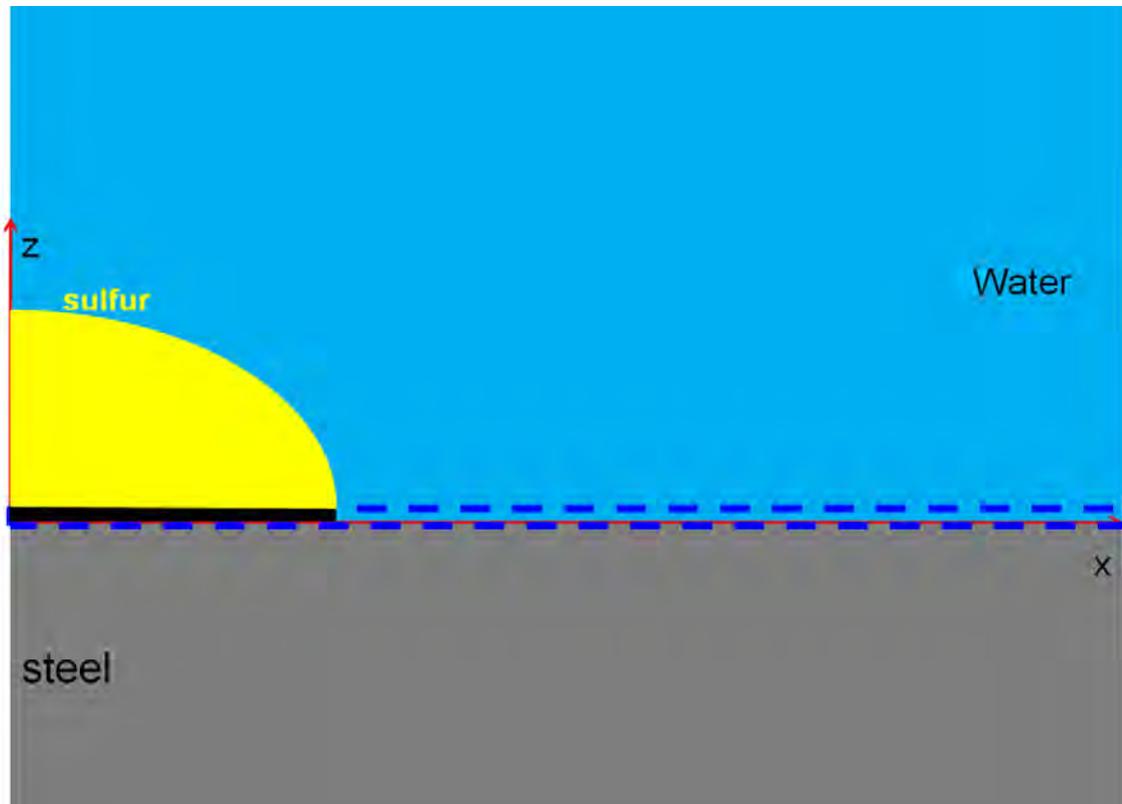
Figure 160. Elemental sulfur corrosion system used in the model.

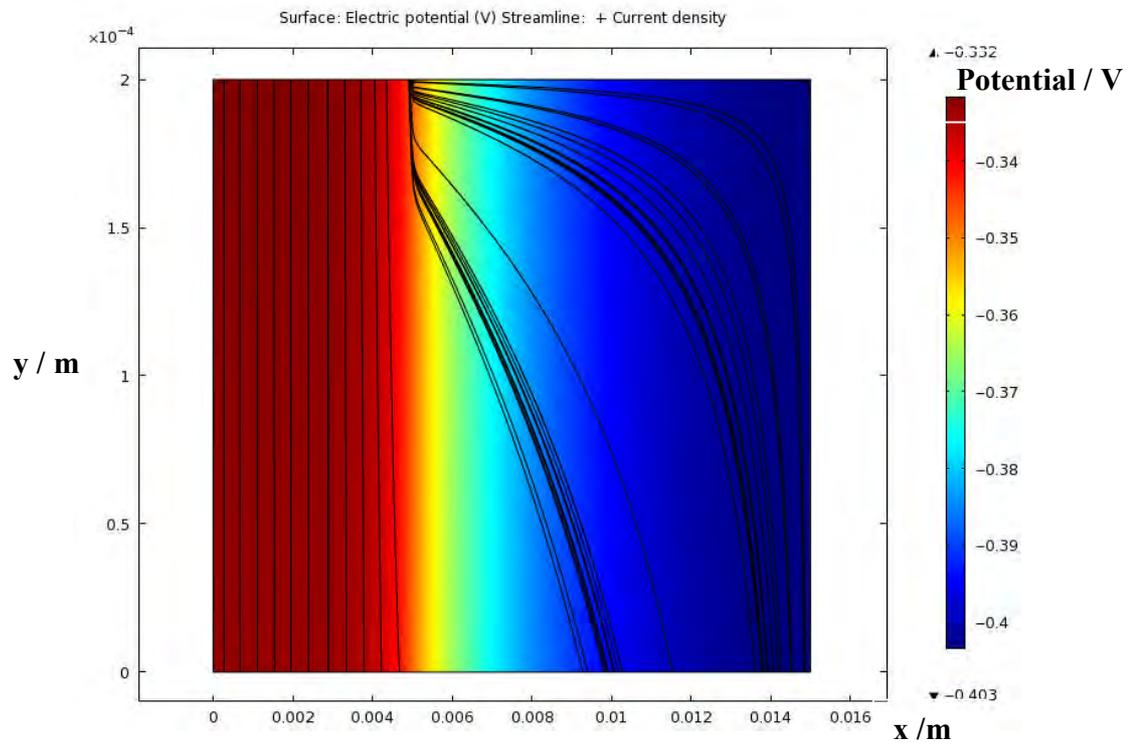
Figure 163. 2D Potential and current distribution – simulation 1.

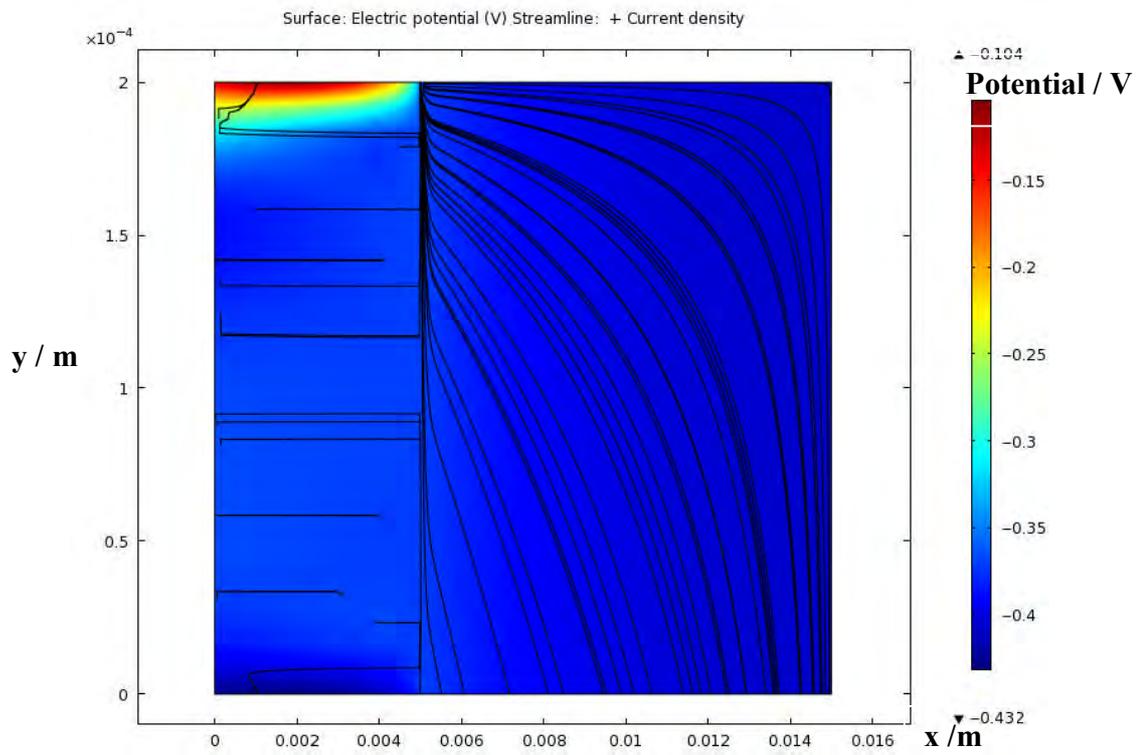
Figure 169. 2D Potential and current distribution – simulation 4.
