Criteria for Protective Film Growth on Carbon Steel Rebar in a Carbonation Process

Yoon-Seok Choi, K. Channa R. De Silva, Xiang Yong, David Young, Srdjan Nesic
Institute for Corrosion and Multiphase Technology,
Department of Chemical and Biomolecular Engineering, Ohio University
342 West State Street
Athens, OH 45701
USA

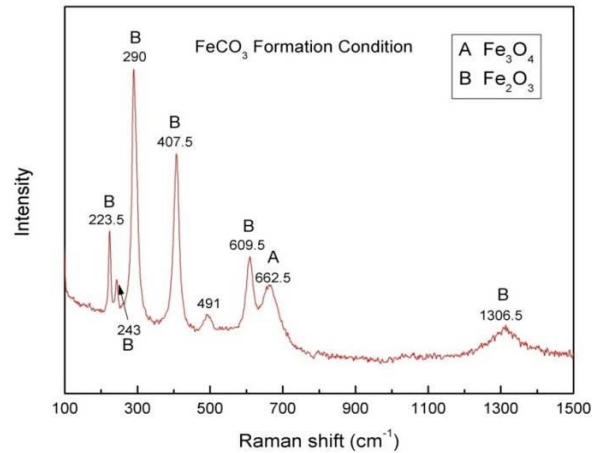
Figure 4: Result of Raman spectroscopy analysis for the specimen exposed to pH 9, 90°C for 72 hours.

Figure 3 shows the SEM image and EDS spectra of the specimen surface after 72 hours of exposure in the pH 9 solution at 90°C . It can be seen that the surface was covered by corrosion product, consisting of Fe, C and O. Figure 4 shows a Raman spectrum of the corrosion product layers. The corrosion products were mainly composed of magnetite and hematite, identifying the layer as mill scale. There is no vibrational mode at $\text{ca. } 1086 \text{ cm}^{-1}$, which means that FeCO_3 is absent from the corrosion products.

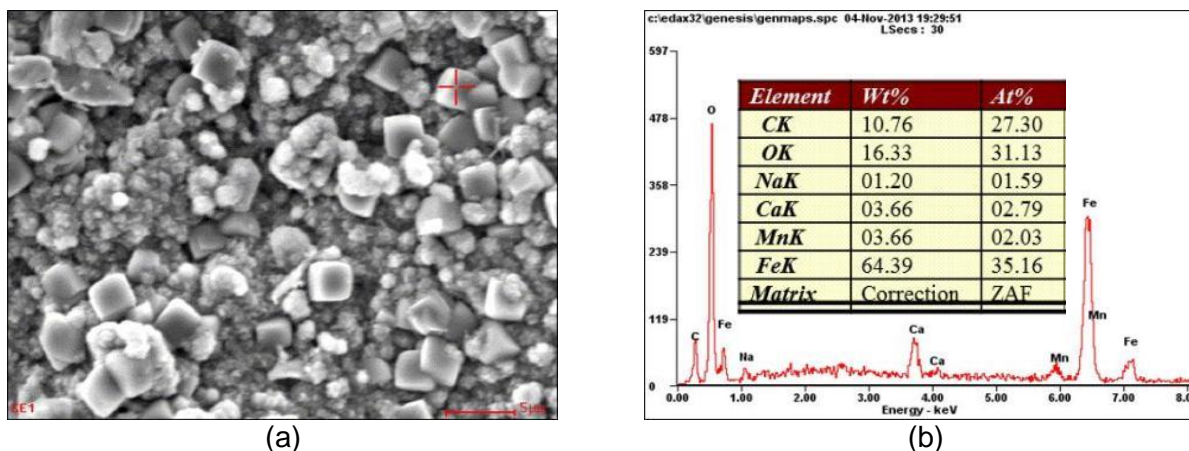
Figure 6: SEM image (a) and EDS spectra (b) of the rebar surface exposed to the service conditions (3.5 wt.% NaCl, pH 8.5, 25°C) for 120 hours.

After exposing the steel rebar in the service conditions for 120 hours, the specimen surface was observed by SEM and EDS. It is interesting to note that crystalline corrosion products accumulated on the specimen surface, had a morphology similar to FeCO_3 , as demonstrated in Figure 6.

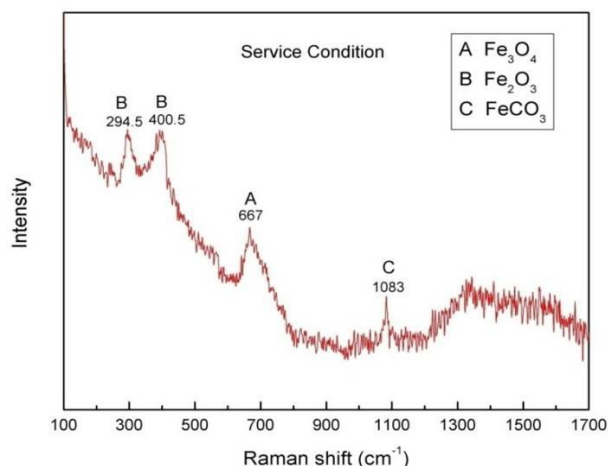
Figure 7: Result of Raman spectroscopy analysis for the specimen exposed to the service conditions for 120 hours.

The Raman spectroscopy result of the rebar surface after exposing to the service conditions is shown in Figure 7. There is a vibration mode at 1083 cm^{-1} , which indicates the existence of a carbonate product, most probably FeCO_3 . The FeCO_3 was generated probably due to the presence of CO_3^{2-} ions from NaHCO_3 used to adjust the solution pH. However, it seems to be unprotective based on the corrosion rates shown in Figure 5.

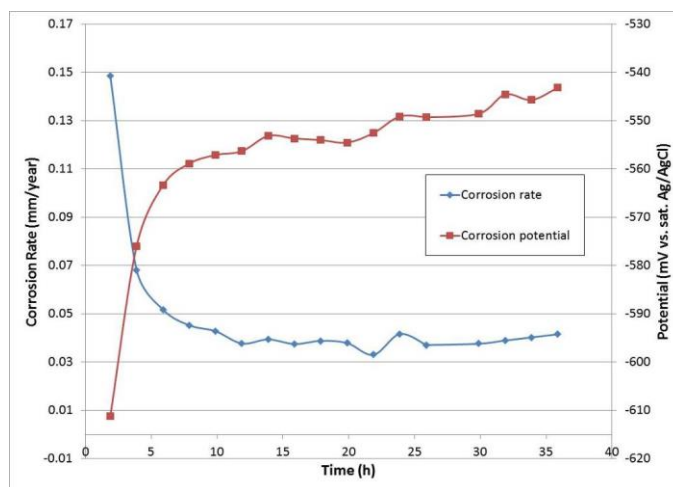
Figure 8: Variations of corrosion rate and corrosion potential with time for the as-received steel rebar under FeCO_3 formation conditions 2 (pH 6.6, 80°C, 50 ppm Fe^{2+}).

The corrosion rate and OCP variations of the as-received rebar in the newly selected FeCO₃ formation conditions is demonstrated in Figure 8. The corrosion rate decreased with time and then stabilized at a low value of around 0.04 mm/y, while the OCP increased with time.

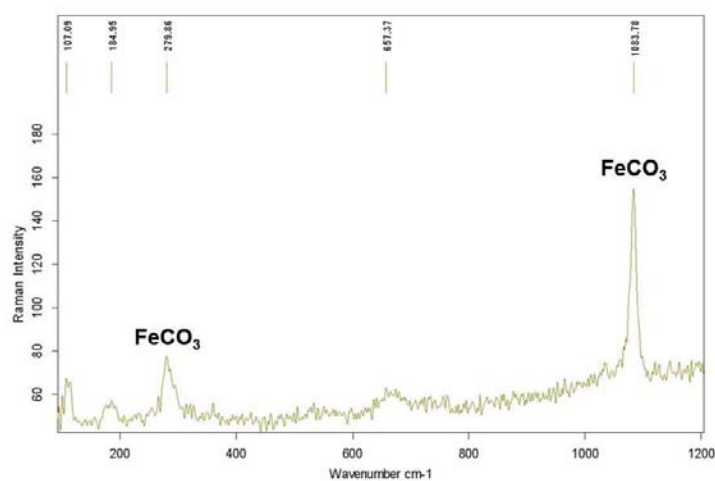
Figure 10: Result of Raman spectroscopy analysis for the specimen exposed to pH 6.6, 80°C for 36 hours.

Figure 9 shows the SEM image and EDS spectrum of the specimen surface after 36 hours of exposure in the 1 wt.% NaCl solution (pH 6.6, 80°C). It can be seen that the surface was covered by crystalline corrosion product (morphology typical of FeCO₃), consisting of Fe, C and O. The specimen surface was also analyzed by Raman spectroscopy, an acquired spectrum being shown in Figure 10. The strong peaks at 279.86 and 1083.78 cm⁻¹ indicate the presence of FeCO₃. Figure 11 shows the SEM images and EDS spectra of the cross-section of the specimen after 36 hours of exposure in the 1 wt.% NaCl solution (pH 6.6, 80°C). It clearly demonstrates a thin outer layer and a thick inner layer. Based on the results of surface analysis, the outer layer can be identified as FeCO₃ and the inner layer is the mill scale. The thickness of the FeCO₃ layer is around 4 μm, while the thickness of the mill scale layer is around 33 μm.

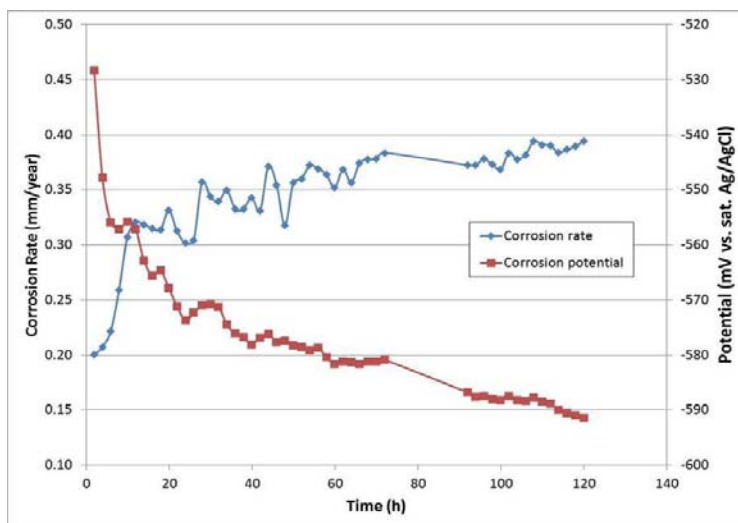
Figure 12: Variations of corrosion rate and corrosion potential with time for the steel rebar under service conditions (3.5 wt.% NaCl, pH 8.5, 25°C).

When the rebar specimen with both FeCO_3 and mill scale was moved to the service condition, the corrosion rate increased with time and the corrosion potential decreased with time, as demonstrated in Figure 12. The final corrosion rate after 120 hours exposure was around 0.4 mm/y, which is a little less than the one shown in Figure 5 due to the FeCO_3 contributing some degree of protectiveness.

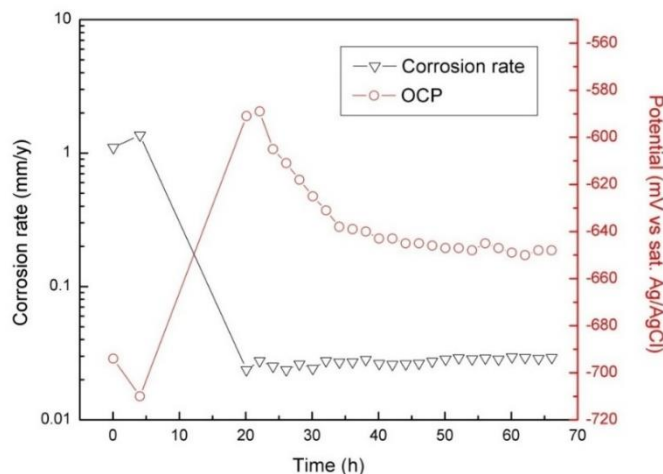
Figure 16: Variations of corrosion rate and corrosion potential with time for the sandblasted steel rebar under FeCO₃ formation conditions (pH 6.6, 80°C, 50 ppm Fe²⁺).

In the current condition, the mill scale was mechanically removed by sandblasting before forming the FeCO₃ on the steel rebar surface. Figure 16 demonstrates the variations of corrosion rate and OCP of the sandblasted rebar in the FeCO₃ formation conditions (80°C, 50 ppm Fe²⁺, 1 wt.% NaCl and pH 6.6). The corrosion rate decreased with time from an initial value of around 1 mm/y to a final stable value of around 0.03 mm/y. The corrosion potential sharply increased with time in the first 20 hours, and then decreased to a stable value. The increase of the OCP indicates that some protective layer formed on the specimen surface.

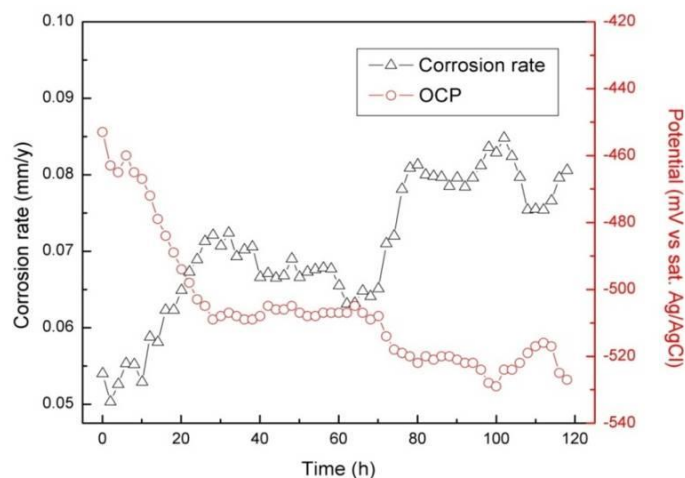
Figure 19: Variations of corrosion rate and corrosion potential with time for the steel rebar under service conditions (3.5 wt.% NaCl, pH 8.5, 25°C).

Figure 19 shows the variations of corrosion rate and OCP with time for the sandblasted rebar specimen with FeCO_3 exposed to the service conditions. The corrosion rate of this specimen slightly increased with time from 0.05 mm/y to 0.08 mm/y and the OCP value decreased with time. Comparing with other conditions shown in Figure 5 and Figure 12, it showed a significantly lower corrosion rate in the service conditions. This indicates that the FeCO_3 layer can give better protection in the absence of mill scale.

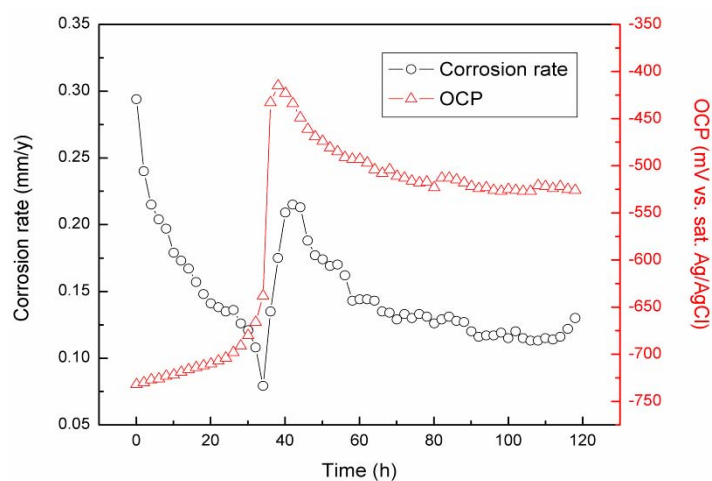
Figure 22. Variations of corrosion rate and corrosion potential with time for the sandblasted steel rebar under service conditions (3.5 wt.% NaCl, pH 8.5, 25°C).

The corrosion behavior of a sandblasted steel rebar (without FeCO_3) was also evaluated in the service condition. The corrosion rate and OCP changes with time are plotted in Figure 22. It is interesting to note that the corrosion rate decreased with time and stabilized on a low value (~ 0.12 mm/y) without the presence of FeCO_3 . The corrosion potential increased with time and then stabilized.

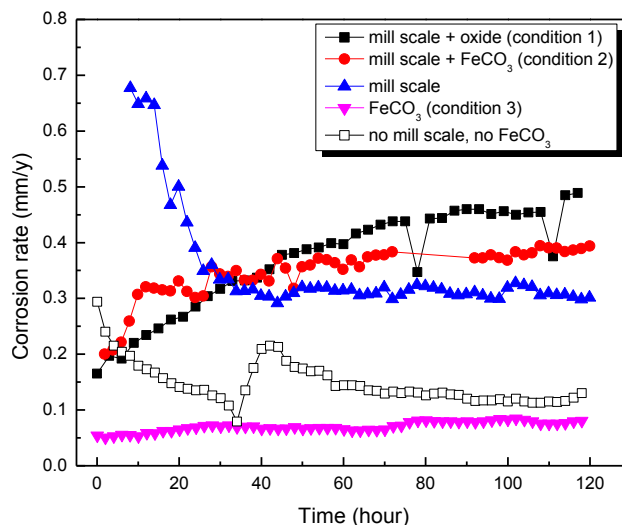
Figure 23: Variations of corrosion rates with time for the steel rebars under service conditions (3.5 wt.% NaCl, pH 8.5, 25°C).

Figure 23 shows the variation of corrosion rates with time in the service conditions for each of the different surface states. It clearly shows that the sandblasted rebar with the FeCO_3 coating has the lowest corrosion rate in the service conditions. It is also observed that the corrosion rates of specimens with mill scale (condition 1, 2 and 3) show a similar value, indicating some level of protection due to the presence of mill scale.
