SURFACE CHEMICAL AND MORPHOLOGICAL CHANGES IN CORROSION PRODUCT LAYERS AND INHIBITORS IN CO₂ CORROSION IN MULTIPHASE FLOWLINES

S. Seal, K. Sapre and V. Desai

Keywords: Imidazolines, Multiphase flow, XPS, Satellite peaks, C-Steel, AFM

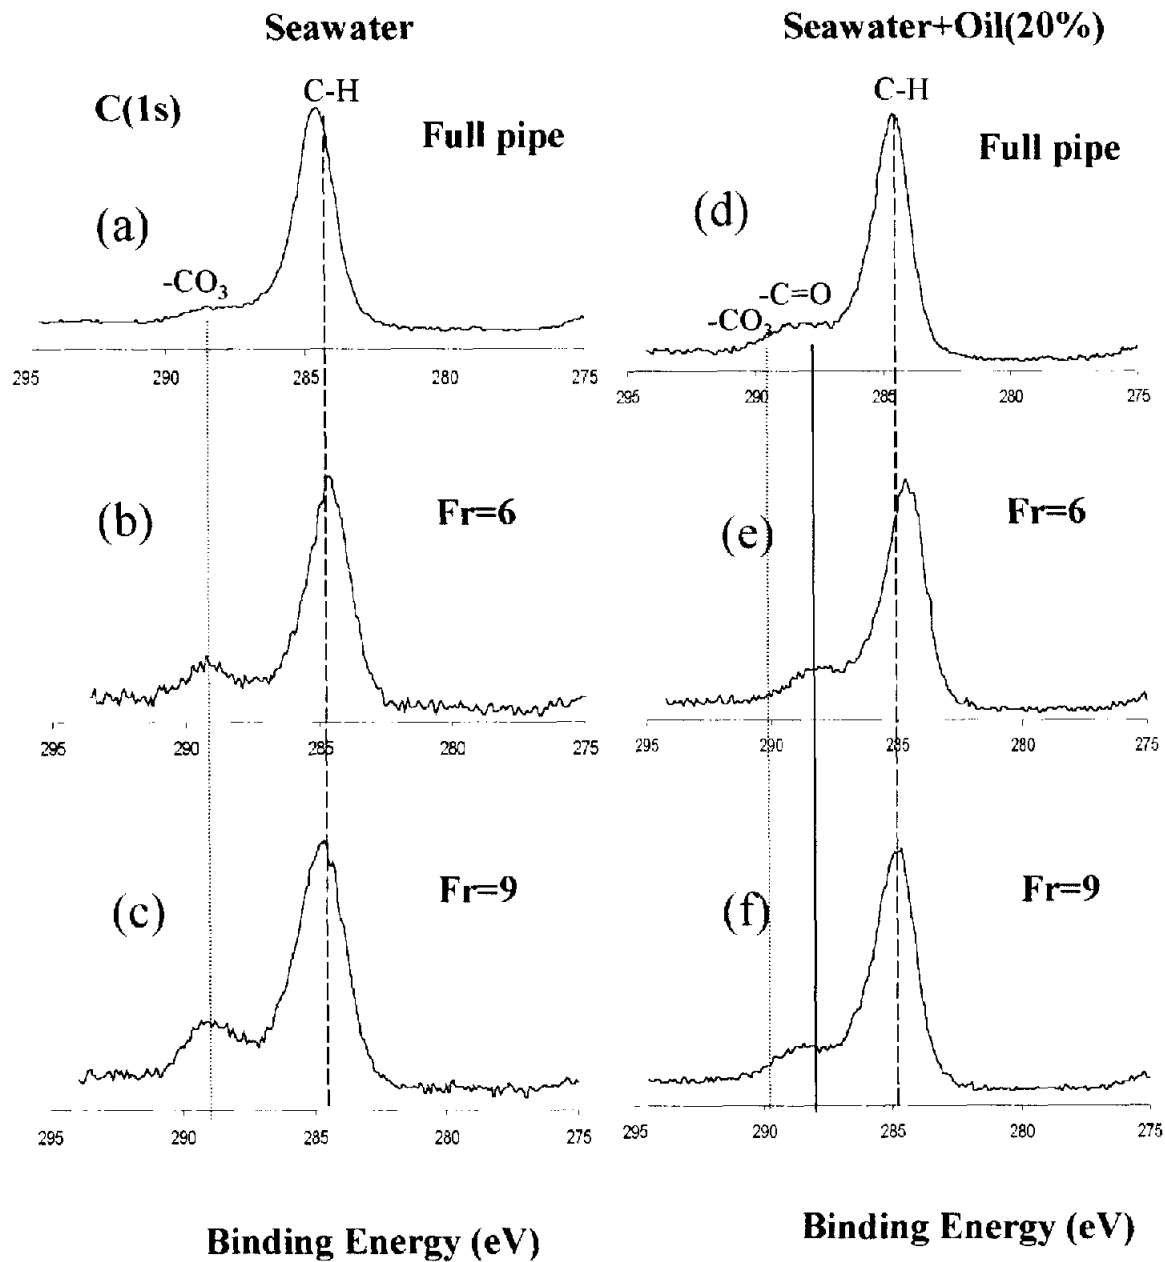
FIGURE 8 - Comparisons between the carbon peaks in Full pipe, Froude 6, Froude 9 flow conditions.

XPS reports by Heuer and Stubbins (1998) indicate the XPS C(1s), Fe(2p) and O(1s) photoline corresponds to 289.4 eV, 710.2 eV and 531.9 eV for a standard and pure iron carbonate crystal.¹⁴ In the seawater condition, the iron carbonate signatures (Figure 8 a, b, c: C 1s binding energy at 289.2 - 289.5 eV) are revealed. It is observed that the intensity increases as the flow is increased (indicating top surface removal), whereas the intensity of the carbonate signal is more or less uniform as the slug flow is increased in the seawater+20% oil mixtures (Figure 8 d, e, f). Nevertheless the carbonate species present on the surface is minimal and it might be due to the decomposition of iron carbonate following oxidation in presence of oxygen and air. Presence of C=O species (C1s binding energy at 288.4 eV) are observed on the steel surface subjected to slug flow.
