CORROSION OF MILD STEEL IN THE PRESENCE OF ELEMENTAL SULFUR

H. Fang, D. Young and S. Nešić
Institute for Corrosion & Multiphase Technology, Ohio University
342 West State Street
Athens, OH 45701

ABSTRACT

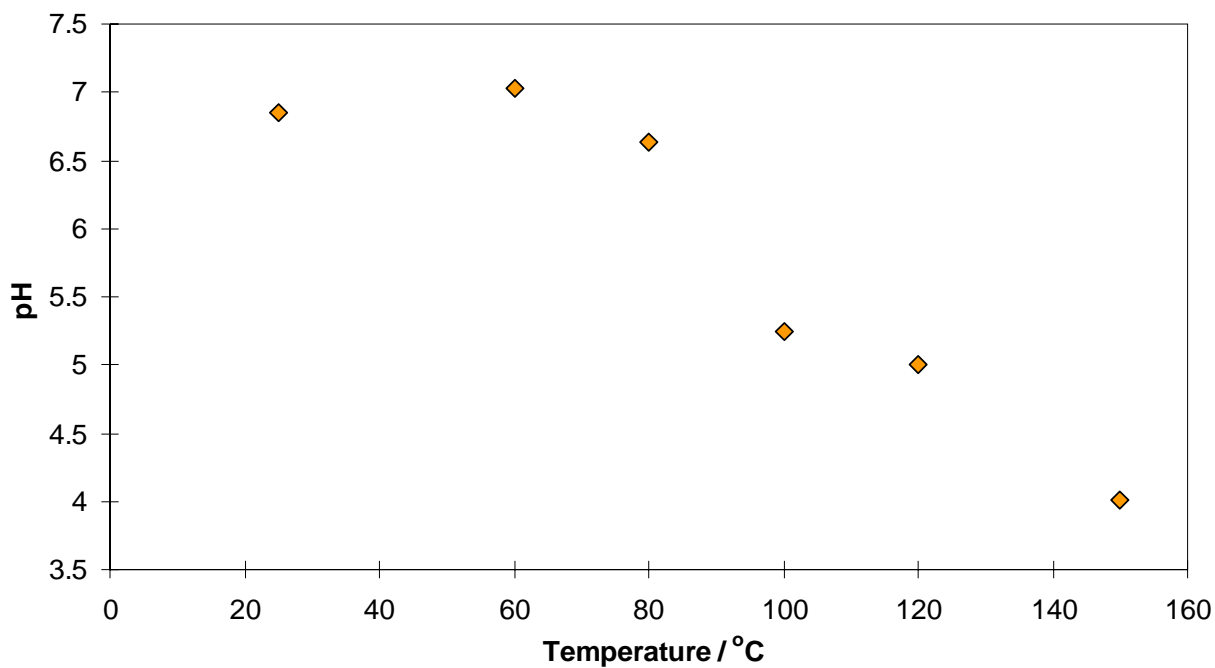
FIGURE 1 – Acidification of water by its reaction with elemental sulfur at different temperatures.

Significant acidification of water upon exposure to elemental sulfur was measurable only at temperatures in excess of 80°C, as shown in Figure 1. The pH values shown there were obtained after waiting for at least a few hours while the measured pH stabilized. The results confirmed that hydrolysis products were indeed being formed by reaction of elemental sulfur with water, be they H₂S, H₂SO₂, H₂SO₃, H₂SO₄ and/or polysulfide species. The pH values measured were significantly higher than those reported in a similar study by Maldonado-Zagal and Boden⁴, however it is difficult to establish why. Also, it is not clear if this mechanism can be used as an explanation for localized attack on mild steel by elemental sulfur, as the lowest pH values observed fall within the typical range of pH seen in water/CO₂ systems.

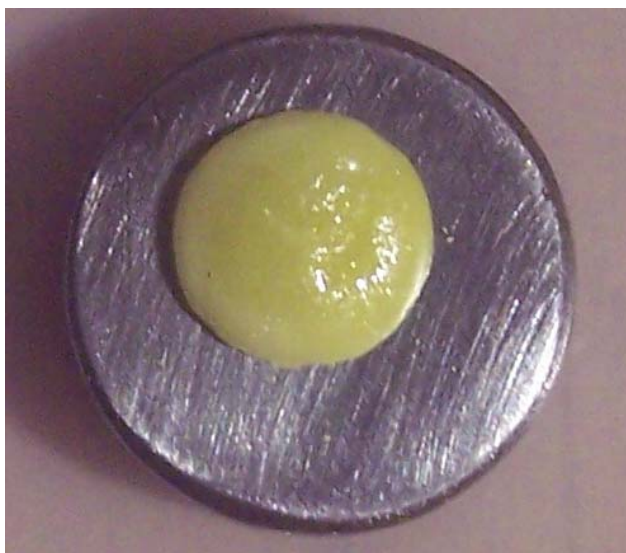
FIGURE 2 – Elemental sulfur deposited on the surface of a corrosion coupon before exposure.

A coupon with elemental sulfur on the surface prior to exposure is shown in Figure 2. The portion of the coupon surface which was in direct contact with the elemental sulfur was significantly blackened after exposure; this was due to the formation of iron sulfide. A typical coupon surface, after the reaction, is shown in Figure 3.

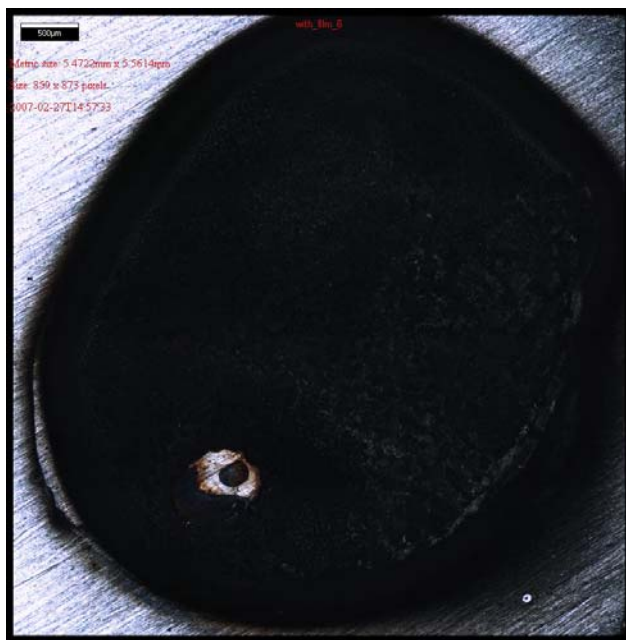
FIGURE 3 – The overall surface of a corrosion coupon after exposure to elemental sulfur (25°C, 3 days).

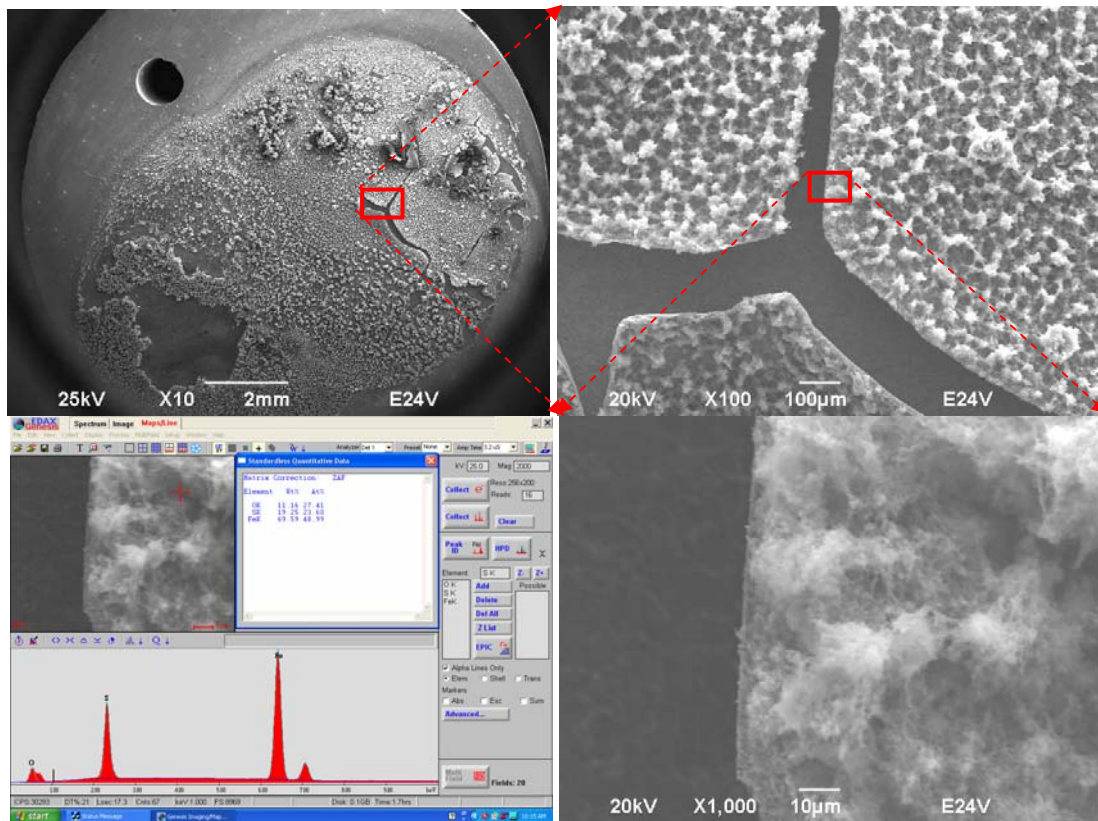
FIGURE 4 – Corrosion coupon contacted with elemental sulfur for 1 day at 25°C, with film.

Representative SEM/EDX data for the corrosion coupon surface that has been in direct contact with elemental sulfur for one day at 25°C is shown in Figure 4. Note that most of the surface film resembles a blistered layer (top left SEM image). Cracking of the film shown in the enlarged image, reveals that it is very thin, which seems to be exfoliating from the surface. A further enlargement of the small area shows that the film appears amorphous, with no well defined morphologies present; this was confirmed by XRD. The composition of the film was shown to consist of iron sulfide by using EDX. The IFM image of the corrosion coupon after the iron sulfide has been removed reveals some pitting corrosion, Figure 5. The top right image corresponds to the small region marked on the “whole coupon” picture to the left of it. The line across the “twin pits” corresponds to the profile data at the bottom of the figure. Note that the first pit has a depth of *ca.* 18 μm whereas the second pit is *ca.* 12 μm. Comparison of general and localized corrosion rate data of generated samples is given below. After four days at 25°C a thicker film has formed at the surface, see Figure 6. The exfoliation of the film is obvious on the enlarged image on the top right. The origin of the lines on the underside of the exfoliated film are due to the polishing marks on the original steel substrate, which have left an imprint on the sulfide film formed by a solid state reaction. Cracking of the film is more severe on this coupon than the one exposed for only one day. From EDX and XRD, it is clear that the film chemistry remains fundamentally unchanged in the longer exposure. Film pit depths appear similar to those observed after 1 day; however, the profile shown in Figure 7 seems to indicate a broadening effect. After a 5 day exposure at 25°C, see Figure 8, the films seem to be even thicker and coarser than before, but pit depth remains similar, see Figure 9.

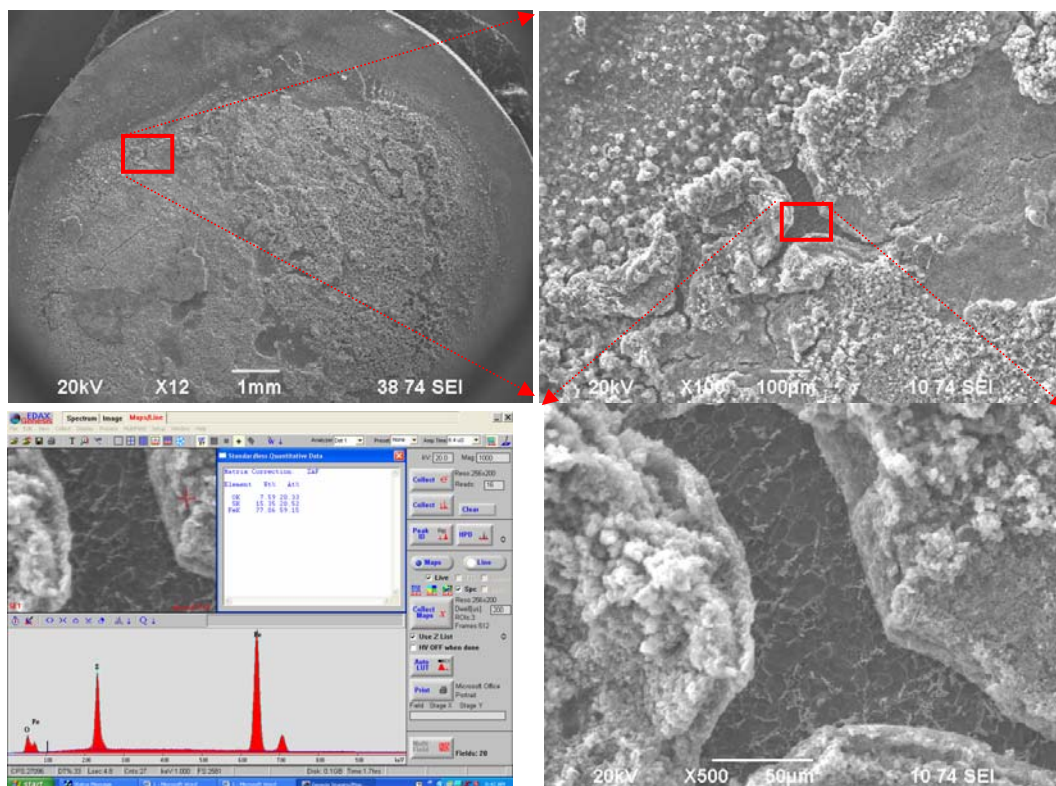
FIGURE 8 – Corrosion coupon contacted with elemental sulfur for 5 days at 25°C, with film.

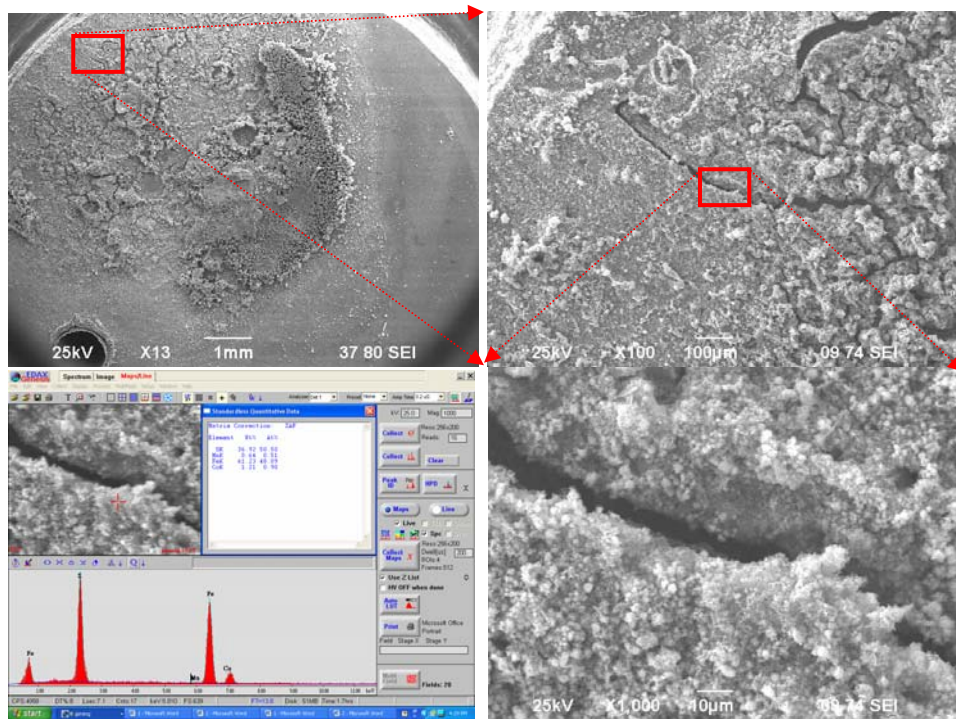
FIGURE 10 – Corrosion coupon contacted with elemental sulfur for 1 day at 80°C, with film.

Another similar series of experiments was conducted at 80°C. After one day at 80°C there is a much thicker film present on the coupon surface than was observed at 25°C, see Figure 10. Distinct iron sulfide microcrystallites seem to have formed. The pitting depth is again about 15 μm, see Figure 11. After 4 days at 80°C, Figure 12, the film has become thicker and coarser, appearing more crystalline. Pitting depth remains at *ca.* 15 μm, Figure 13, but broadening is again observed. Pit density on the surface also appears to be increasing. After 5 days at 80°C, Figure 14, the entire surface seems to be covered by a coarse and cracked film. From XRD, the dominant phase is the crystalline iron sulfide

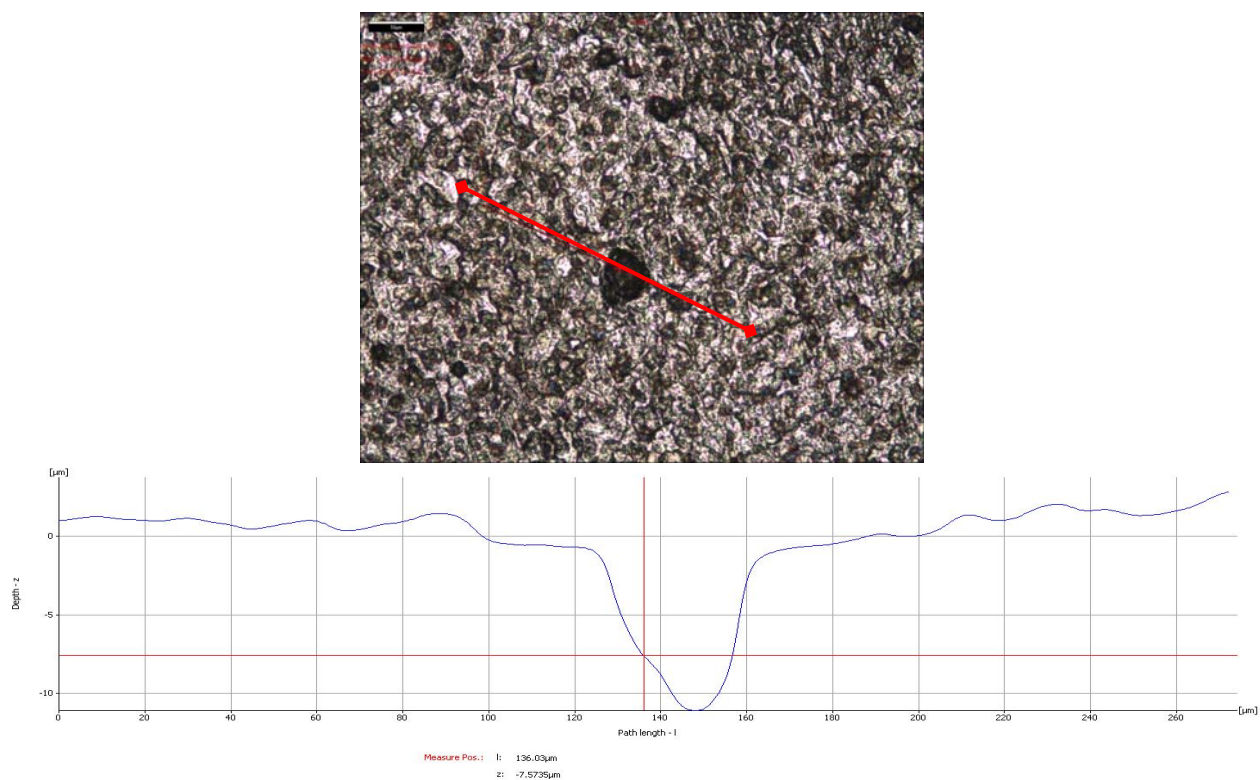
FIGURE 11 – IFM data for coupon contacted with sulfur for 1 day at 80°C, without film.

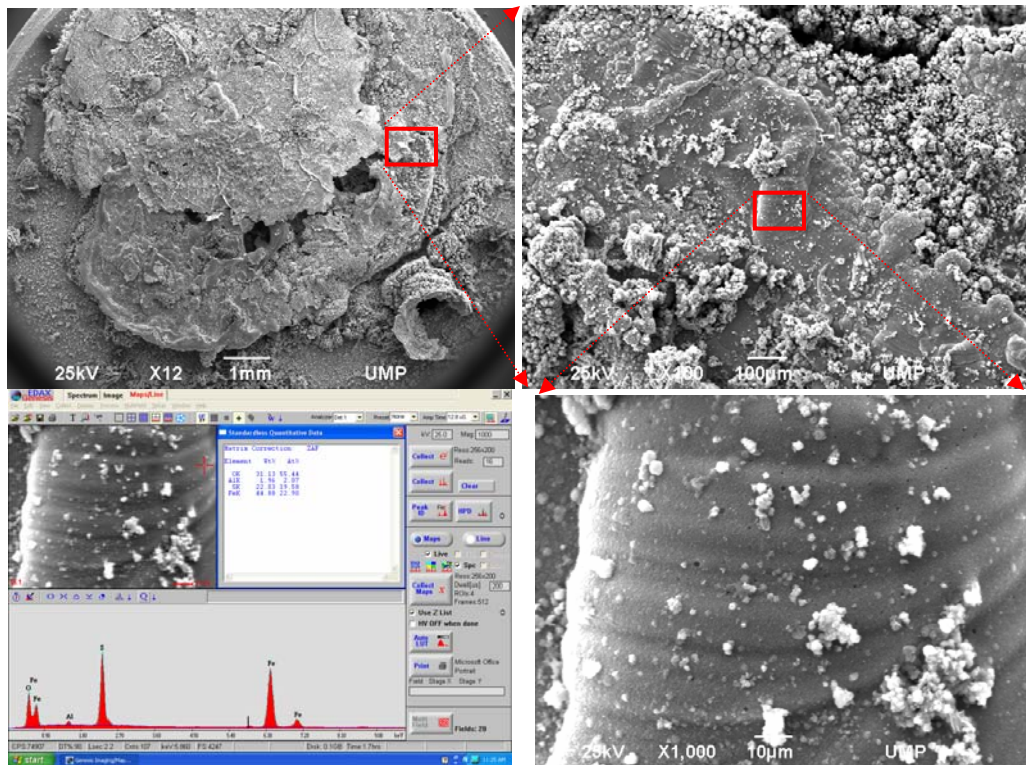
FIGURE 12 – Corrosion coupon contacted with elemental sulfur for 4 days at 80°C, with film.

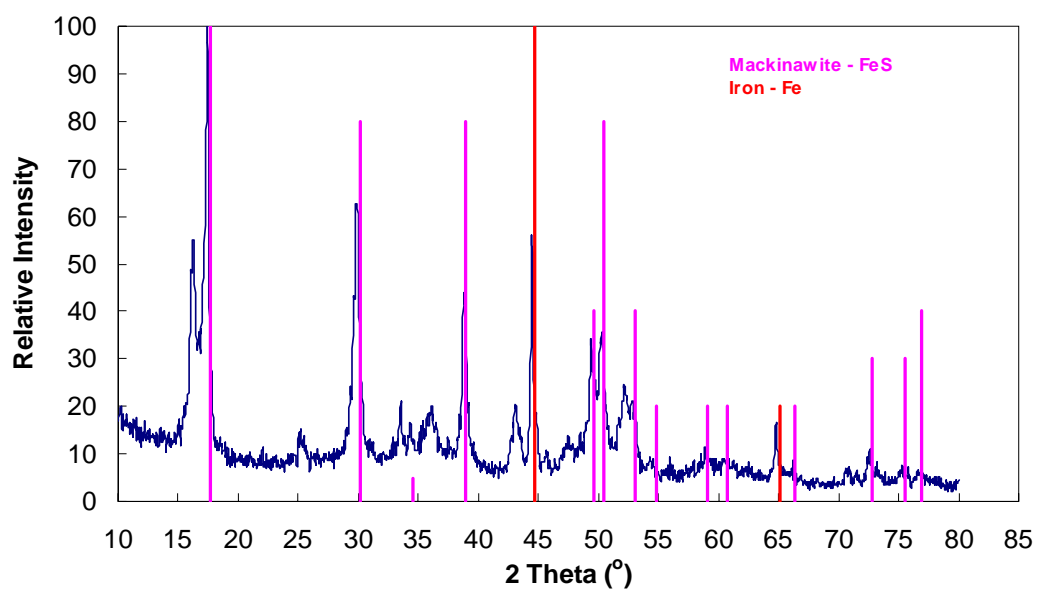
FIGURE 15 – XRD data of the corrosion product after 4 days at 80°C.

mackinawite, see Figure 15. Mackinawite is a layered structure which is common in aqueous environments under mildly sour conditions.⁷

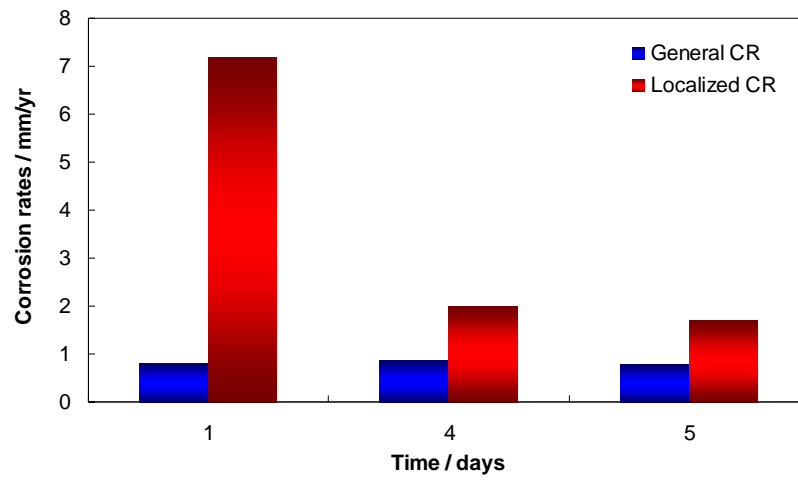
FIGURE 16 – Comparison of general and localized corrosion rates at 25°C.

Comparison of general and localized corrosion rates are shown in Figures 16 and 17. Both refer to the steel surface area underneath the elemental sulfur deposit. At 25°C, the localized corrosion rate (pitting) decreased from 7.2 mm/yr after one day to 1.7 mm/yr after 5 days. The general corrosion rate remained essentially unchanged at *ca.* 0.80 mm/yr. At 80°C, the localized corrosion rate was 5.1 mm/yr after one day, but was reduced to 3.0 mm/yr after 5 days. The general corrosion rate was 1.6 mm/yr at 80°C, double the general corrosion rate measured at 25°C.

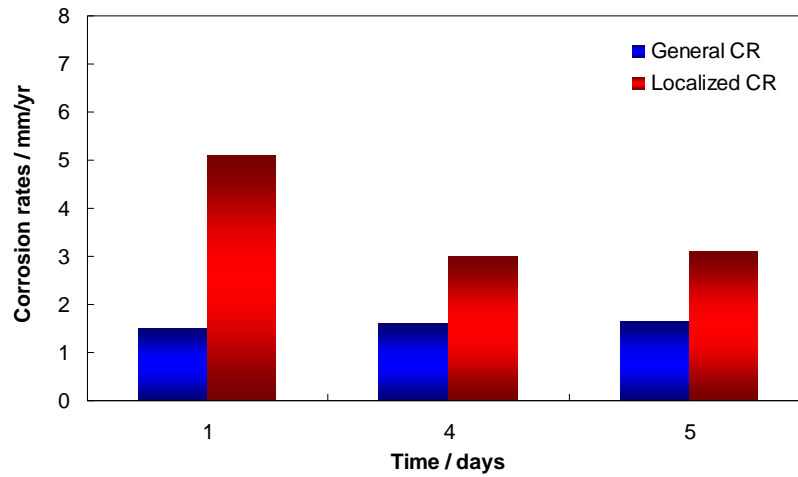
FIGURE 17 – Comparison of general and localized corrosion rates at 80°C.
