# Influence of Acetic Acid on the Integrity and Protectiveness by an Iron Carbonate (FeCO<sub>3</sub>) Corrosion Product Layer

The effect of undissociated acetic acid on the integrity of an iron carbonate (FeCO<sub>3</sub>) layer formed on platinum and X65 steel substrates is investigated. Experiments were conducted using buffered solutions with 0.8 mM to 5 mM undissociated acetic acid. For the platinum substrates, changes in the FeCO<sub>3</sub> layer were monitored via in situ electrochemical quartz crystal microbalance (EQCM) measurements. This investigation was supported by performing electrochemical experiments, under comparable conditions, on the X65 steel specimens, linking the integrity of FeCO<sub>3</sub> layer to its corrosion protection effect. The EQCM measurements revealed that the addition of acetic acid, at all concentrations tested here, caused partial dissolution of the FeCO<sub>3</sub> layer. The dissolution occurred selectively, with the outer layer dissolving first, leaving behind an inner FeCO<sub>3</sub> layer at the end of the immersion experiment. The electrochemical results revealed that introducing the acetic acid caused a sudden increase in the corrosion

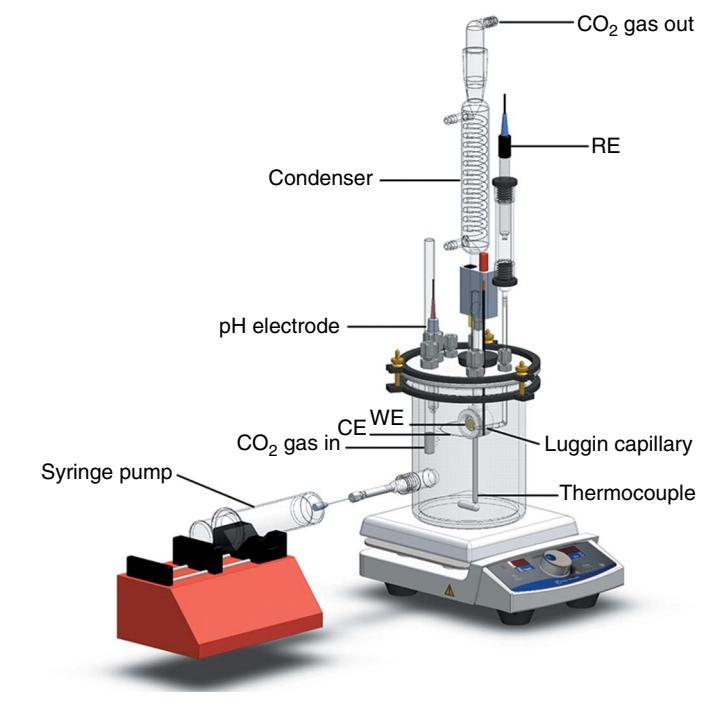
FIGURE 1. Schematic representation of the glass cell setup used for the EQCM measurements.

The platinum-coated quartz crystal WE was used; being a noble metal, the platinum does not corrode, making it possible to

measure the mass gain and loss of the FeCO<sub>3</sub> laver without any interference by the corrosion of the underlying substrate. This was not the case with the obvious alternative-the iron-coated quartz crystal. The thickness of the vapor-deposited iron layer on the quartz crystal is typically around 1 µm and would therefore corrode away before the precipitation process was complete; the layer of iron is also too smooth and would inhibit the nucleation of FeCO<sub>3</sub>. Therefore, the iron-coated quartz crystal, although available, was found not to be suitable for this purpose (after many failed attempts). During the experiments, the platinumcoated guartz crystal WE was cathodically polarized to -700 mV<sub>Aq/AqCl(KClsat</sub>) in order to mimic the corrosion potential of mild steel corroding in a CO<sub>2</sub> aqueous solution. Although it is acknowledged that the precipitation of FeCO<sub>3</sub> on the platinum substrate is different than that happening on mild steel, the polarization was used to try and create similar water chemistry conditions at the metal surface and facilitate the precipitation of FeCO<sub>3</sub>.

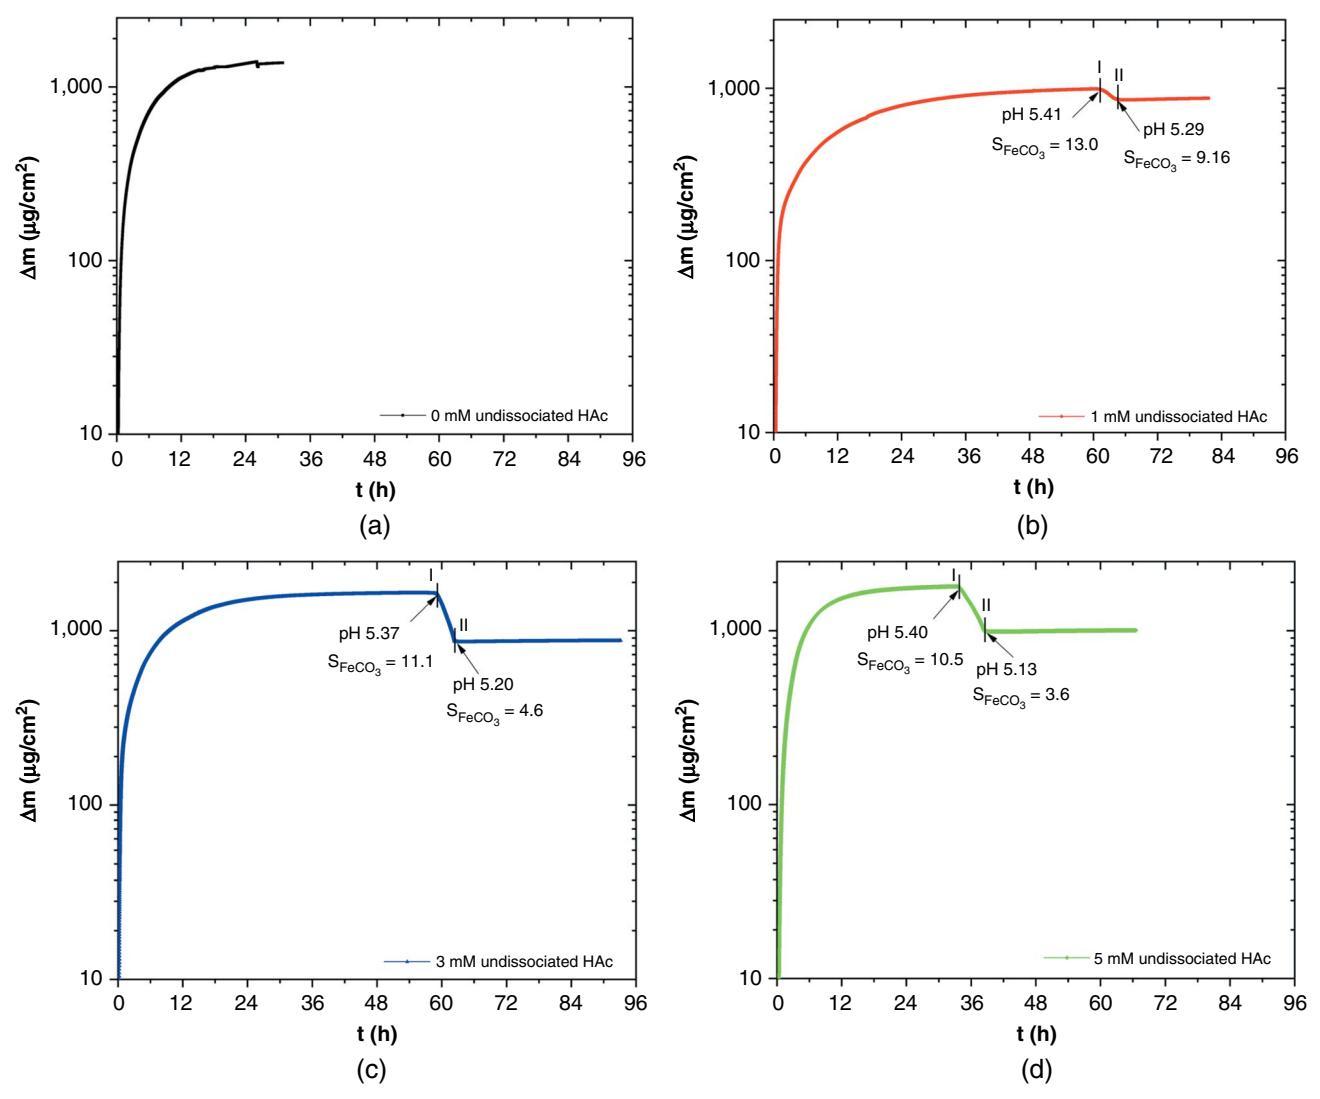
**FIGURE 2.** Mass change vs the immersion time for the cathodically polarized ( $-700 \text{ mV}_{Ag/AgCl[KClsat]}$ ) platinum-coated quartz crystal electrode exposed to a 0.1 wt% NaCl solution at initial pH 6.0, 80°C, and 0.53 bar pCO<sub>2</sub>, initial S<sub>FeCO3</sub> = 200 before and after injection of a buffered solution containing different amounts of undissociated HAc: (a) no addition of HAc, (b) 1 mM of undissociated HAc, (c) 3 mM of undissociated HAc, and (d) 5 mM of undissociated HAc.

precipitation rate slowed down and eventually approached zero, as  $S_{FeCO_3}$  decreased from the initial 200 to below 10, thereby reducing the driving force for precipitation. During this time, the pH of the solution also decreased from pH 6 to pH 5.4, due to the consumption of the  $CO_3^{2^-}$  ions by FeCO<sub>3</sub> precipitation, which caused the dissociation reactions of the weak acids (bicarbonate ion and carbonic acid):

to move from the left to right, thereby preserving equilibrium. When the buffered HAc solution (at the same pH as the main solution) was injected into the system, a decrease in mass was observed indicating partial dissolution of the FeCO<sub>3</sub> layer. The measured decrease in the mass was proportional to the concentration of HAc: 11% of the FeCO<sub>3</sub> layer was lost at 1 mM HAc, 46% of the FeCO<sub>3</sub> layer dissolved at 3 mM HAc, and

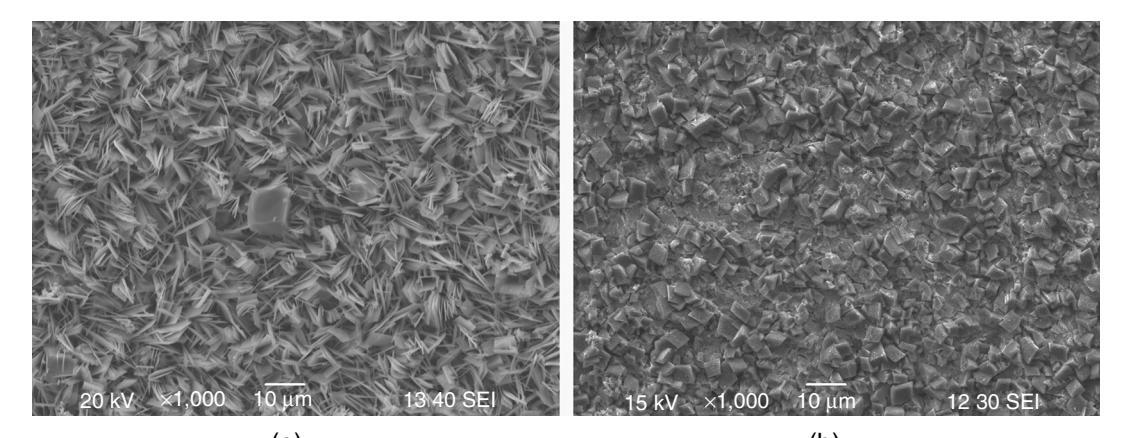
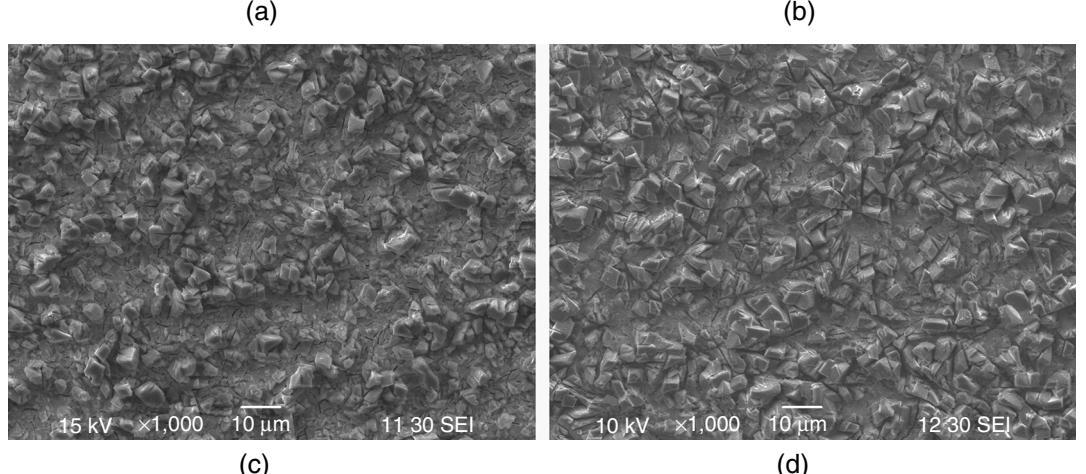
**FIGURE 3.** SEM image of the platinum-coated quartz crystal electrode surface covered with FeCO<sub>3</sub> crystals exposed to a 0.1 wt% NaCl solution at initial pH 6.0, 80°C, and 0.53 bar pCO<sub>2</sub>, supersaturated with FeCO<sub>3</sub> (initial  $S_{FeCO_3} = 200$ ) following injection of a buffered solution containing different amounts of undissociated HAc: (a) no addition of HAc, (b) 1 mM of undissociated HAc, (c) 3 mM of undissociated HAc, and (d) 5 mM of undissociated HAc.

The SEM images of the specimens collected at the end of the experiments are presented in Figure 3. For the specimen after the "blank" test (conducted in the absence of HAc), the surface is fully covered by FeCO<sub>3</sub> (as confirmed below), showing a plate-like morphology with the occasional presence of prismatic crystals (Figure 3[a]). The present study did not focus on the factors that affect the precipitation of an FeCO<sub>3</sub> layer, normally happening on the surface of iron or steel, as this was done and presented in an earlier publication.<sup>27</sup> There, the pH was shown to change the morphology of FeCO<sub>3</sub> from prismatic crystals obtained at pH 6.6 to plate-like crystals formed at pH 6.0. Using various characterization techniques, including XPS and Raman spectroscopy, it was proven that regardless of the different morphologies, the composition was FeCO<sub>3</sub> in all cases.

Following addition of HAc (at different concentrations), the appearance of the surface layer has completely changed (Figures 3[b], [c], and [d]). The FeCO<sub>3</sub> plates have disappeared (dissolved), and the surface remained partially covered by FeCO<sub>3</sub> prismatic crystals, with some "bare" prism-free areas observed between the visible crystals. The specimens from the blank and the experiment with 3 mM HAc were selected here for further surface characterization. The results of Raman spectroscopy done on these specimens are depicted in Figure 4. The two main characteristic peaks of FeCO<sub>3</sub> (siderite)

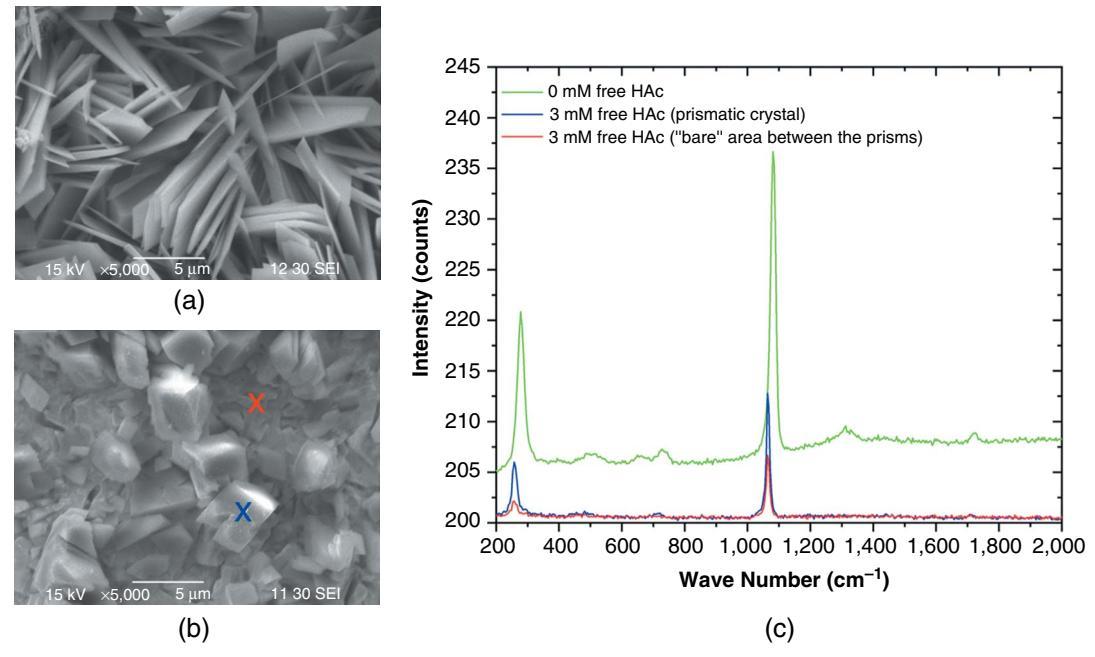
**FIGURE 4.** SEM image of the platinum-coated quartz crystal electrode surface covered with  $FeCO_3$  crystals exposed to a 0.1 wt% NaCl solution at initial pH 6.0, 80°C, and 0.53 bar pCO<sub>2</sub>, supersaturated with  $FeCO_3$  (initial  $S_{FeCO_3} = 200$ ) following injection of a buffered solution containing different amounts of undissociated HAc: (a) no addition of HAc, and (b) 3 mM undissociated HAc. (c) Results of Raman spectroscopy of the surface of specimens shown in (a) and (b).

at 292 cm<sup>-1</sup> and 1,087 cm<sup>-1</sup> wave numbers are detected for both specimens.<sup>28</sup> According to the results of Raman spectroscopy analysis of siderite and chukanovite presented in the paper by Michelin, et al.,<sup>29</sup> the minor peaks at 655 cm<sup>-1</sup>, 726 cm<sup>-1</sup>, and 500 cm<sup>-1</sup> might be attributed to either FeCO<sub>3</sub> or Fe<sub>2</sub>(OH)<sub>2</sub>CO<sub>3</sub> (chukanovite) or both. Unfortunately, as the peaks for these two phases are too close, it is not possible to distinguish between them using Raman spectroscopy technique. It is not clear which of these phases or any other phases are related to the peaks at 1,309 cm<sup>-1</sup> and 1,711 cm<sup>-1</sup> that are

observed in the spectrum of the specimen before exposure to HAc (the green line in Figure 5[c]). However, the results of alternative characterization analysis (XPS) support the idea that the main phase in the corrosion product layer was FeCO<sub>3</sub>.<sup>27</sup>

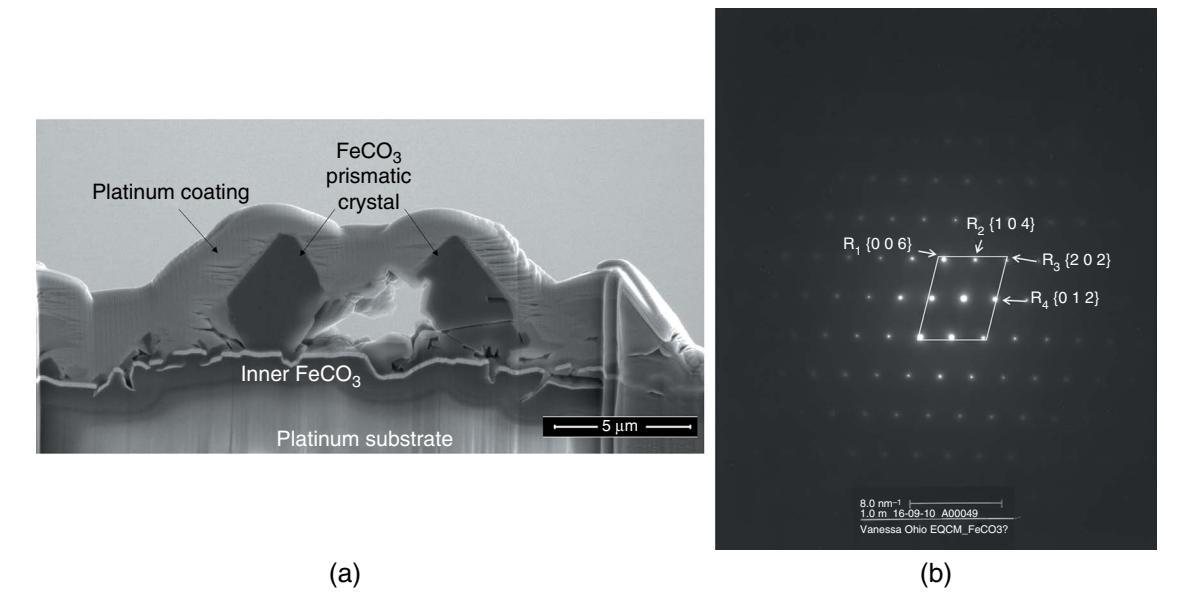
**FIGURE 5.** (a) SEM image of the cross-sectional view of the platinum-coated quartz crystal electrode surface covered with  $FeCO_3$  crystals exposed to a 0.1 wt% NaCl solution at initial pH 6.0, 80°C, and 0.53 bar pCO<sub>2</sub>, supersaturated with  $FeCO_3$  (initial  $S_{FeCO_3}$  = 200) following injection of a buffered solution containing 3 mM undissociated HAc, and (b) electron diffraction pattern of a prismatic crystal.

The measurements on the specimen from the experiment with 3 mM HAc were performed both in the area covered by  $FeCO_3$  prismatic crystals and in the "bare" areas between the prisms. Interestingly, both areas show the presence of  $FeCO_3$ , meaning that the "bare" areas between the prisms were not depicting the bare platinum surface but were actually covered by

a thin FeCO<sub>3</sub> layer, which was not distinguishable in the SEM images. Considering the results of Raman spectroscopy, no meaningful difference was observed between the two specimens (blank and 3 mM HAc) in terms of the composition of the layer present on the surface.

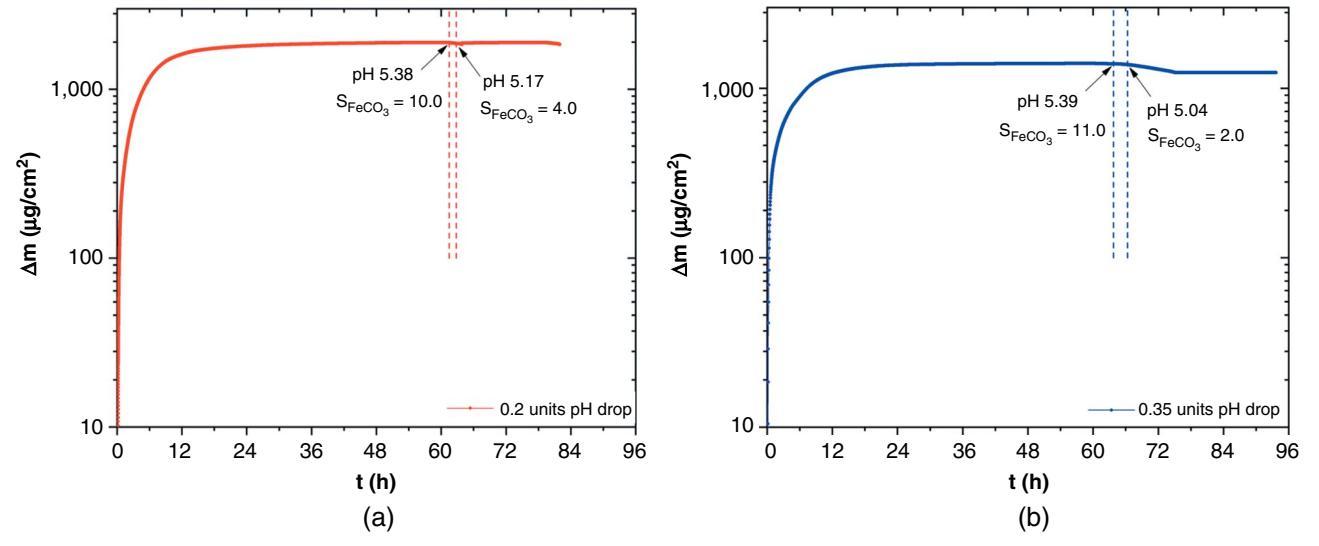
**FIGURE 6.** Values of mass change vs. the immersion time for the cathodically polarized (–700  $mV_{Ag/AgCl[KCIsat]}$ ) platinum-coated quartz crystal electrode surface covered with FeCO<sub>3</sub> crystals exposed to a 0.1 wt% NaCl solution at initial pH 6.0, 80°C, and 0.53 bar pCO<sub>2</sub>, supersaturated with FeCO<sub>3</sub> (initial S<sub>FeCO<sub>3</sub></sub> = 200) following injection of a deoxygenated HCl solution, introducing (a) 0.2 and (b) 0.35 units pH drop.

Now that it is established that some  $FeCO_3$  crystals that formed by precipitation were dissolved due to HAc injection, let us try to answer why this happened. As noted above, the buffered HAc solution was injected at the same pH as the main solution supersaturated with FeCO<sub>3</sub>; however, this led to a small decrease in the pH of the main solution by 0.1 to 0.3 units, as shown in Table 3. One can wonder if this small pH decrease (acidification) was the main reason that led to the partial dissolution of the FeCO<sub>3</sub> layer, as has been suggested by other researchers.<sup>15,17</sup> To answer this question, an extra set of EQCM experiments was performed for which the same kind of scenario was created: formation of FeCO<sub>3</sub> layer followed by the same small drop in pH, but this time achieved by injecting a deoxygenated solution of strong HCl acid (rather than weak HAc). The results are provided in Figure 6.

As seen in Figure 6, the small change in pH caused a very small mass decrease, as detected by the EQCM. For the case when the injection of the HCl solution led to a pH drop of 0.2 units, the change in mass of the FeCO<sub>3</sub> was 20  $\mu$ g/cm<sup>2</sup>, which is significantly lower than what was measured when the buffered HAc solution was injected and caused a similar decrease in pH (0.2 units), when the mass change of FeCO<sub>3</sub> was orders of magnitude higher: 773 µg/cm<sup>2</sup>. The similar outcome was seen when the injection of HCl caused a pH drop by 0.35 units and the mass change in FeCO<sub>3</sub> was 155  $\mu$ g/cm<sup>2</sup>, which is much smaller than what was measured when buffered HAc solution was injected and caused a similar pH drop (0.3 units) when the mass change of FeCO<sub>3</sub> was much higher—803  $\mu$ g/cm<sup>2</sup>. This is corroborated by the SEM images and EDS analysis shown in Figures 7 and 8, which show negligible change in the morphology, FeCO<sub>3</sub> coverage, and chemical composition after the

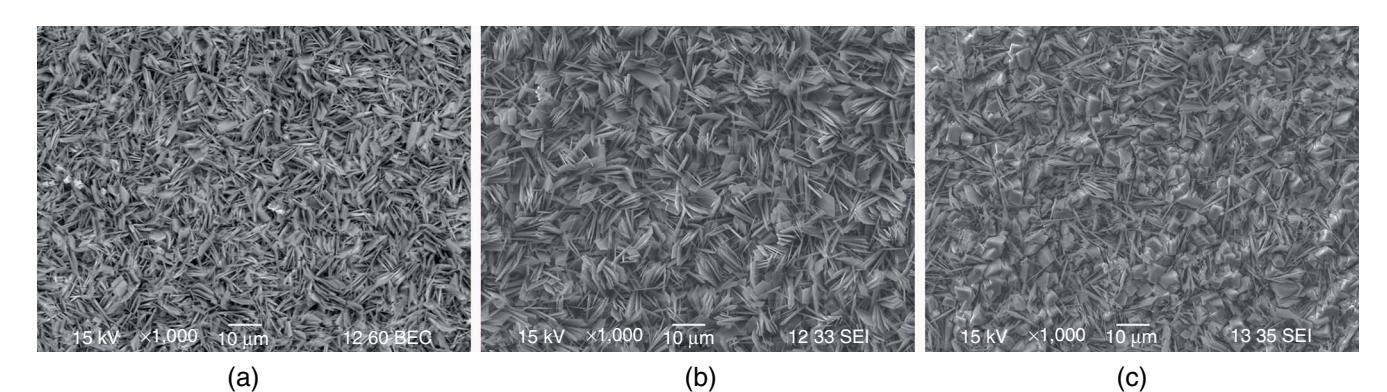
**FIGURE 7.** (a) SEM images of the platinum-coated quartz crystal electrode surface covered with  $FeCO_3$  crystals exposed to a 0.1 wt% NaCl solution at initial pH 6.0, 80°C, and 0.53 bar pCO<sub>2</sub>, supersaturated with  $FeCO_3$  (initial  $S_{FeCO_3}$  = 200) and following injection of a deoxygenated HCl solution, introducing (b) 0.2 and (c) 0.35 units pH drop.

Following injection of buffered HAc, the Ac<sup>-</sup> ions are consumed by this reaction, which moved from left to right; at the same time, due to consumption of Ac<sup>-</sup> ions, the HAc dissociation (Reaction [9]) also shifts from left to right in order to maintain equilibrium, which results in a pH decrease. Regardless, it was experimentally proven above that this small pH decrease that occurred when buffered HAc was injected into the main solution was not the main cause for the dissolution of the FeCO<sub>3</sub> layer (Figures 6 and 7). So, other possibilities were explored.

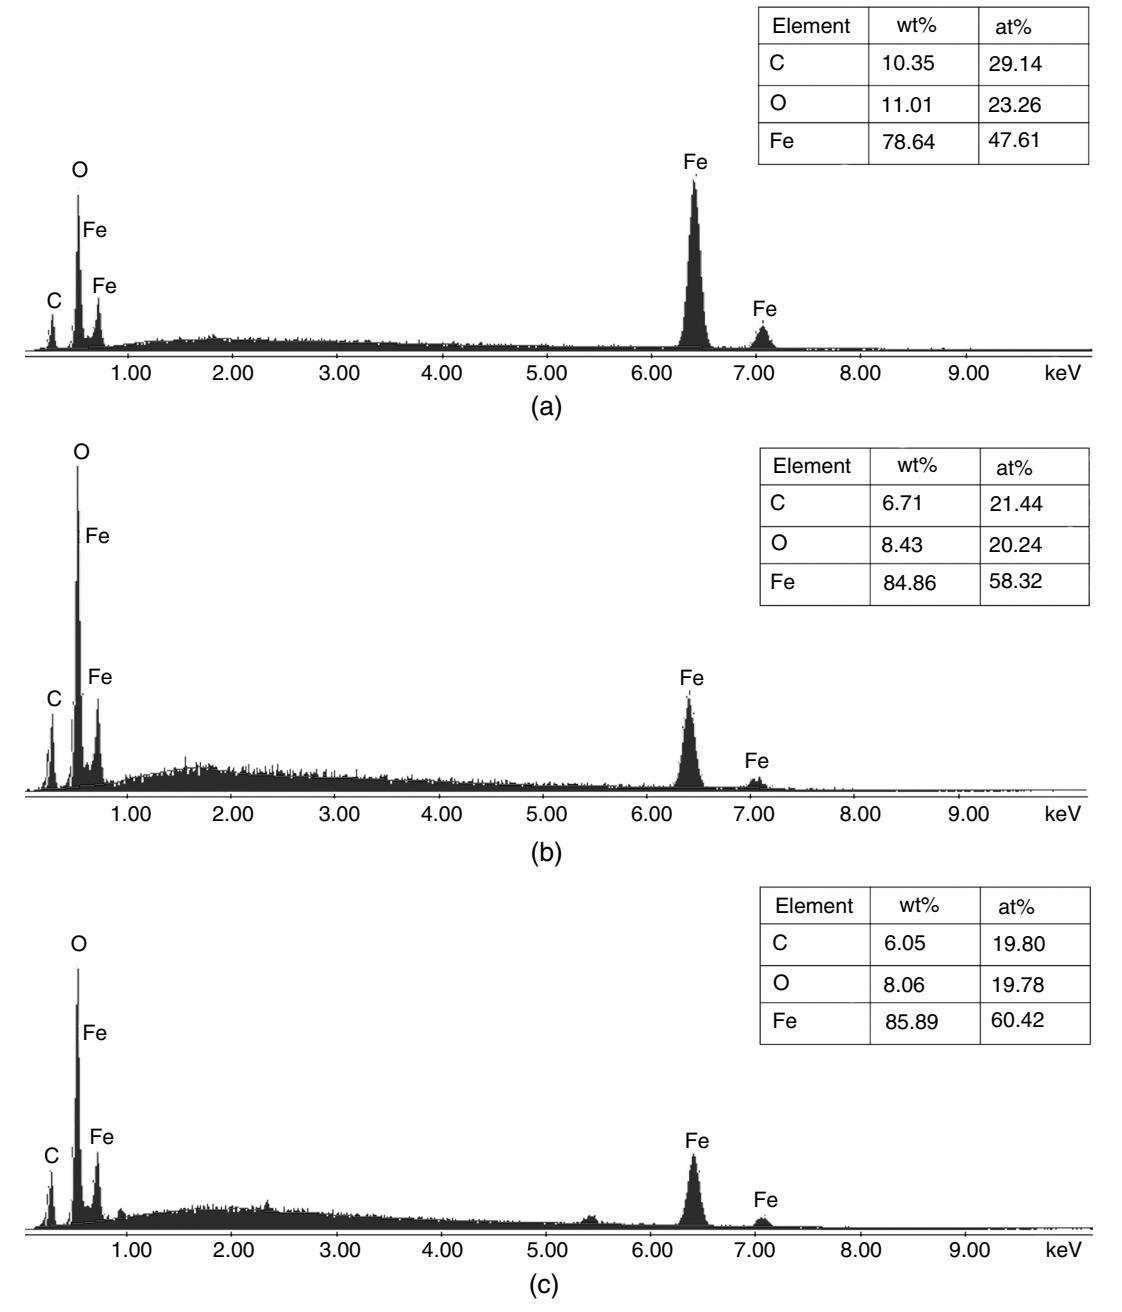
**FIGURE 8.** (a) The result of EDS analysis of the platinum-coated quartz crystal electrode surface covered with  $FeCO_3$  crystals exposed to a 0.1 wt% NaCl solution at initial pH 6.0, 80°C, and 0.53 bar pCO<sub>2</sub>, supersaturated with  $FeCO_3$  (initial  $S_{FeCO_3}$  = 200) and following injection of a deoxygenated HCl solution, introducing (b) 0.2 and (c) 0.35 units pH drop.

HCl solution injection, when compared to the surface prior to the injection (i.e., from the "blank" test). Therefore, it can be concluded that the small drop in pH caused by the injection of the buffered HAc solution was not the main cause for dissolution of the FeCO<sub>3</sub> layer, and one needs the look at other possible causes. One clue was given by Gulbrandsen:<sup>18</sup> the formation of iron acetate complexes in solution. The other could be related to the change of ionic strength of solution following the injection of HAc. Both possibilities will be explored in the *Discussion* section below. But for now, let us turn our attention to the effect of the injection of HAc on the actual corrosion rate of X65 mild steel protected by an FeCO<sub>3</sub> layer.

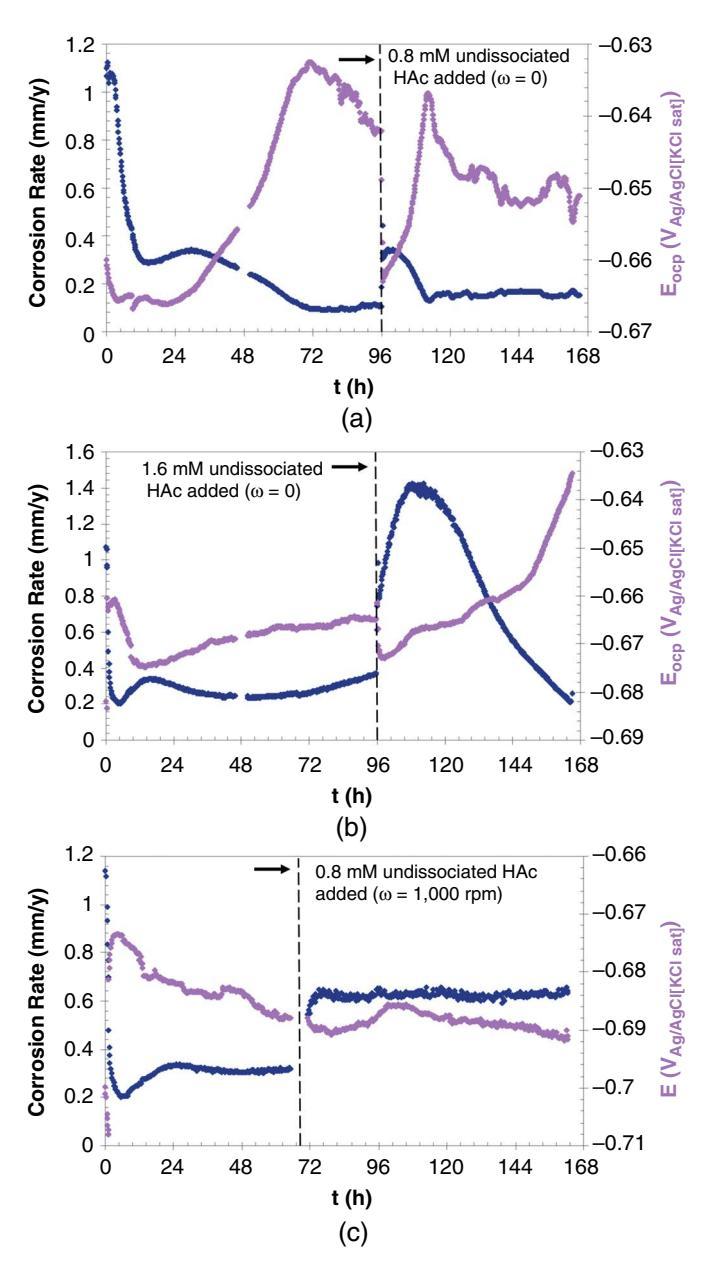
**FIGURE 9.** Variation of corrosion rate and  $E_{ocp}$  vs. the immersion time for the X65 steel specimen exposed to a 3 wt% NaCl solution at initial pH 6.3, 80°C, and 0.53 bar pCO<sub>2</sub>, supersaturated with FeCO<sub>3</sub> (initial  $S_{FeCO_3} = 100$ ) before and after injection of a buffered solution containing (a) 0.8 mM undissociated HAc, under stagnant condition, (b) 1.6 mM undissociated HAc, under stagnant condition, and (c) 0.8 mM undissociated HAc, under the rotation speed of 1,000 rpm.

The X65 steel corrosion rate measurements are presented in Figure 9. The bare steel corrosion rates seen at the beginning of the experiments started out relatively high: approximately 1 mm/y. This value decreased to approximately

0.3 mm/y or lower after another few days of immersion, due to the precipitation of a protective FeCO<sub>3</sub> layer (composition will be confirmed below). As the corrosion rates decreased, the values of the open-circuit potential ( $E_{ocp}$ ) initially decreased as well, indicating a diffusion barrier being formed. As the corrosion rate decreased further, the  $E_{ocp}$  shifted toward more positive values, which suggest pseudo-passivation of the surface by the precipitating FeCO<sub>3</sub> layer, as explained by Han, et al.<sup>30</sup> Following the addition of the buffered HAc solution, the corrosion rates increased, then reached a peak and decreased back to similar low levels as were seen before addition of HAc. This suggests that any damage/dissolution to

the protective  $FeCO_3$  layer due to HAc was repaired by further precipitation of  $FeCO_3$ .

When having the flow (RCE at 1,000 rpm), Figure 9(c) shows that the high corrosion rate that was caused by the addition of the buffered HAc solution remained high until the end of the experiment, i.e., the layer could not be repaired as happened in stagnant conditions. This is due to an increase in turbulent mixing and the higher rate of diffusion of species between the bulk and the steel surface.<sup>31-32</sup>

Regardless, it can also be observed from the results presented above that the larger FeCO<sub>3</sub> crystals (both plates and prisms) from the outer layer were preferably dissolved, when compared to the thin adherent inner layer of FeCO<sub>3</sub> that was much more resilient (i.e., more resistant to dissolution). One could speculate that this is somehow related to the favorable morphology of the inner layer, but another plausible explanation can be postulated. Even if the thin adherent inner layer of FeCO<sub>3</sub> was just as readily dissolved as the outer layer consisting of plates and/or prismatic crystals, it can be argued that it that was easier to "rebuild/repair." This is because of its location closer to the steel surface, where due to corrosion of the underlying steel substrate, the concentration of Fe<sup>2+</sup> ions was higher and the concentration of H<sup>+</sup> ions was lower (i.e., the pH was higher). Both factors contribute to having a higher saturation level of FeCO<sub>3</sub> in the inner layer, driving the rate of precipitation up and making it easier to rebuild/repair the damaged FeCO<sub>3</sub> layer. In the case of FeCO<sub>3</sub> formed on platinum, there was no corrosion of the substrate, hence the concentration of Fe<sup>2+</sup> ions in the thin adherent inner FeCO<sub>3</sub> layer was not any higher than elsewhere in the layer, however, the concentration of H<sup>+</sup> ions was still much lower (i.e., surface pH higher) due to the cathodic potential applied to the platinum substrate. This explanation is also consistent with the electrochemical measurements (Figures 9[a] and [b]) where it can be seen that after injecting the buffered HAc solution the corrosion potential suddenly decreased while the corrosion rate increased as the outer FeCO<sub>3</sub> layer dissolved and the FeCO<sub>3</sub> inner layer was damaged, only to see both the corrosion potential and corrosion rate recover as the inner FeCO<sub>3</sub> layer was rebuilt/repaired. The exception is seen in Figure 9(c), where the intense flow

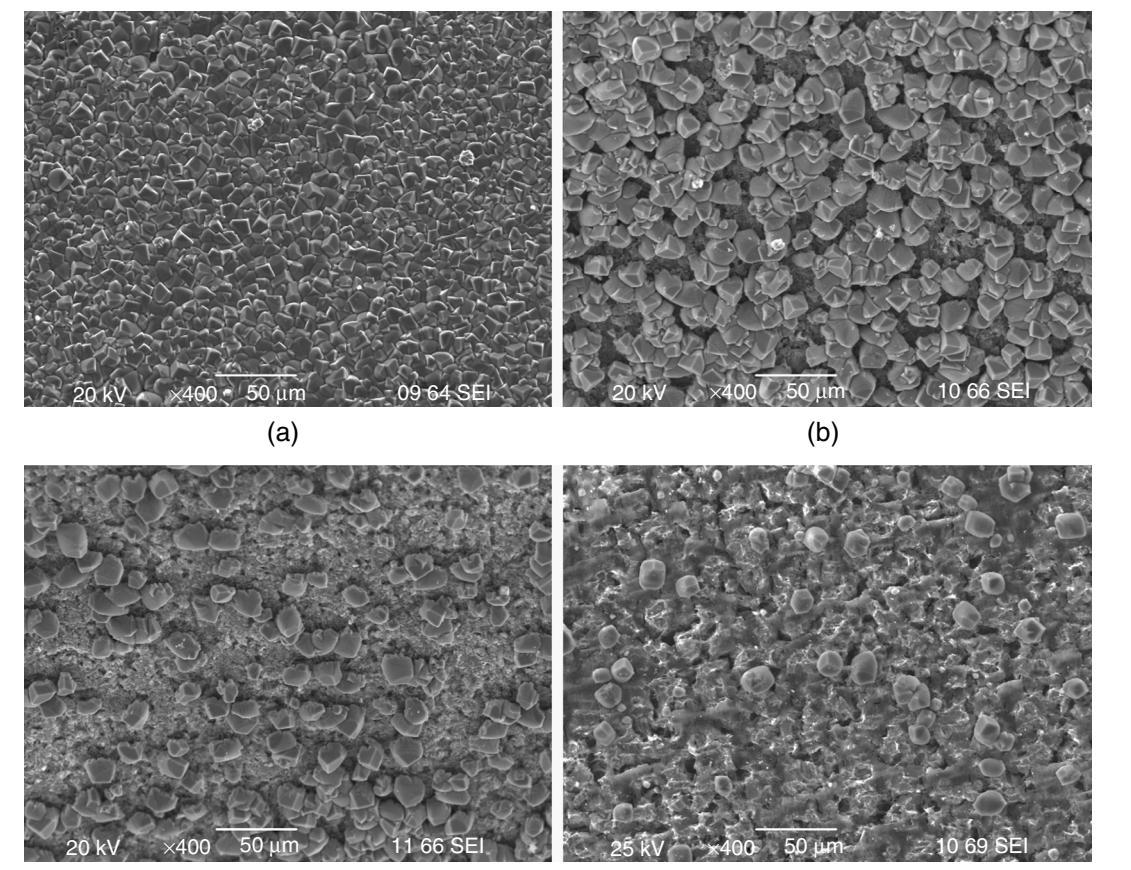
**FIGURE 10.** SEM image of the X65 steel specimen exposed to a 3 wt% NaCl solution at initial pH 6.3, 80°C, and 0.53 bar pCO<sub>2</sub>, supersaturated with FeCO<sub>3</sub> (initial  $S_{FeCO_3}$  = 100) following injection of a buffered solution containing different amounts of undissociated HAc: (a) no addition of HAc, (b) 0.8 mM undissociated HAc, under stagnant condition, (c) 1.6 mM undissociated HAc, under stagnant condition, and (d) 0.8 mM undissociated HAc, under rotation speed of 1,000 rpm.

According to the SEM images showing the surface of the X65 mild steel collected at the end of the experiments, a significant loss of  $FeCO_3$  prismatic crystals following the addition of HAc is observed (Figures 10[b] and [c]). The loss seemed to be more severe when the concentration of HAc was higher. These results are in agreement with those presented earlier for the platinum substrate (Figure 3). The observations confirm that the solubility of the  $FeCO_3$  increased with the addition of the buffered HAc, even if the pH change was minimal.

The combined effect of the flow and HAc removed even more of the FeCO<sub>3</sub> prismatic crystals (Figure 10[d]). In this case, the "bare" areas without any FeCO<sub>3</sub> prismatic crystals seemed more porous (compared to the one seen after exposure to stagnant condition (Figure 10[b]), supporting the electrochemical measurements in Figure 9(c), which indicated the nonprotective nature of the remaining FeCO<sub>3</sub> layer.

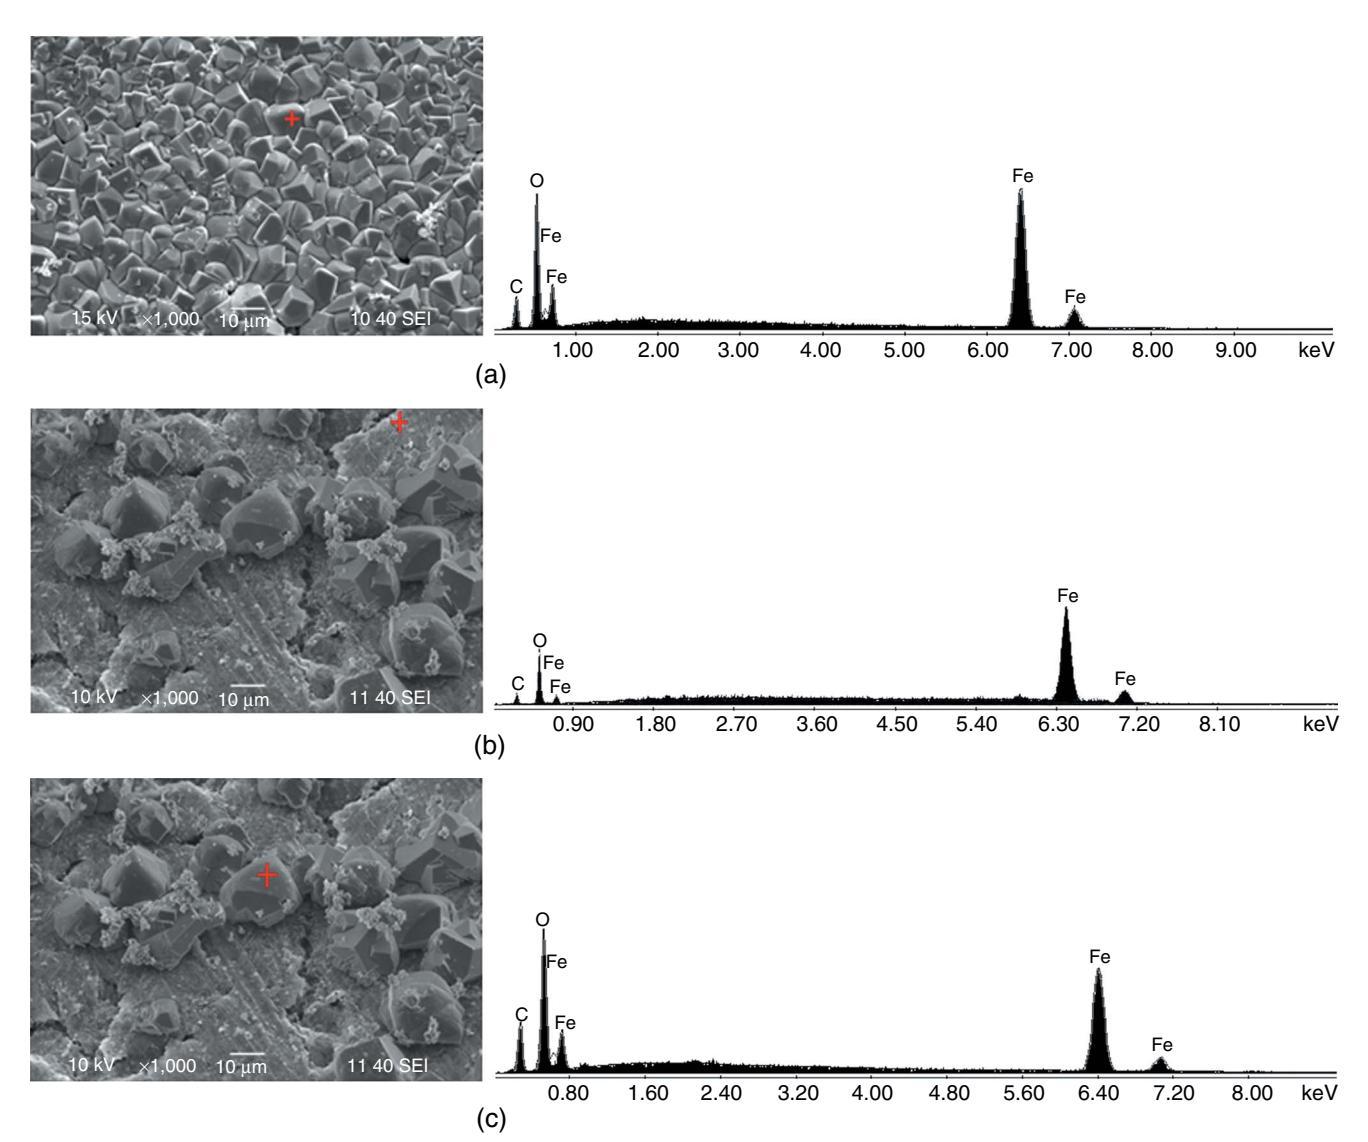
**FIGURE 11.** SEM image and the result of EDS analysis of the X65 steel specimen exposed to a 3 wt% NaCl solution at initial pH 6.3, 80°C, and 0.53 bar  $pCO_2$ , supersaturated with FeCO<sub>3</sub> (initial  $S_{FeCO_3}$  = 200) following injection of a buffered solution containing different amounts of undissociated HAc: (a) no addition of HAc, under stagnant condition, (b) 3 mM undissociated HAc, under stagnant condition (results of EDS analysis of the "bare" area between the prisms), and (c) 3 mM undissociated HAc, under stagnant condition (results of EDS analysis of a prismatic crystal).

For further analytical characterization, one specimen was exposed in similar conditions as those listed in Figure 9(b) but this time an even more concentrated HAc solution (3 mM HAc at pH 6.3) was added. The results of EDS analysis of the surface show the presence of iron (Fe), oxygen (O), and carbon (C) when analyzing the remaining prismatic crystals, as well as the "bare" areas in between (Figures 11[b] and [c]). The EDS analysis of the "bare" areas between the prisms show lower intensity peaks of Fe, O, and C, the constituent elements that form FeCO<sub>3</sub>, compared to the EDS results of the prismatic crystals; however, this elemental analysis is not conclusive.

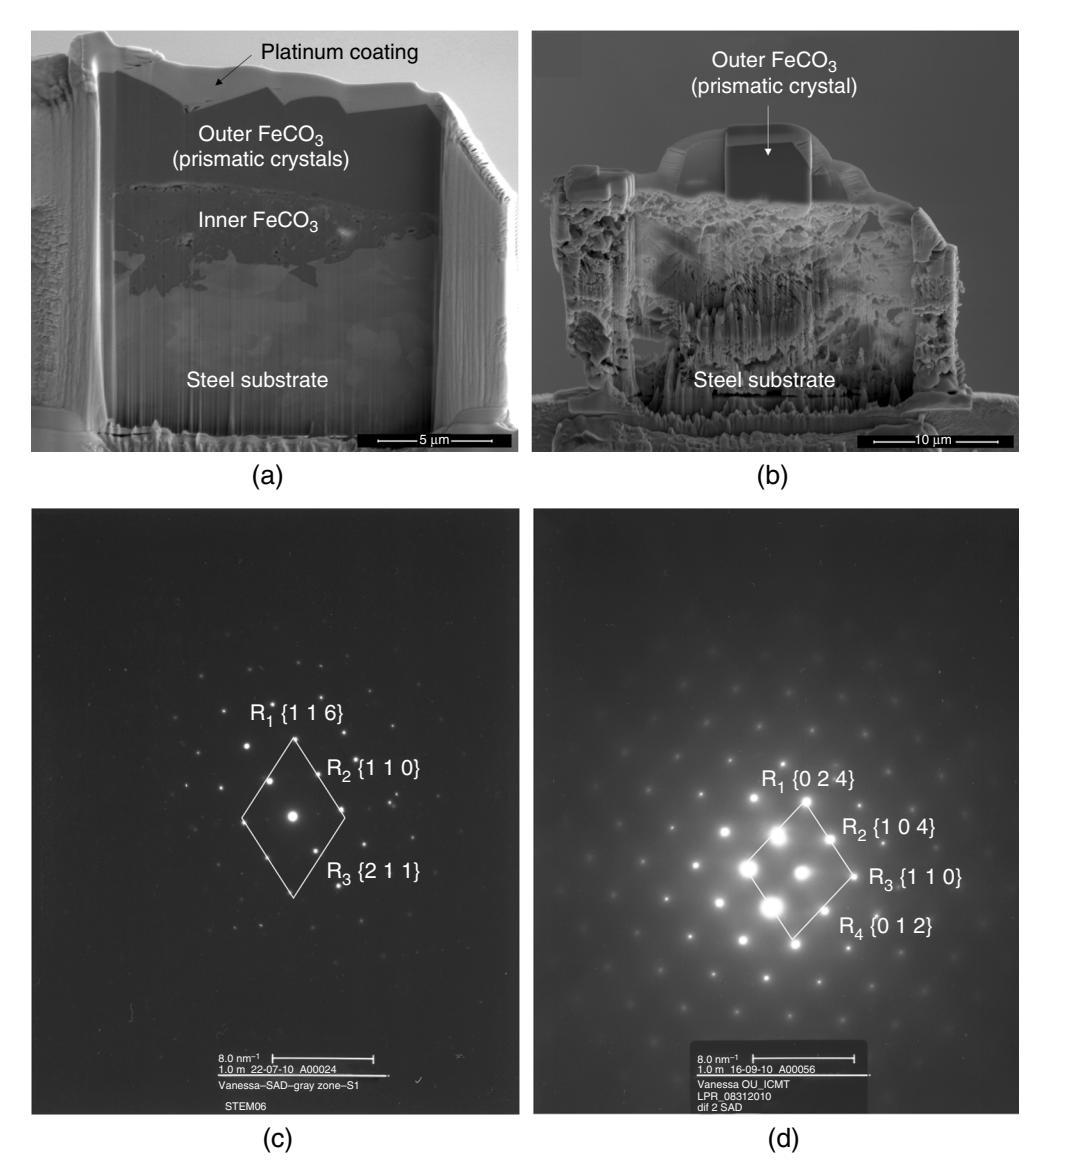
**FIGURE 12.** SEM image of the cross-sectional view of the X65 steel specimen exposed to a 3 wt% NaCl solution at initial pH 6.3, 80°C, and 0.53 bar  $pCO_2$ , supersaturated with FeCO<sub>3</sub> (initial  $S_{FeCO_3}$  = 200) following injection of a buffered solution containing different amounts of undissociated HAc: (a) no addition of HAc and (b) 3 mM undissociated HAc, under stagnant condition. Electron diffraction pattern of (c) prismatic crystals (in [a]), and (d) prismatic crystal (in [b]).

A more accurate examination of this specimen and the blank specimen was conducted by making cross-sectional FIB samples and by electron diffraction pattern analysis using a TEM. Figure 12 depicts these results. The Bragg reflections (interplanar spacing [ $d_{hkl}$ ]) obtained from the lattice planes for the prismatic crystals correspond to the diffraction patterns of FeCO<sub>3</sub>.

In all of the images shown above, it is very important to note the "two-layered" structure of the precipitated FeCO<sub>3</sub>, which has been previously reported.<sup>33-37</sup> The outer layer consisted of either prisms or plates, which sit on top of a denser inner layer (indicated in Figure 12[a]). It is believed that this much thinner inner layer, which is adherent to the steel substrate, is the one that holds the key to corrosion protection by blocking the active electrochemical sites, leading to pseudo-passivation, seen in Figure 9 above. The outer, more porous layer offers a diffusion barrier and is not as effective at reducing the corrosion rate, which is controlled by a slow chemical reaction (CO<sub>2</sub> hydration) and not diffusion. The outer layer which is a diffusion barrier forms first (as plates and prisms) shown in Figures 3(a) and 10(a) and its main role is to create favorable conditions at the steel surface (high pH and ferrous ion concentration) so that the much more protective inner FeCO<sub>3</sub> layer can form. This is often missed when looking at SEM images of mild steel surfaces exposed to CO<sub>2</sub> solutions, when all of the attention is on the appearance and properties of the outer FeCO<sub>3</sub> layer. The recent studies by Ingham, et al.,<sup>38</sup> from
