Study of Sweet Corrosion in Horizontal Multiphase, Carbon Steel Pipelines

A.K. Vuppu and W.P. Jepson, Ohio U.

This paper was presented at the 26th Annual OTC in Houston, Texas, U.S.A., 2-5 May 1994.

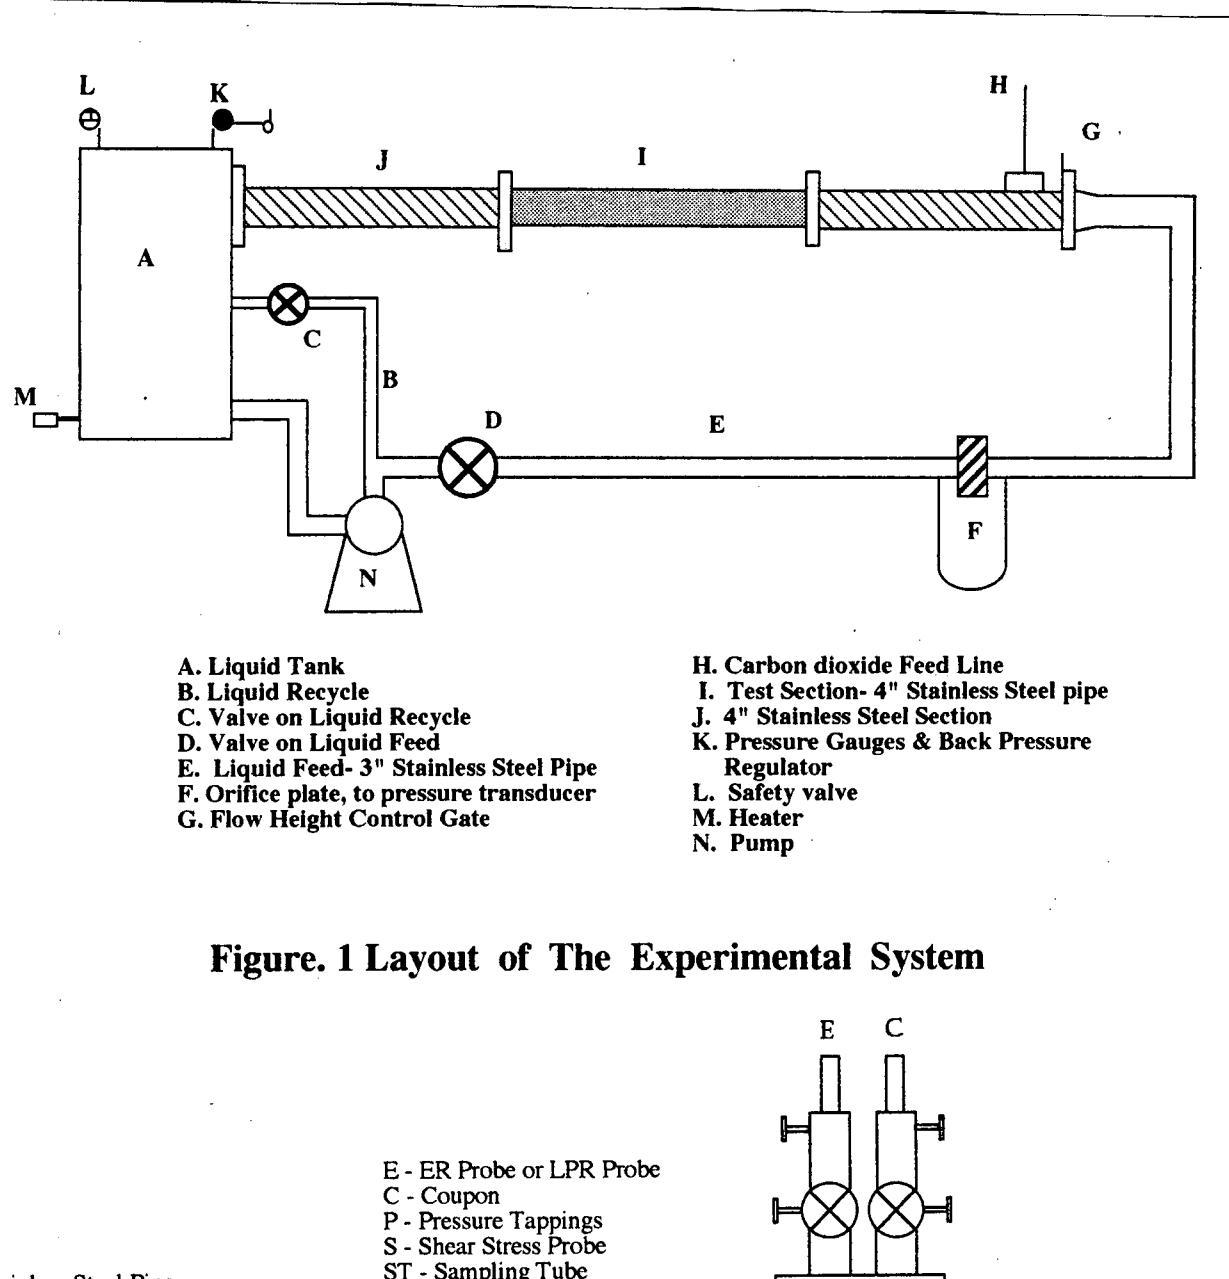
The experiments are performed in a 316 stainless steel flow loop shown in Figure 1. The system is designed to withstand a maximum pressure of 10 MPa. The tank has a capacity of 1.15 m³. Two heaters connected to a thermostatic controller maintain the desired temperature in the system. The fluid is pumped by a 5 kW stainless steel pump to a 7.62cm ID pipe where the flowrate is measured. It then passes into a 10 m long, 10.16 cm ID pipeline. The test section within the 10 m pipeline is outlined in Figure 2. Electrical resistance (ER), linear polarization resistance (LPR) probes and coupons are placed at positions C and E to determine the corrosion rates. It was found that the LPR probes did not perform well at high oil concentrations. Its use was limited to oil concentrations up to 20%. All the probes are flush mounted with the pipe wall. The pressure drops, wall shear stress were also be measured at points P and S respectively. These results are not discussed here.

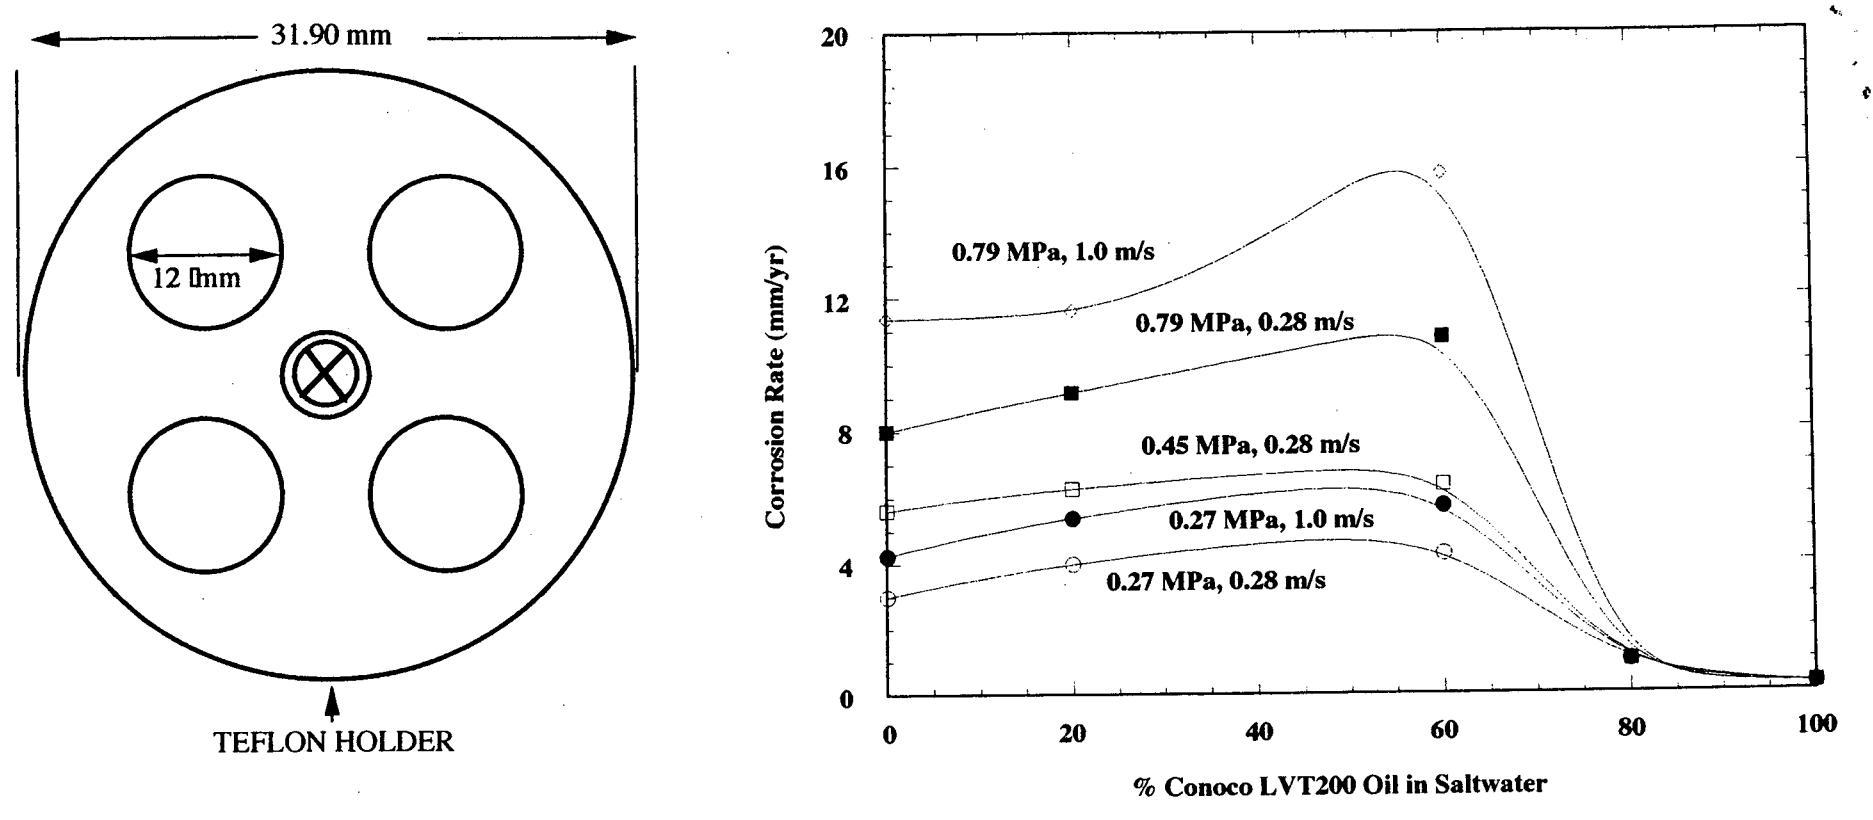
Equilibrium corrosion rates measured by the ER probe are plotted at various pressures and flow rates. Figure 4 shows the graph of corrosion rate vs oil composition. These results show that the corrosion rate increases slightly as the oil fraction increases and then decreases rapidly to a negligible value below 40% water cuts. Samples taken from the flow show the presence of a water layer at the bottom of the pipe up to 40% water cut. Below this, oil seems to be the continuous phase adjacent to the pipe wall.

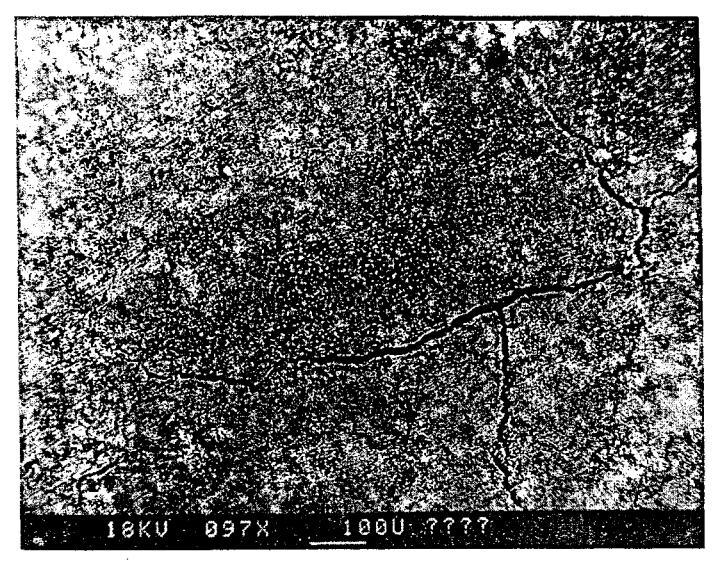
Figure. 5 Corrosion products for 100% Salt water at 40C and 0.136 MPa, Full pipe flow.

Uniform corrosion is generally observed in full pipe flow. This is shown in Figure 5 which is for 100% saltwater at 40C and 0.136 MPa at a magnification of 97. Here, it can be seen that the corrosion deposit is in the form of a layer of relatively constant thickness with many long cracks in it. This layer seems to be porous in nature and can easily be removed.

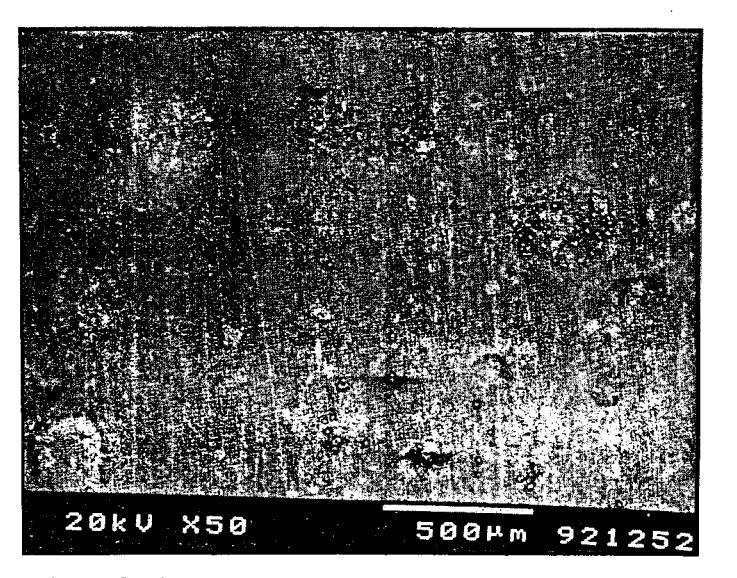
Figure. 8 - Surface with very less corrosion product for Oil only conditions at 40C, 0.79 MPa.

still embedded in a porous layer. The porosity increased with increasing oil concentration. Above 60% oil, the coupon surfaces become almost devoid of any kind of corrosion deposits. This is shown in Figure 8 for oil only at 40C and 0.79 Mpa.

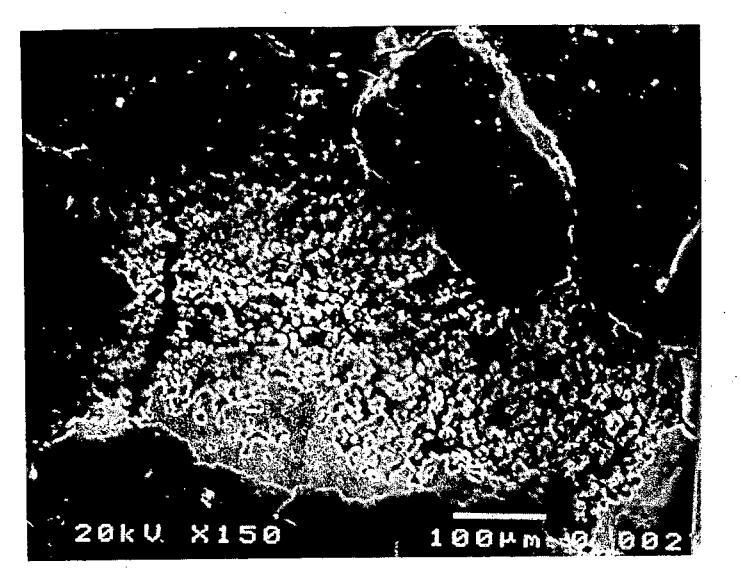
Figure. 9 - Iron carbonate crystals loosely distributed and covered by a crust with large cracks for 60% oil, at 40C and 0.79 MPa.

The effect of increasing temperature from 40C to 60C is illustrated in Figures 7 and 9. For 60% oil, as the temperature is increased, the coupon surface is covered by a layer of iron carbonate crystals. The crystals are loosely spread and do not appear to form a dense film. Cracks are present in the carbonate layer. On top of the crystals is a smooth, crumbly crust which can be easily broken away.

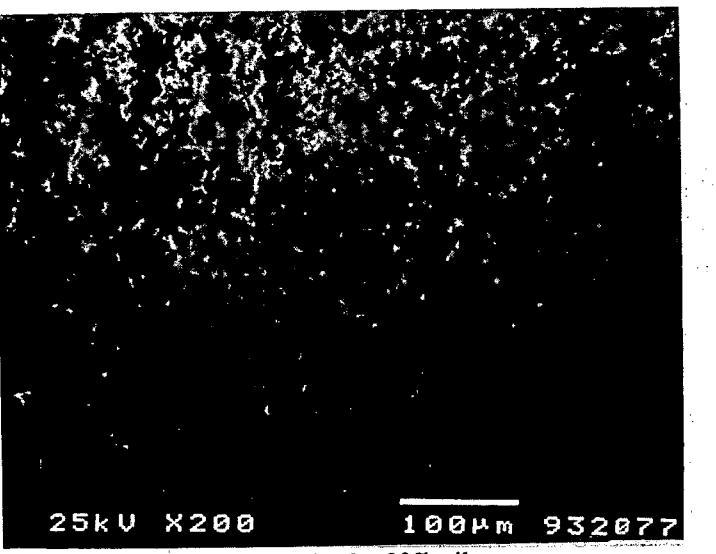
Figure. 11 - Corrosion deposits for 20% oil at 60C and 0.79 MPa.

The effect of increasing carbon dioxide partial pressure is shown in Figures 10, 11 and 12. Figures 10 and 11 are for 20% oil at 60C and 0.27 and 0.79 MPa respectively. It can be seen that, at the lower pressure, the iron carbonate is present in a smooth, porous layer with several deep cracks in it. For the higher pressure, the porous layer becomes coarser with more carbonate crystals present. For 60% oil at 60C, a comparison of Figures 9 and 12 shows that, at the lower pressure, the corrosion product consisted of small iron carbonate crystals deposited in the form of circular pools while in the other areas the crusty layer similar to the one present in Figure 9 is found. Increasing pressure increases the extent of crystal formation.

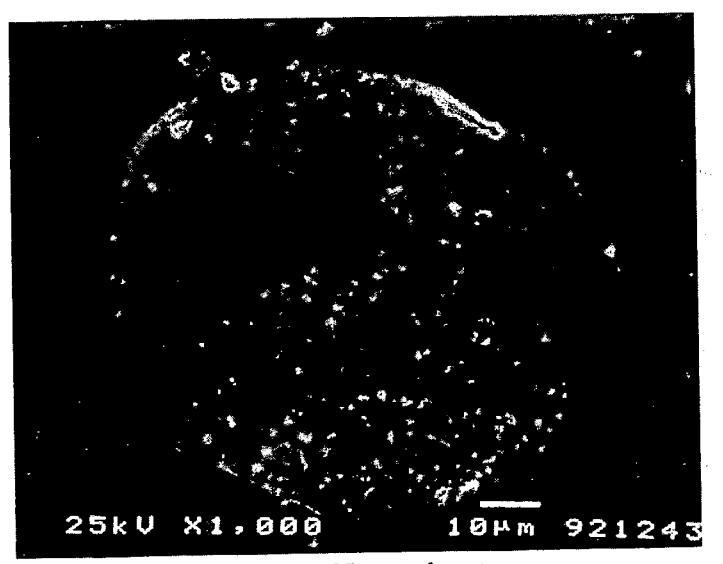
Figure. 12 - Circular pools of Iron carbonate crystals deposited on top of a porous corrosion deposit for 60% oil at 60C and 0.27 MPa.

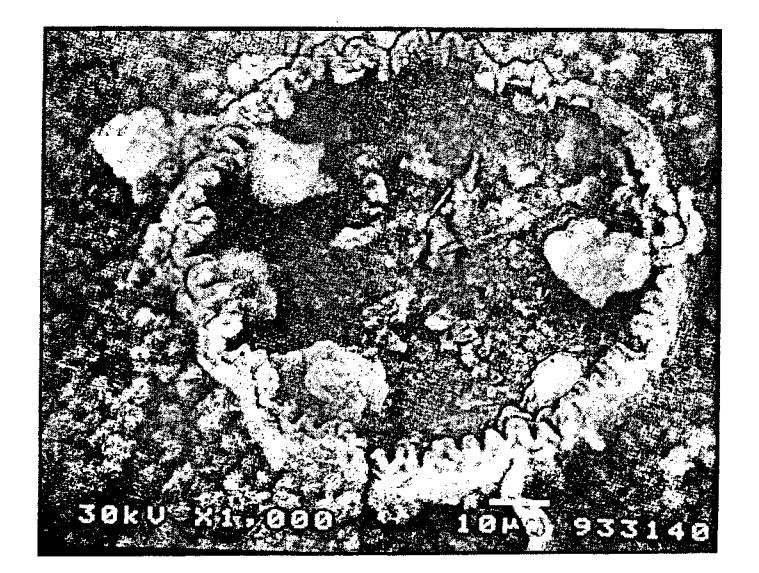
Figure. 15 - Circular bubble impact points in the corrosion deposit at a Froude No. 12 for 60% oil with 50 ppm drag reducing agent at 40C and 0.136 MPa.

When a drag reducing agent was used in slug flow studies, signs of severe, flow induced corrosion was noticed. At 60% oil, at a Froude number of 12, a large number of circular craters were noticed. These are shown in Figure 15. The adsorbed drag reducing agent and the corrosion deposit in these areas were ripped off. This is attributable to gas bubbles, that are entrained at the slug front, being forced to impinge on the bottom of the pipe in the mixing zone of the slug. These bubbles can collapse producing a cavitation type phenomenon. The pressure wave released has great strength and is sufficient to remove the corrosion products from the pipe wall at the point of impact. The corrosion deposit around these "impact points" is similar to that without any drag reducing agent present but is very thin. In these impact areas there is bare metal which leads to further corrosion.

The impact regions have a diameters between 0.1mm to 0.2mm. These are about twice as large as those reported by Xia et al^5 . This is due to the non-stagnant nature of the flow here.

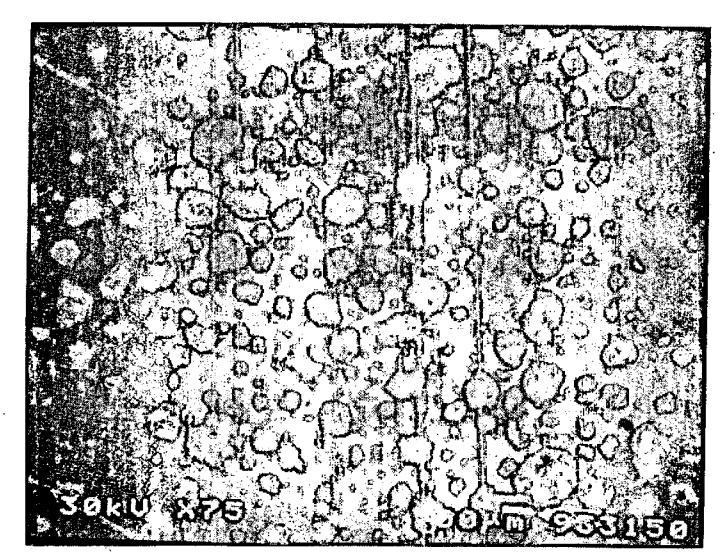
Figure. 16 - Regions of local corrosion in the bubble impact points on the inhibited surface at a Froude No. 11 for 60% oil with 50 ppm inhibitor, at 40C and 0.136 MPa.

The effect of corrosion inhibitors was then studied. Several inhibitors that were used exhibited signs of bubble impact points at the high Froude numbers. When the coupons were examined, it is found that a very thin film of the inhibitor is deposited on top of iron carbonate crystals. However, bubble impact points are observed throughout the coupon face and evidence of breakdown of the inhibitor film can be seen. This is evident in Figure 16. There were still high levels of corrosion in these areas and showed a lack of effectiveness under these conditions.
