# $\mathrm{CO}_2$ TOP OF THE LINE CORROSION IN THE PRESENCE OF $\mathrm{H}_2\mathrm{S}$

the Russ College of Engineering and Technology of Ohio University

In partial fulfillment of the requirement for the degree Master of Science

Alvaro Camacho Manuitt

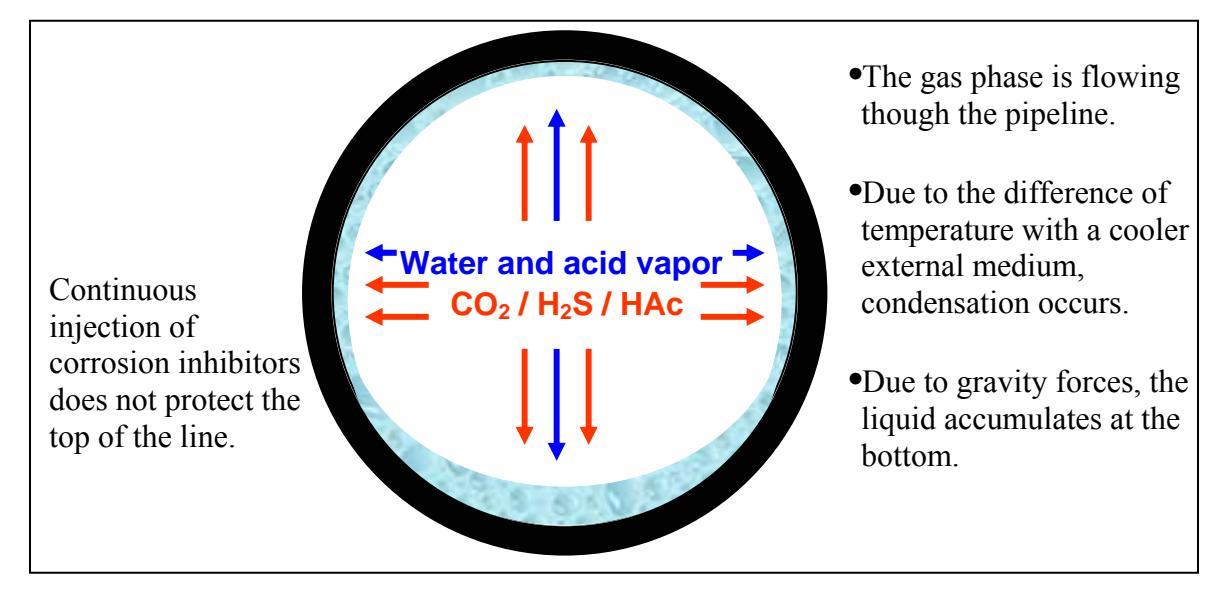
**Figure 1. Key factors affecting TLC**

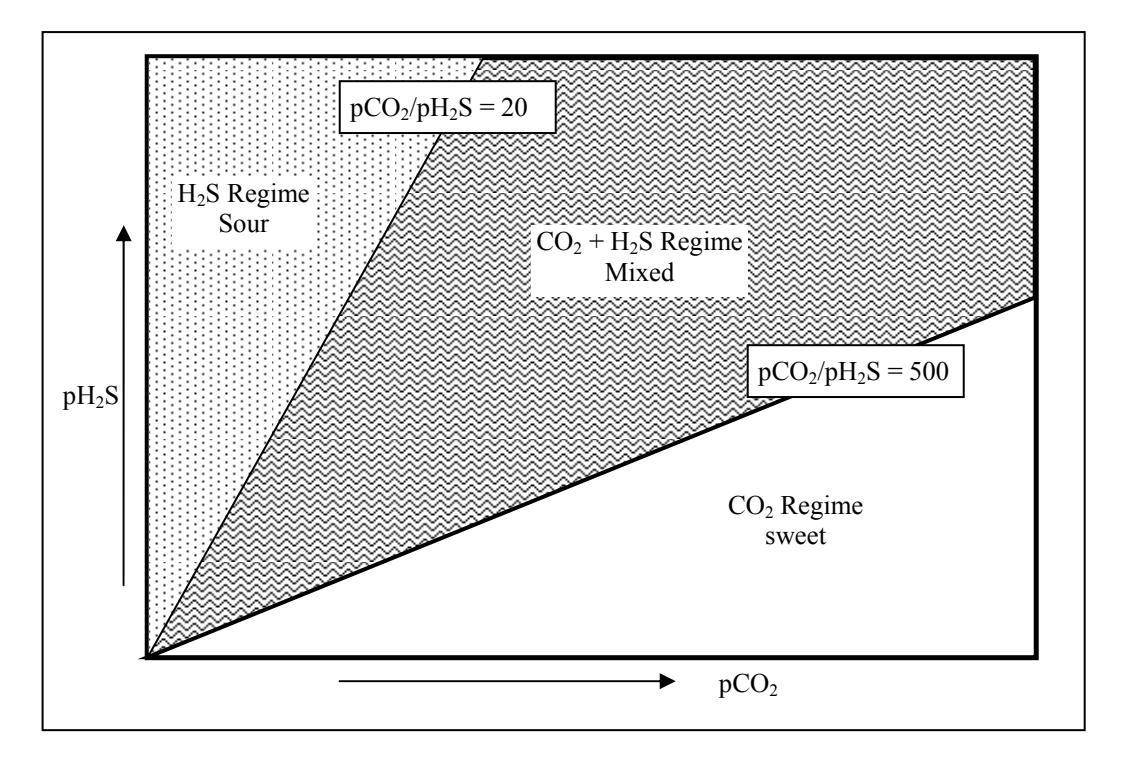
Figure 2. Corrosion regimes in CO<sub>2</sub>/H<sub>2</sub>S corrosion defined by Pots, et al.<sup>20</sup>

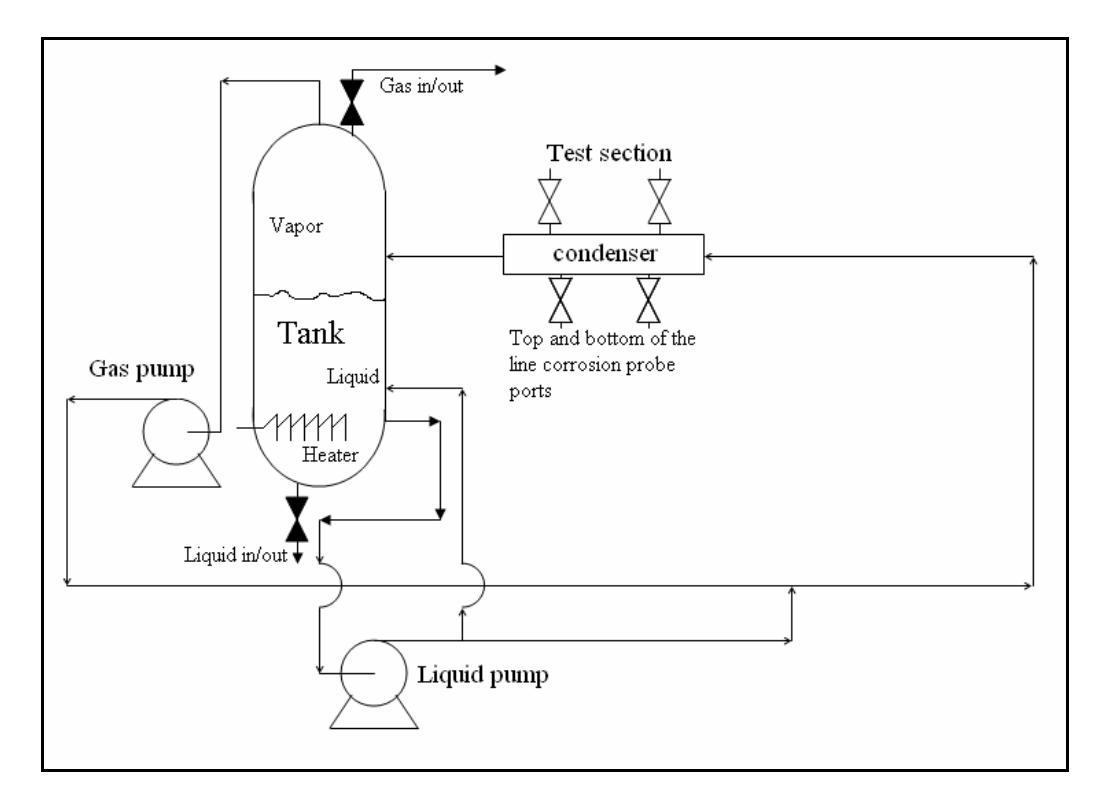
Figure 3. Schematic diagram of the H<sub>2</sub>S flow loop

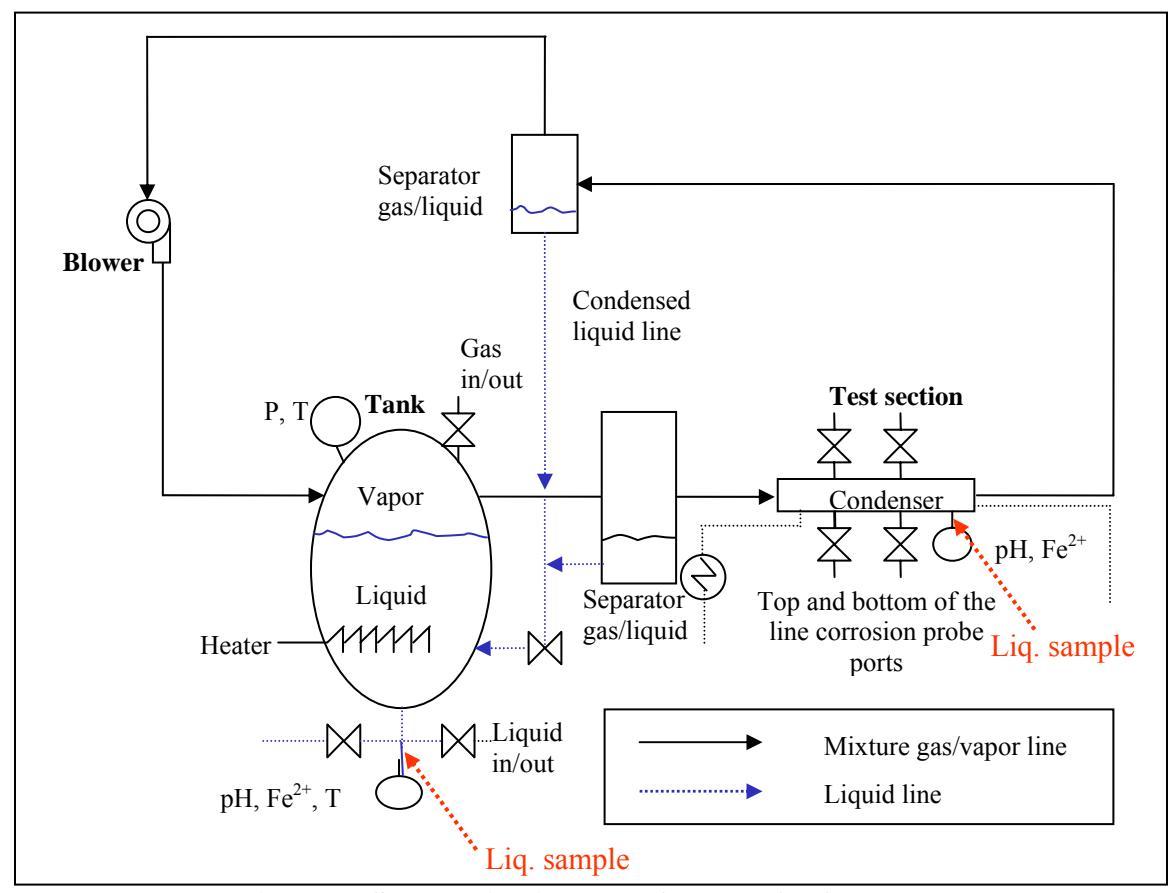
Figure 6. Schematic diagram of the TLC I flow loop

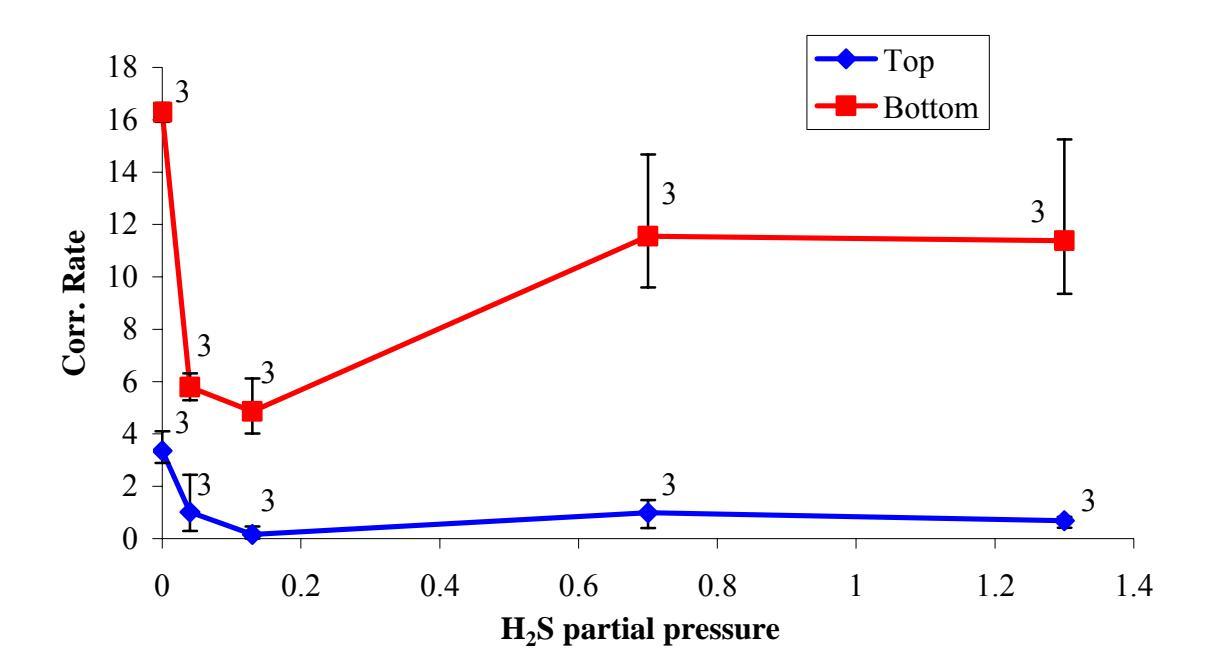
Figure 16. Series I. Effect of the H<sub>2</sub>S partial pressure at the top and bottom of the line. High temperature, P = 30,  $pCO_2 = 1.3$ ,  $V_G = 5$  m/s, high condensation rate, test duration: 2 days. (Surface analyses are presented in Figures 22 to 38)

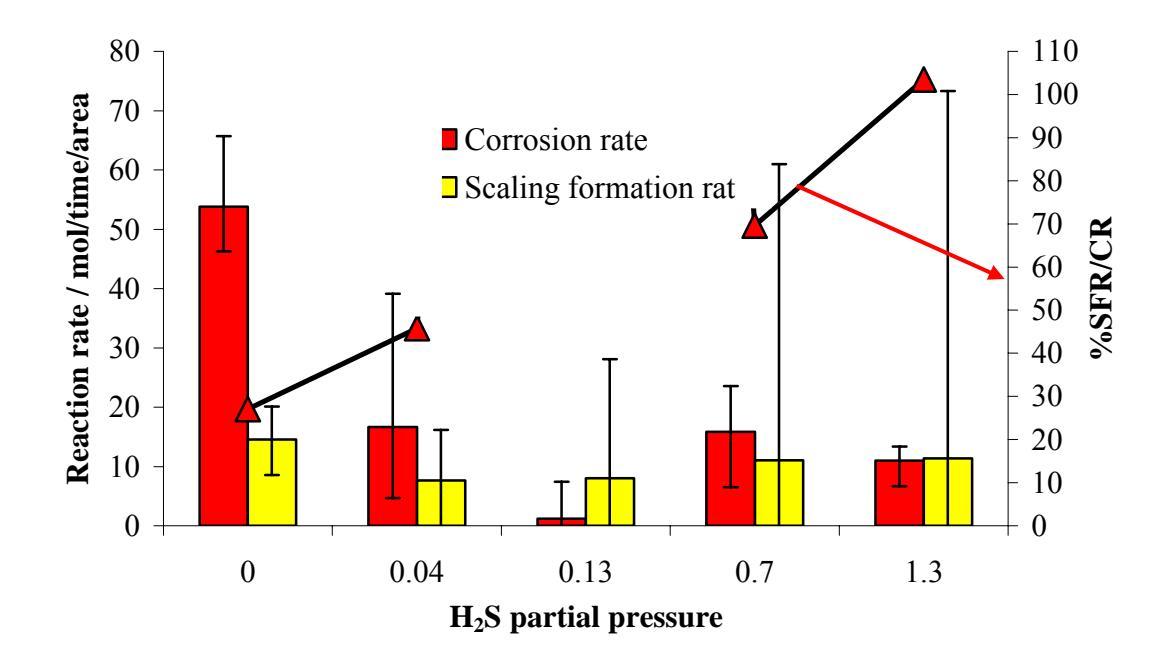
Figure 17. Series I. Rate of reaction under the effect of the  $H_2S$  partial pressure at the top of the line. High temperature, P = 30,  $pCO_2 = 1.3$ ,  $V_G = 5$  m/s, high

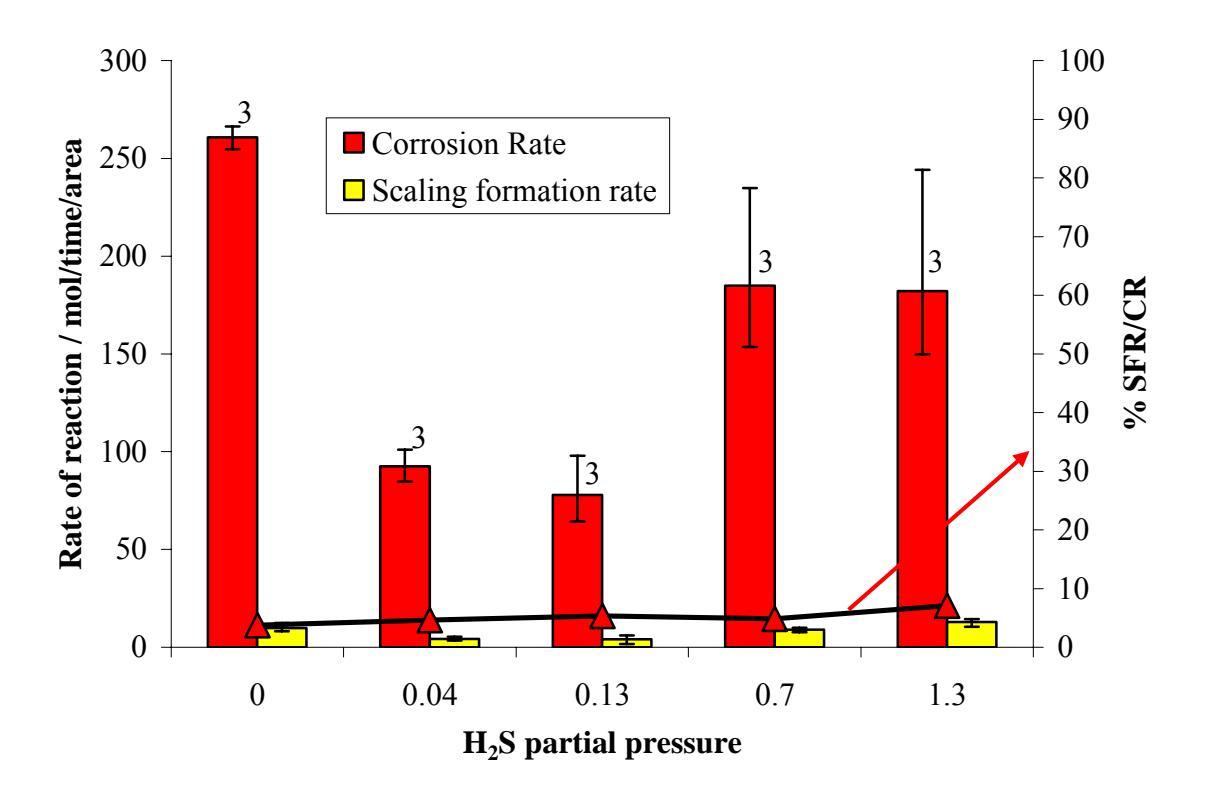
Figure 18. Series I. Rate of reaction under the effect of the H<sub>2</sub>S partial pressure at the bottom of the line. High temperature, P = 30,  $pCO_2 = 1.3$ ,  $V_G = 5$  m/s, high condensation rate, test duration: 2 days. (Surface analyses are shown in Figures 22 to 38)

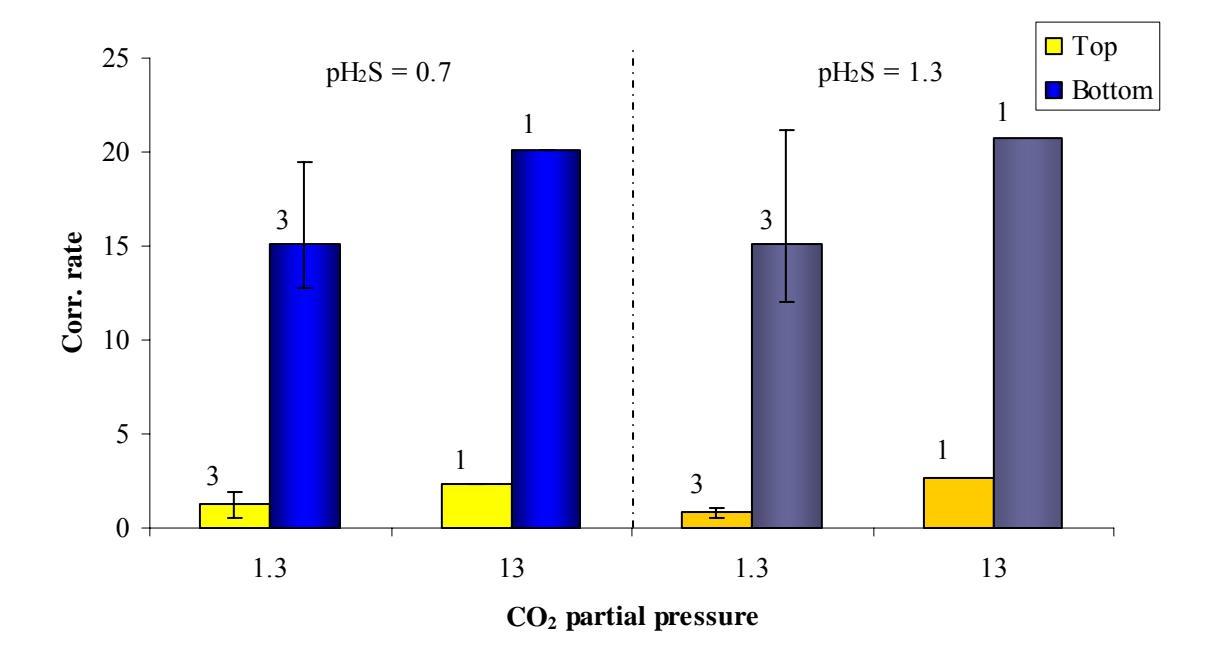
Figure 19. Series I. Effect of the CO<sub>2</sub> partial pressure at the top of the line. High temperature, P = 30,  $V_G = 5$  m/s, high condensation rate, test duration: 2 days. (Surface analyses are shown in Figures 22 to 38)

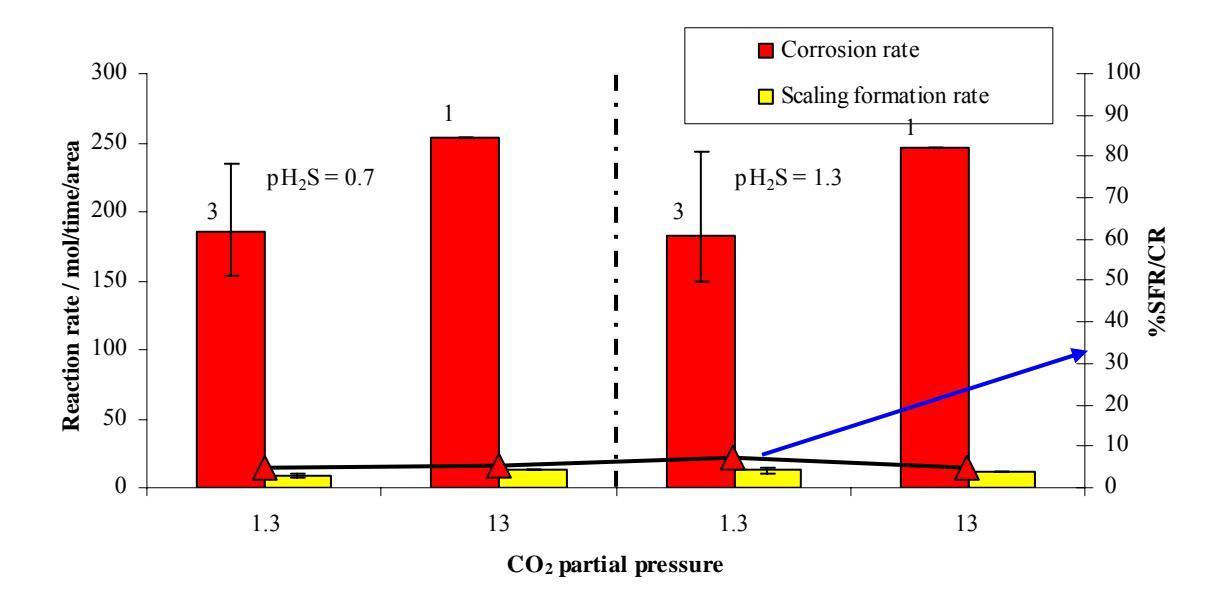
Figure 21. Series I. Rate of reaction under the effect of different H<sub>2</sub>S and CO<sub>2</sub> partial pressures at the bottom of the line. High temperature, P = 30,  $V_G = 5$  m/s, high condensation rate, test duration: 2 days. (Surface analyses are shown in Figures 22 to 38)

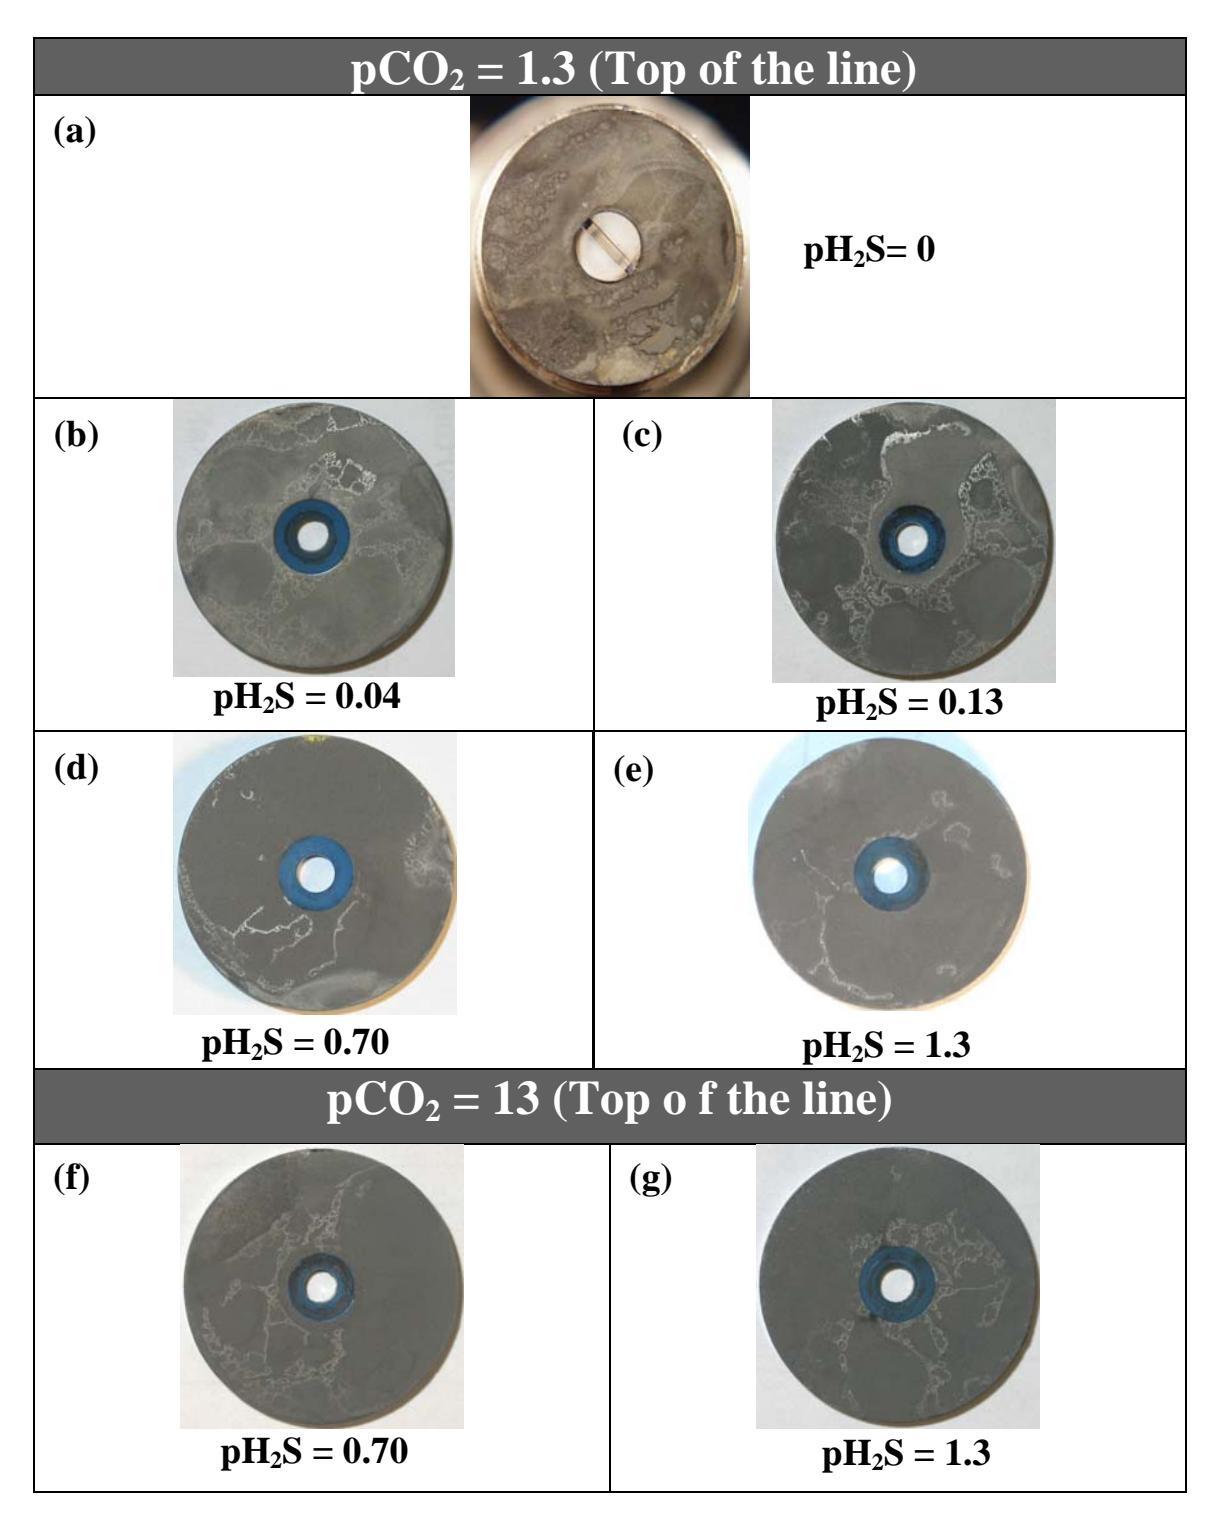
Figure 22. Series I. Morphology of carbon steel API X-65 coupons immediately after removal from the loop, tested at the top of the line. High temperature, P = 30,  $V_G = 5$ m/s, high condensation rate, test duration: 2 days. (Corrosion rate are presented in Figure 16, 17, 19 and 20)

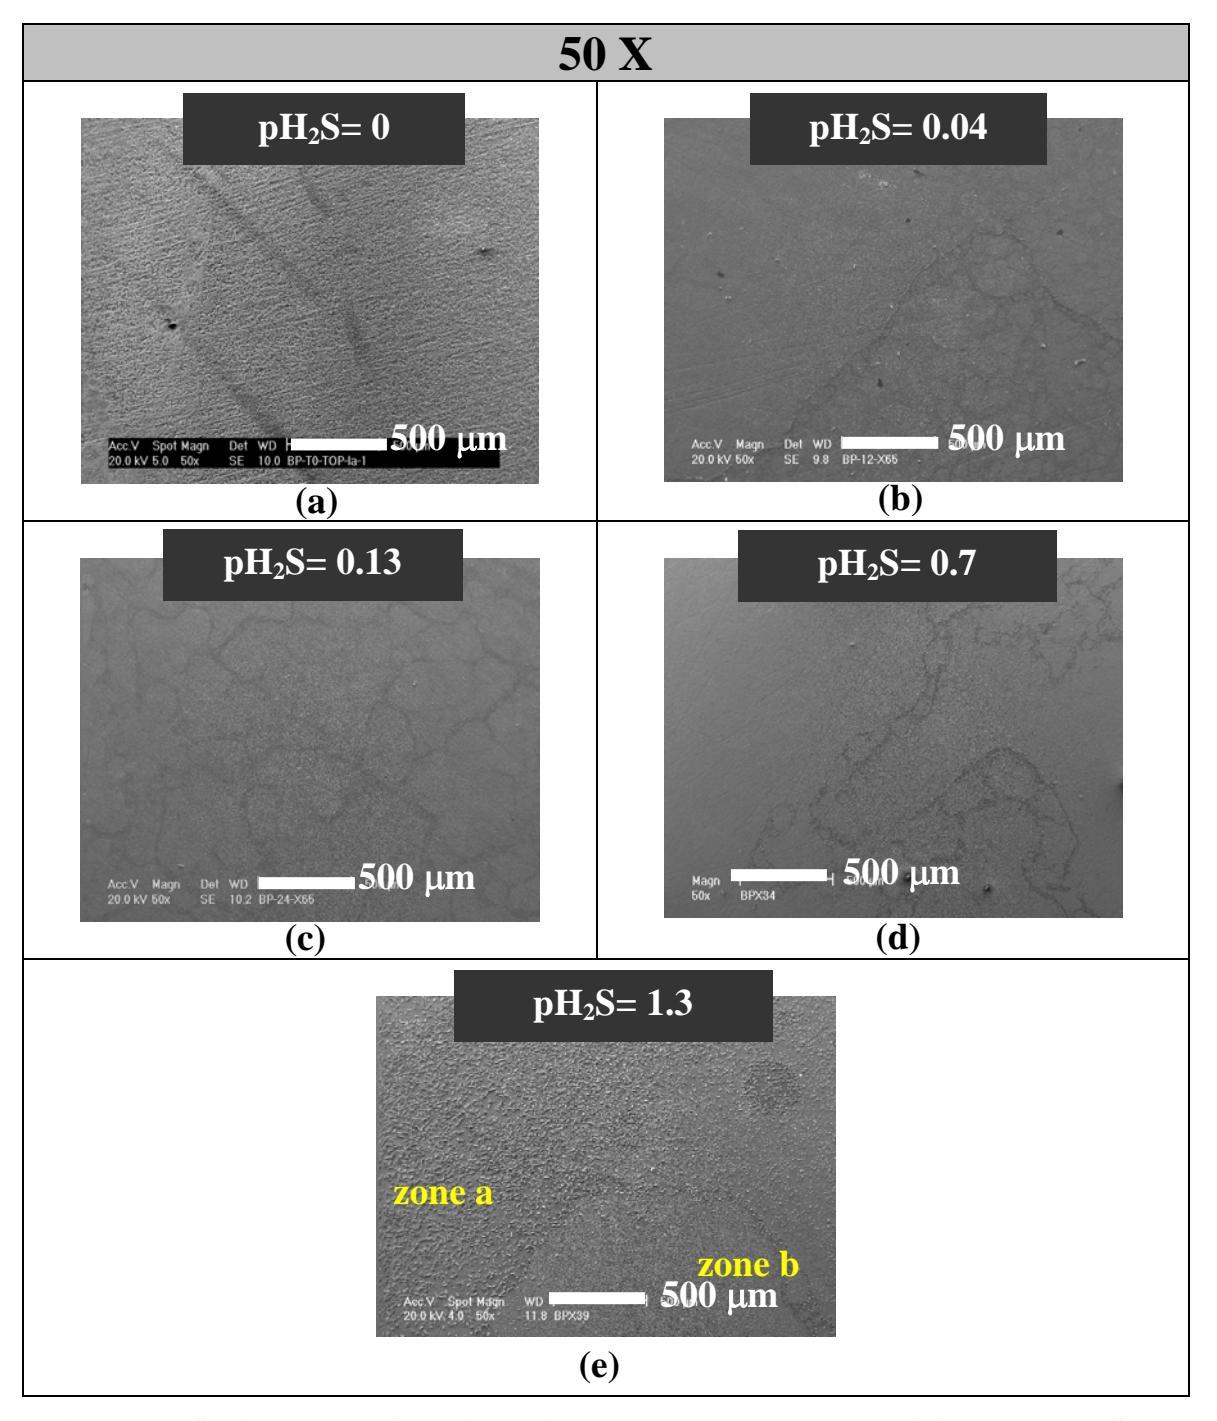
Figure 23. Series I. Top of the line. High temperature, P = 30,  $pCO_2 = 1.3$ ,  $pH_2S = 0$ ,  $V_G = 5$  m/s, high condensation rate , test duration: 2 days (50x) (Corrosion rate are presented in Figures 16, 17, 19 and 20)

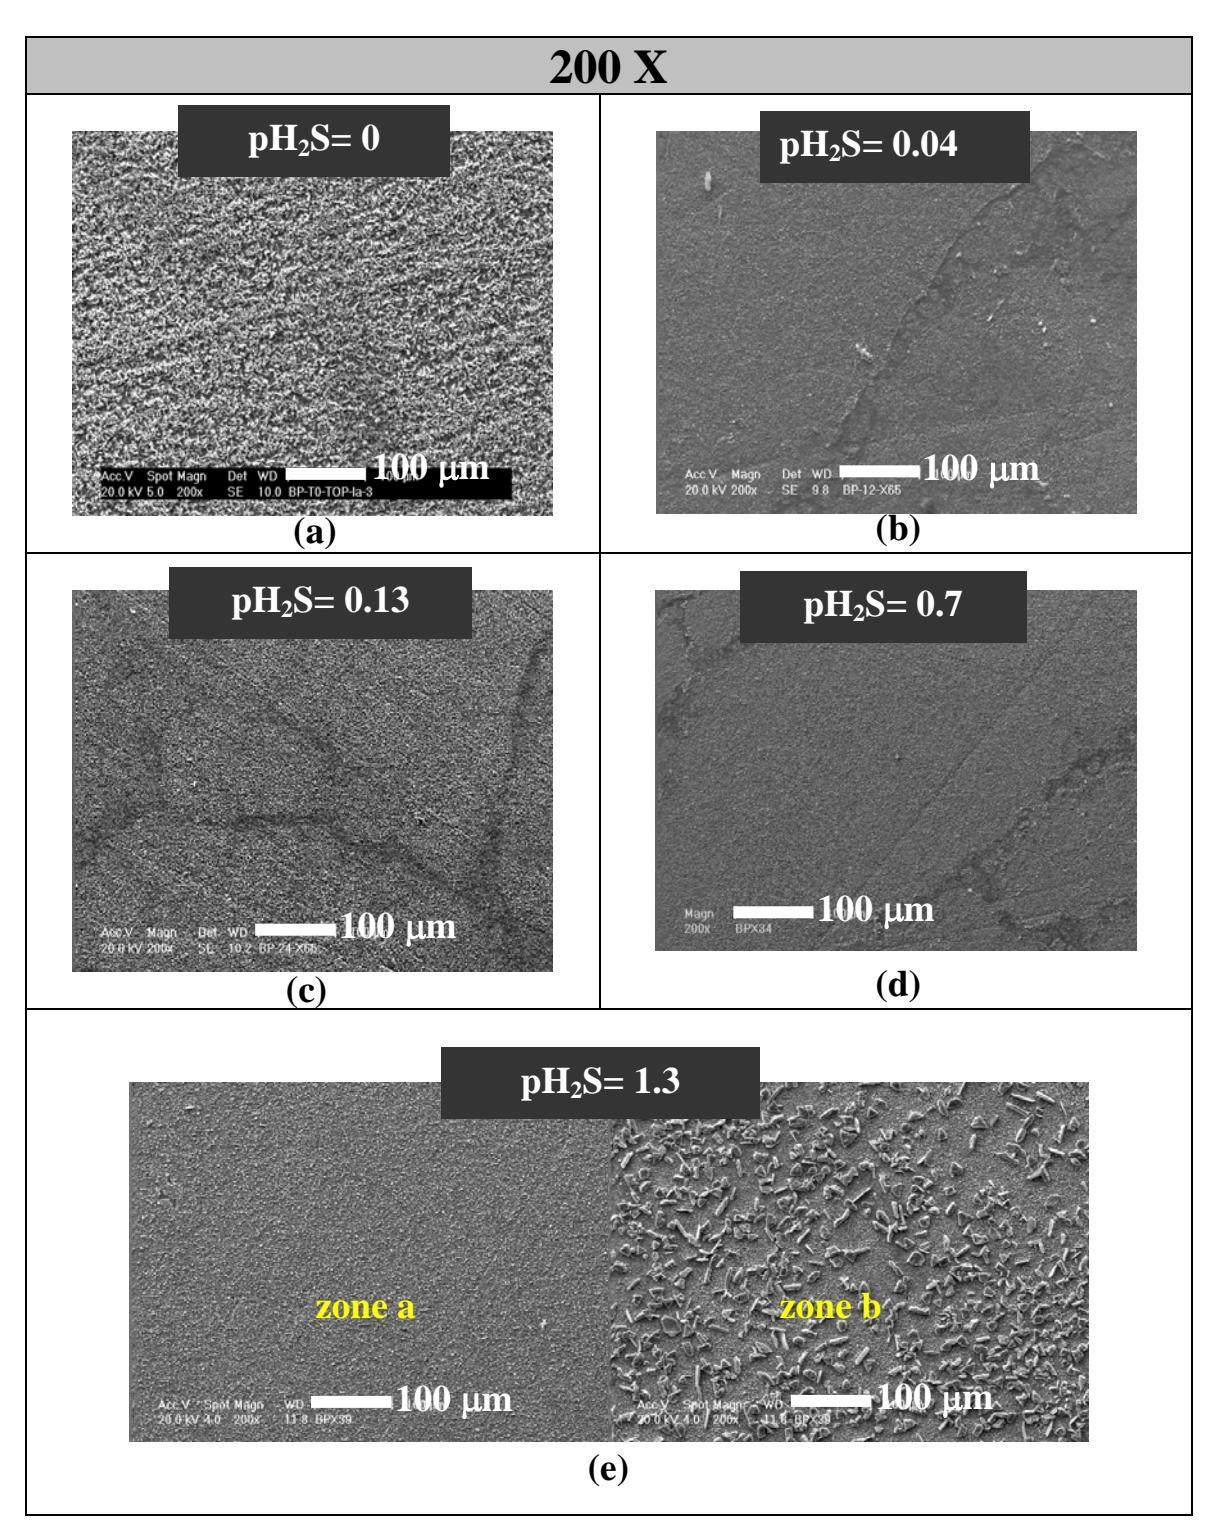
Figure 25. Series I. Top of the line. High temperature, P = 30,  $pCO_2 = 1.3$ ,  $V_G = 5$  m/s, high condensation rate, test duration: 2 days (200x) (Corrosion rate are presented in Figures 16, 17, 19 and 20)

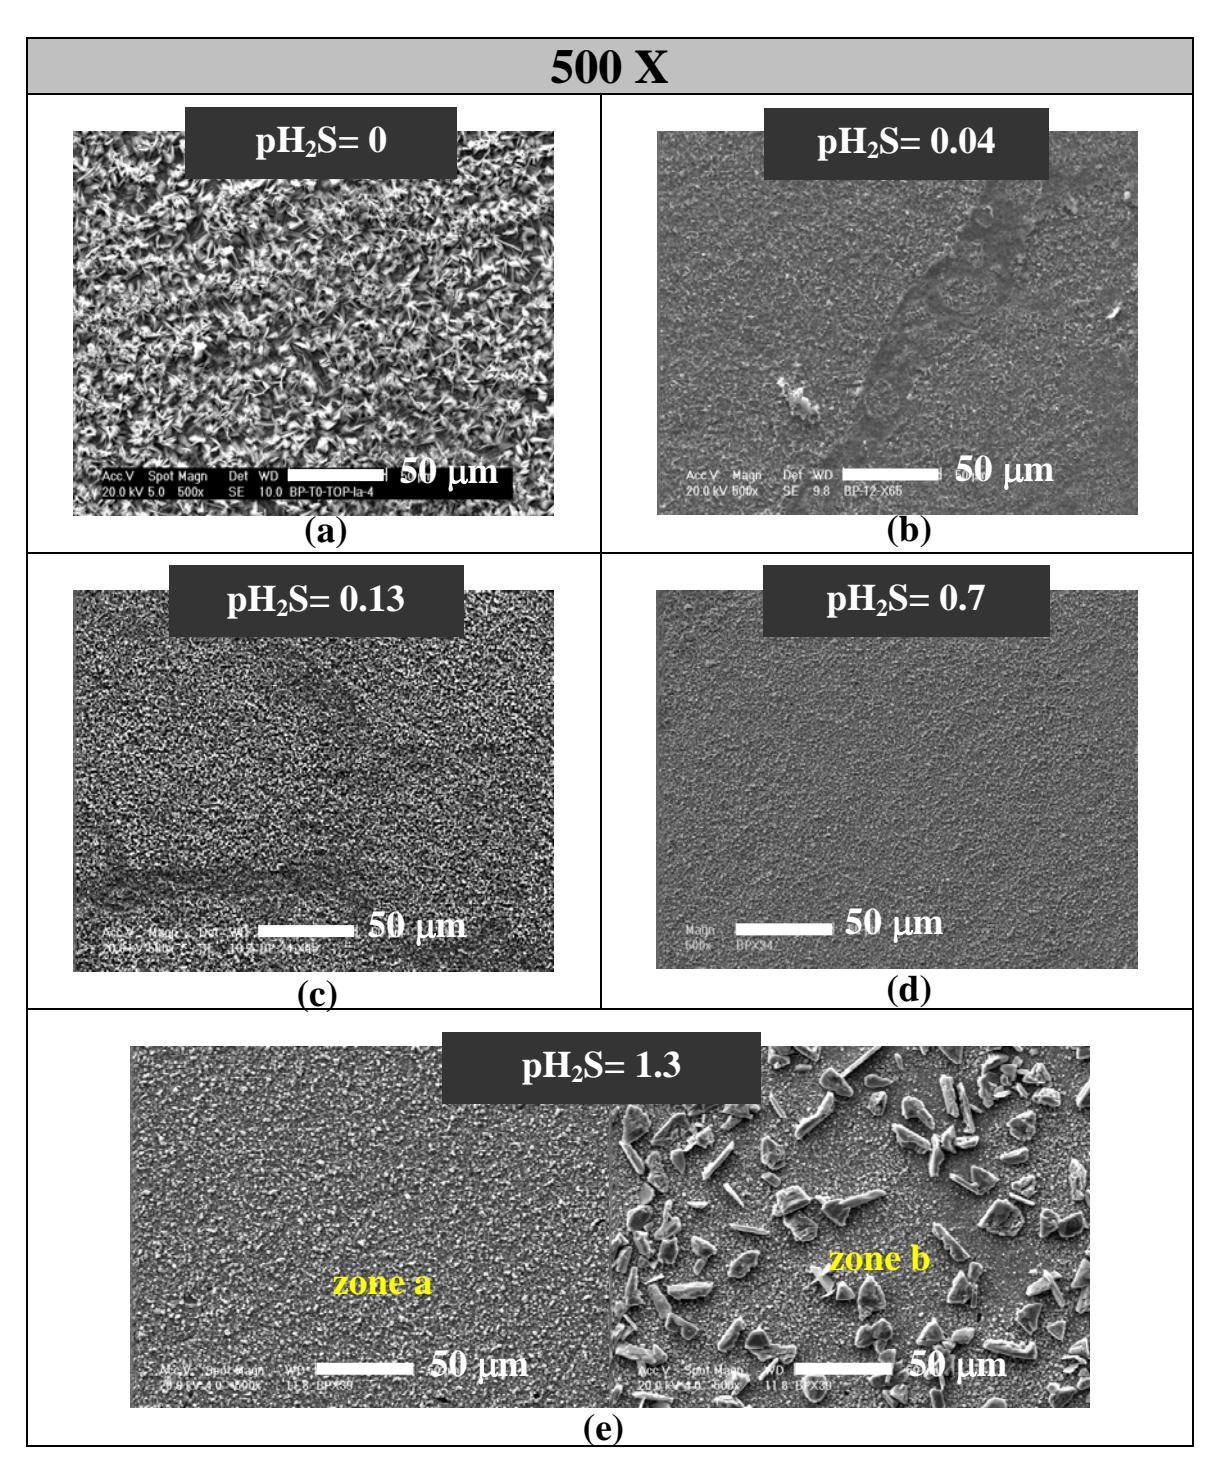
Figure 26. Series I. Top of the line. High temperature, P = 30,  $pCO_2 = 1.3$ ,  $V_G = 5$  m/s, high condensation rate, test duration: 2 days (500x) (Corrosion rate are presented in Figures 16, 17, 19 and 20)

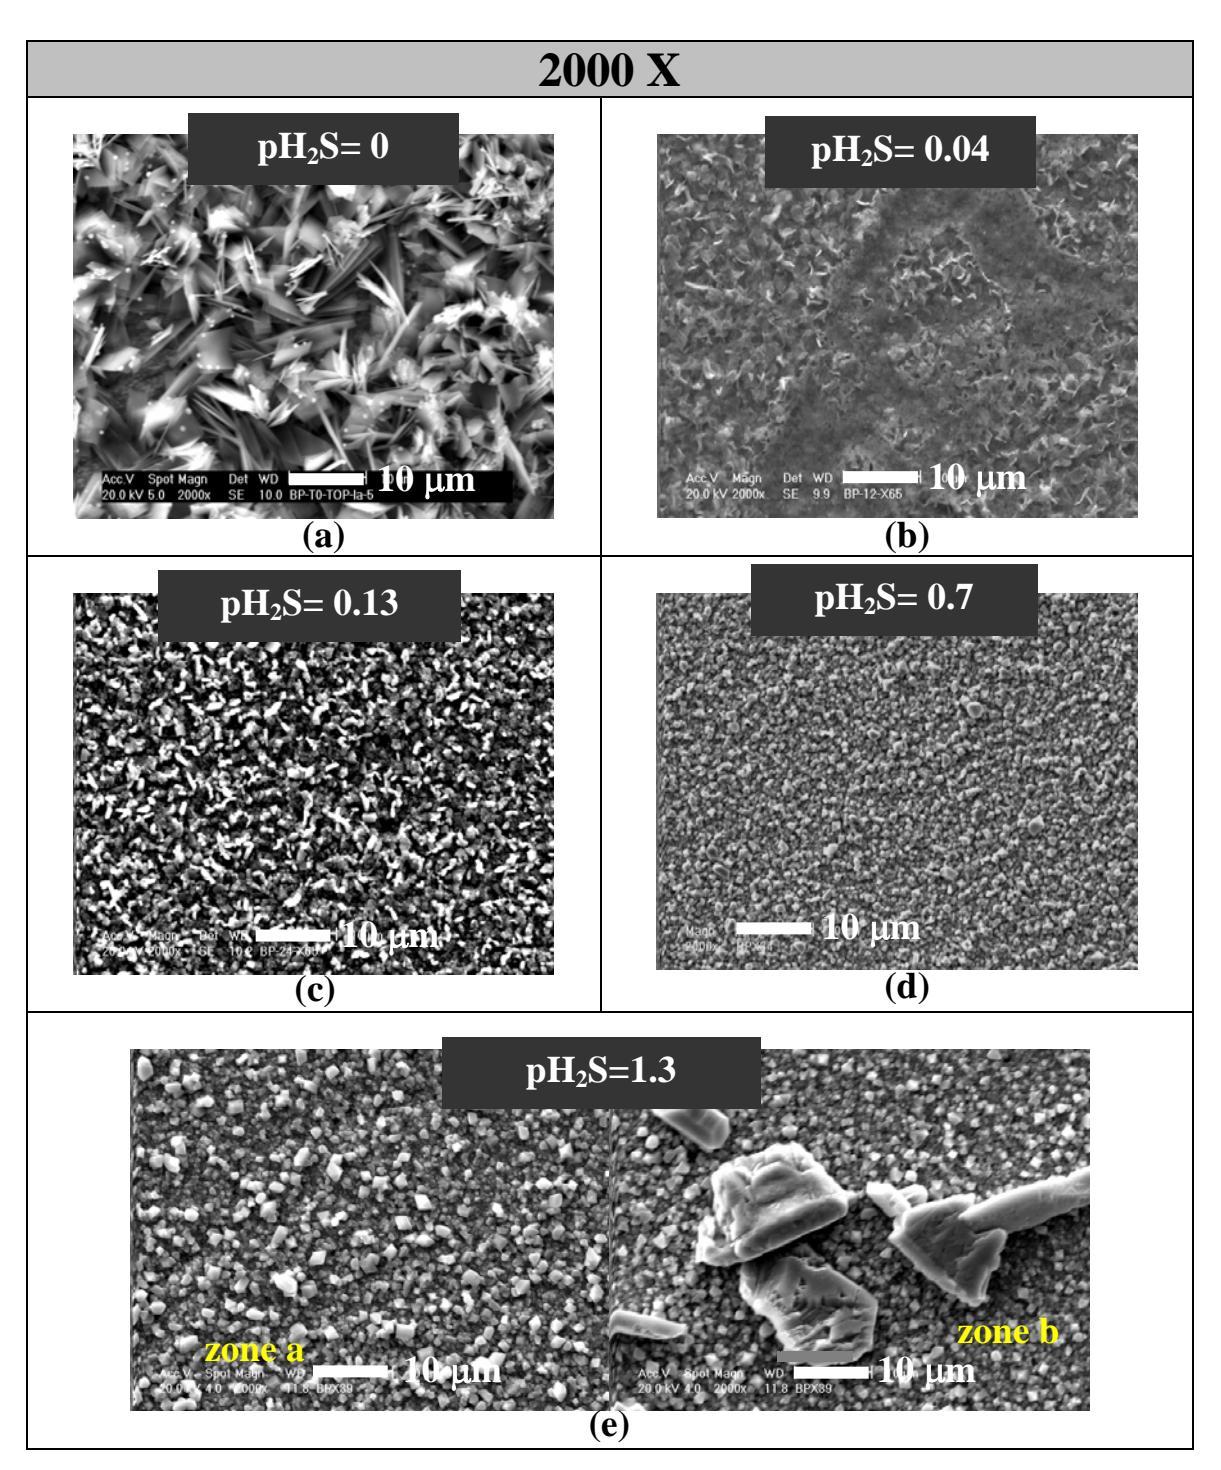
**Figure 27. Series I. Top of the line. High temperature, P = 30, pCO<sub>2</sub> = 1.3, V<sub>G</sub> = 5 m/s, high condensation rate, test duration: 2 days (2000x)** (Corrosion rate are presented in Figures 16, 17, 19 and 20)

same surface examined at higher magnification shows these features (see Figure 27a).

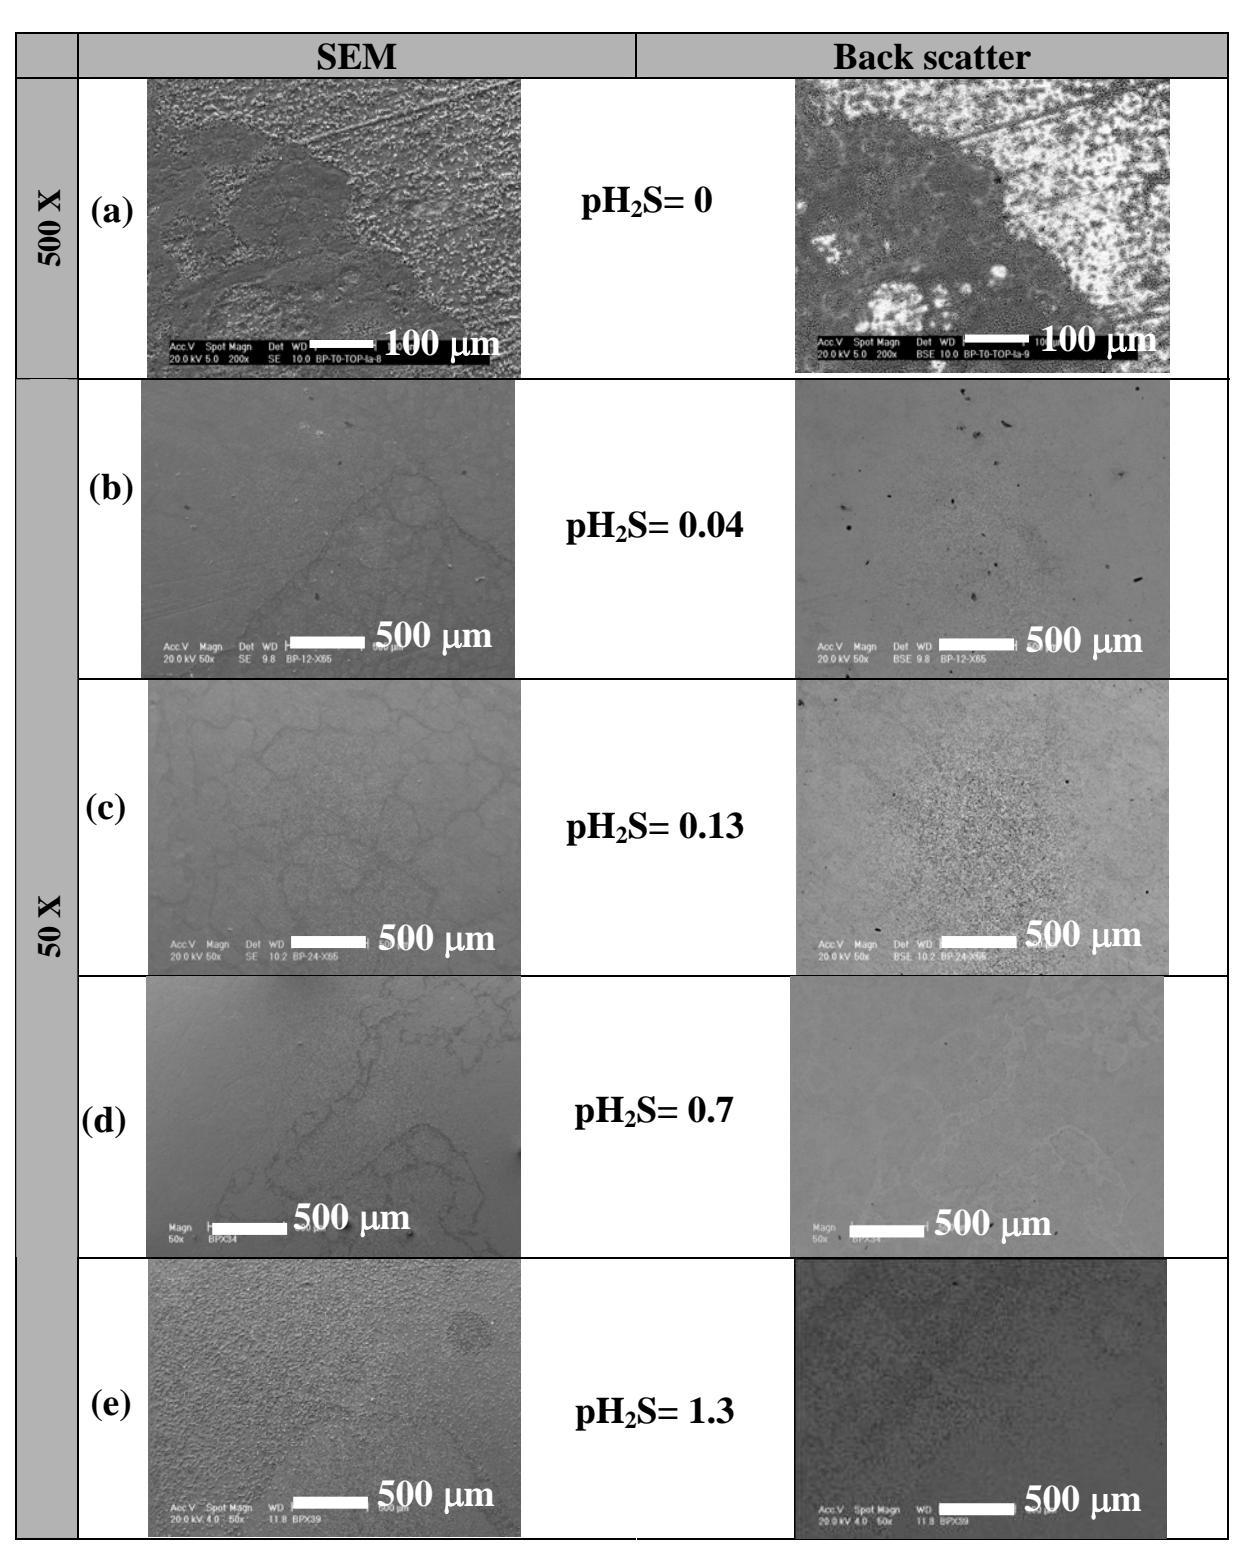
Figure 28. Series I. Backscatter images .Top of the line. High temperature, P = 30,  $pCO_2 = 1.3$ ,  $V_G = 5$  m/s, high condensation rate, test duration: 2 days (Corrosion rate are presented in Figures 16, 17, 19 and 20)

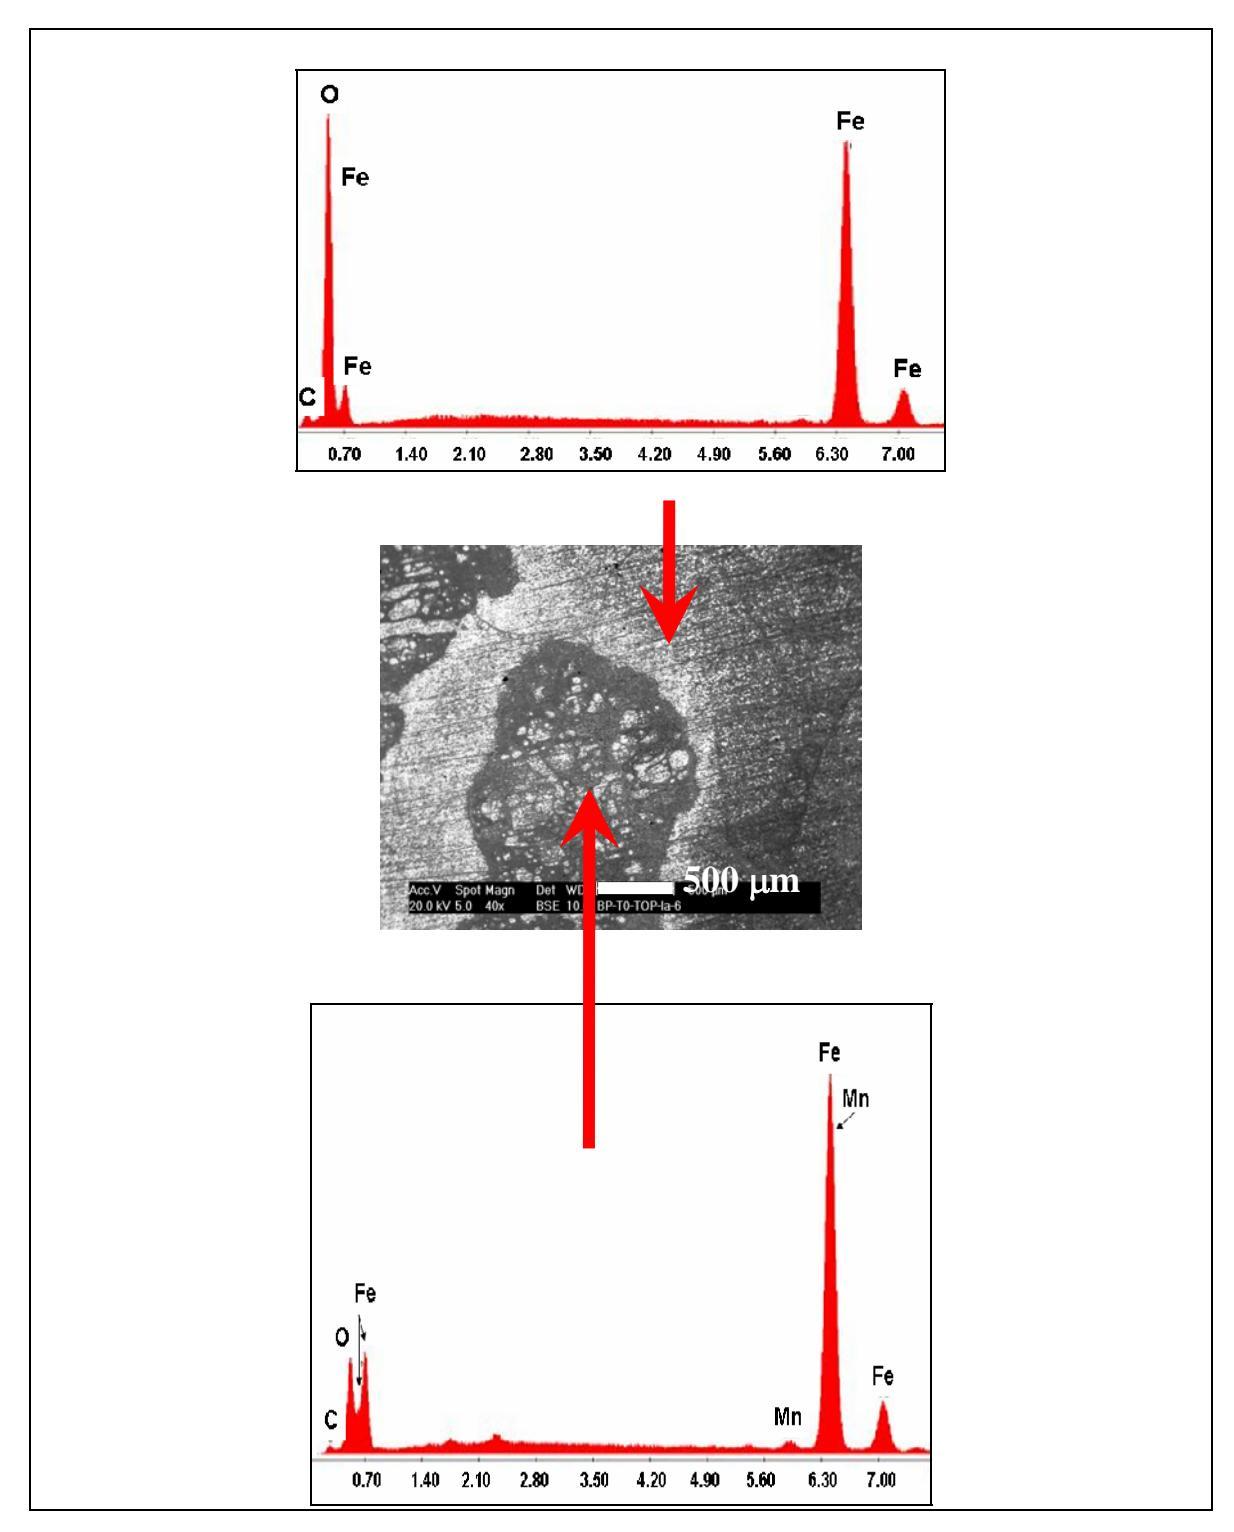
Figure 29. Series I, Experiment I-0. EDS analysis. Top of the line. High temperature, P = 30,  $pCO_2 = 1.3$ ,  $pH_2S= 0$ ,  $V_G = 5$  m/s, high condensation rate, test duration: 2 days (Corrosion rate are presented in Figures 16 and 17)

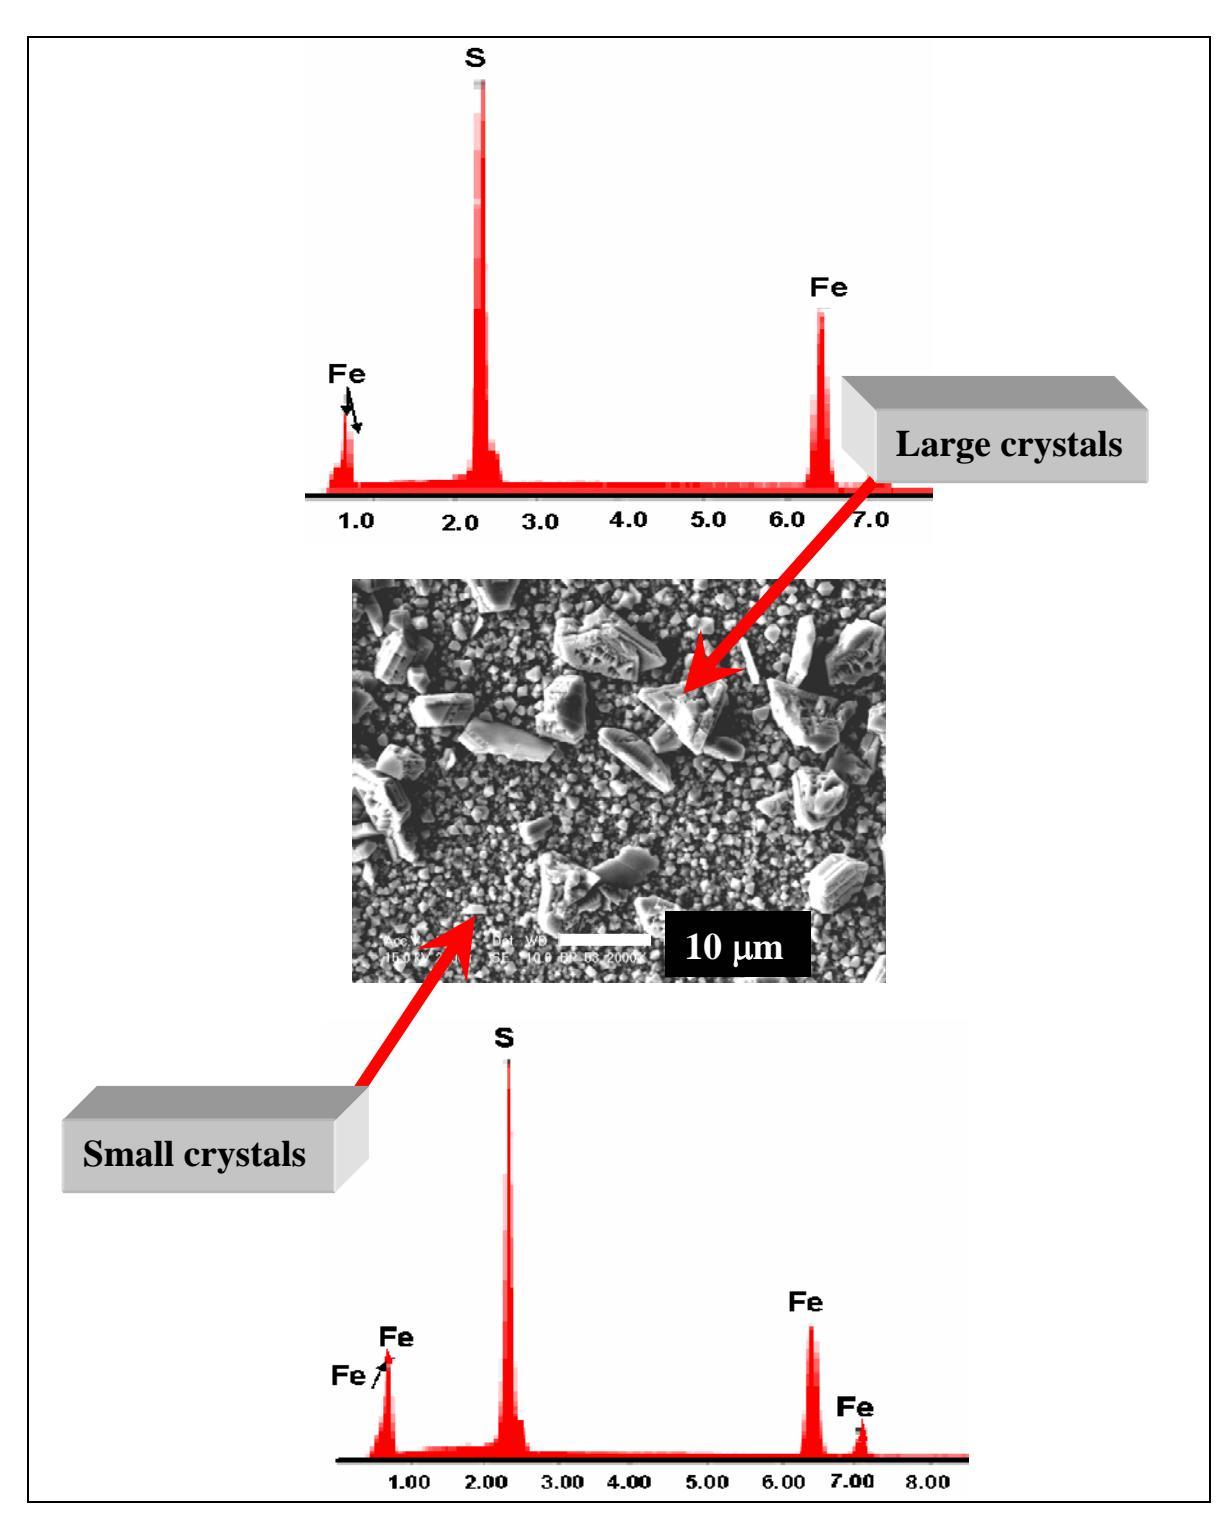
Figure 30. Series I, Experiment III-3. EDS analysis. Top of the line. High temperature, P = 30,  $pCO_2 = 1.3$ ,  $pH_2S = 1.3$ ,  $V_G = 5$  m/s, high condensation rate, test duration: 2 days. (Corrosion rate are presented in Figures 16, 17, 19 and 20)
