# $\mathrm{CO}_2$ TOP OF THE LINE CORROSION IN THE PRESENCE OF $\mathrm{H}_2\mathrm{S}$

the Russ College of Engineering and Technology of Ohio University

In partial fulfillment of the requirement for the degree Master of Science

Alvaro Camacho Manuitt

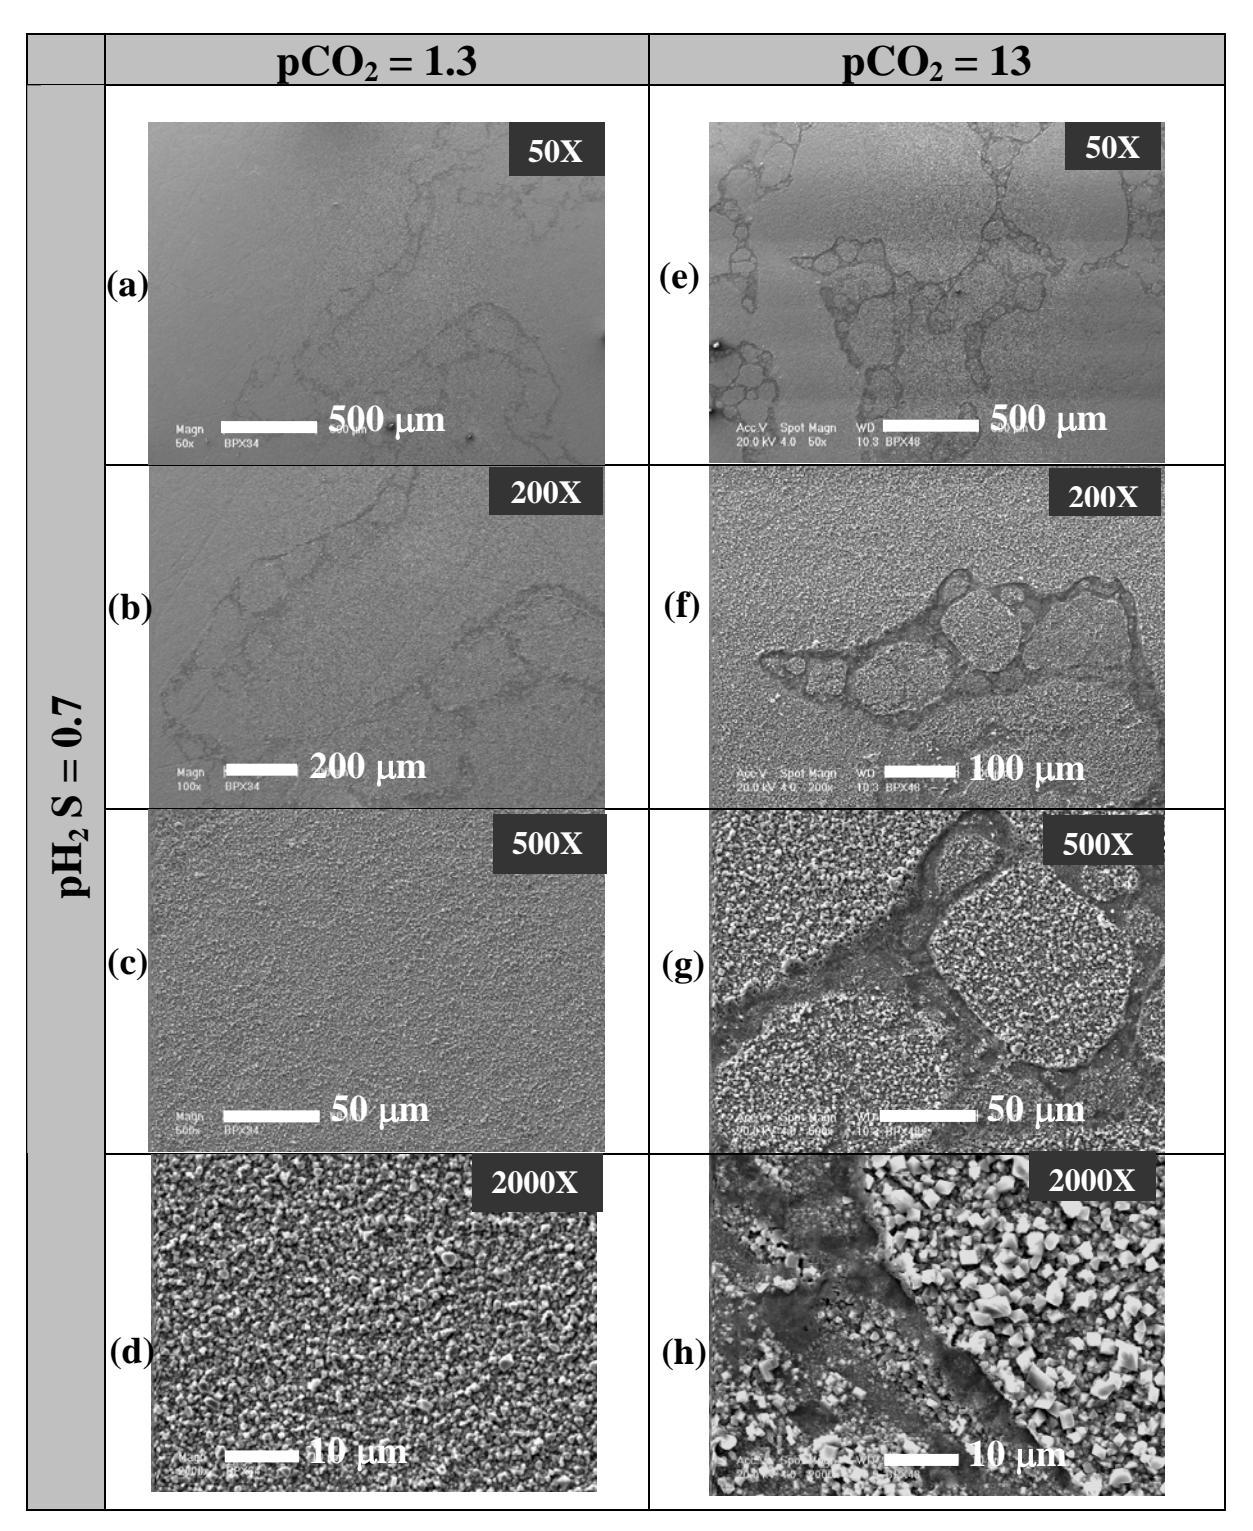
Figure 31. Series I, Test I-3 and I-5. Top of the line. High temperature, P = 30,  $pH_2S= 0.7$ ,  $V_G = 5$  m/s, high condensation rate, test duration: 2 days (Corrosion rate are presented in Figures 16, 19 and 21)

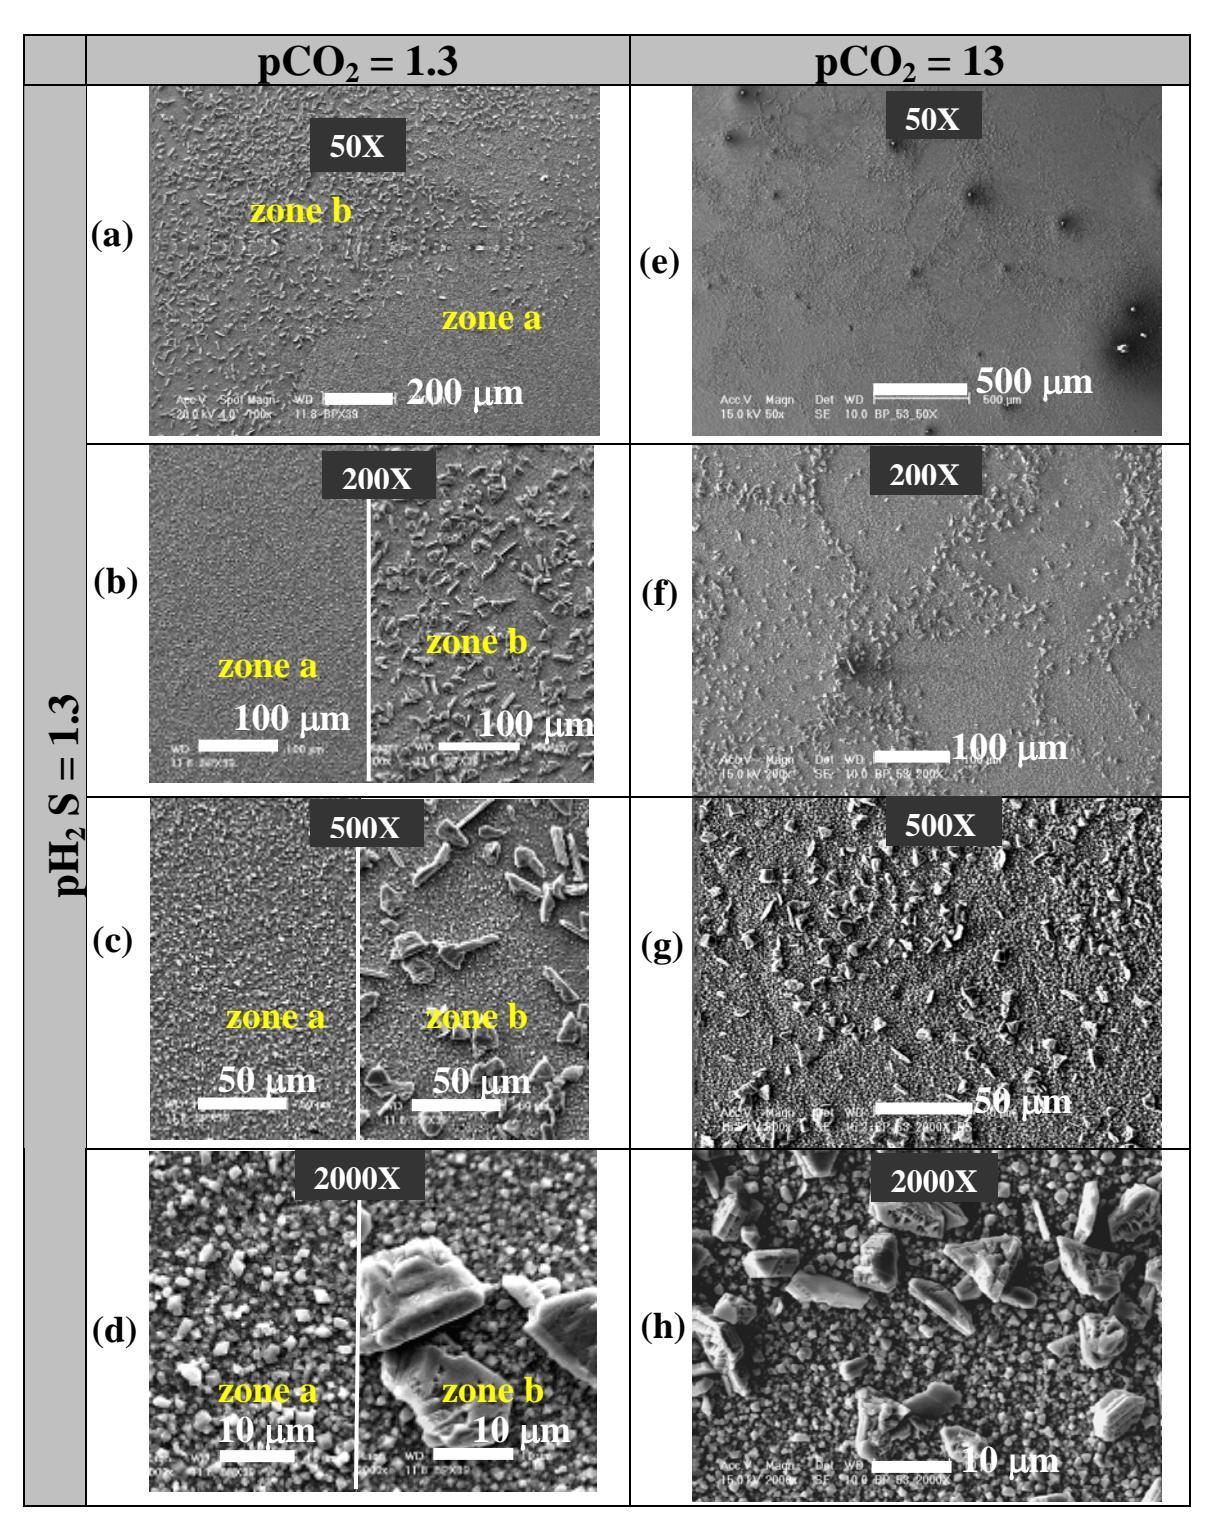
Figure 32. Series I, Test I-4 and I-6. Top of the line. High temperature, P = 30, pH<sub>2</sub>S= 1.3, V<sub>G</sub> = 5 m/s, high condensation rate, test duration: 2 days (Corrosion rate are presented in Figures 16, 19 and 21)

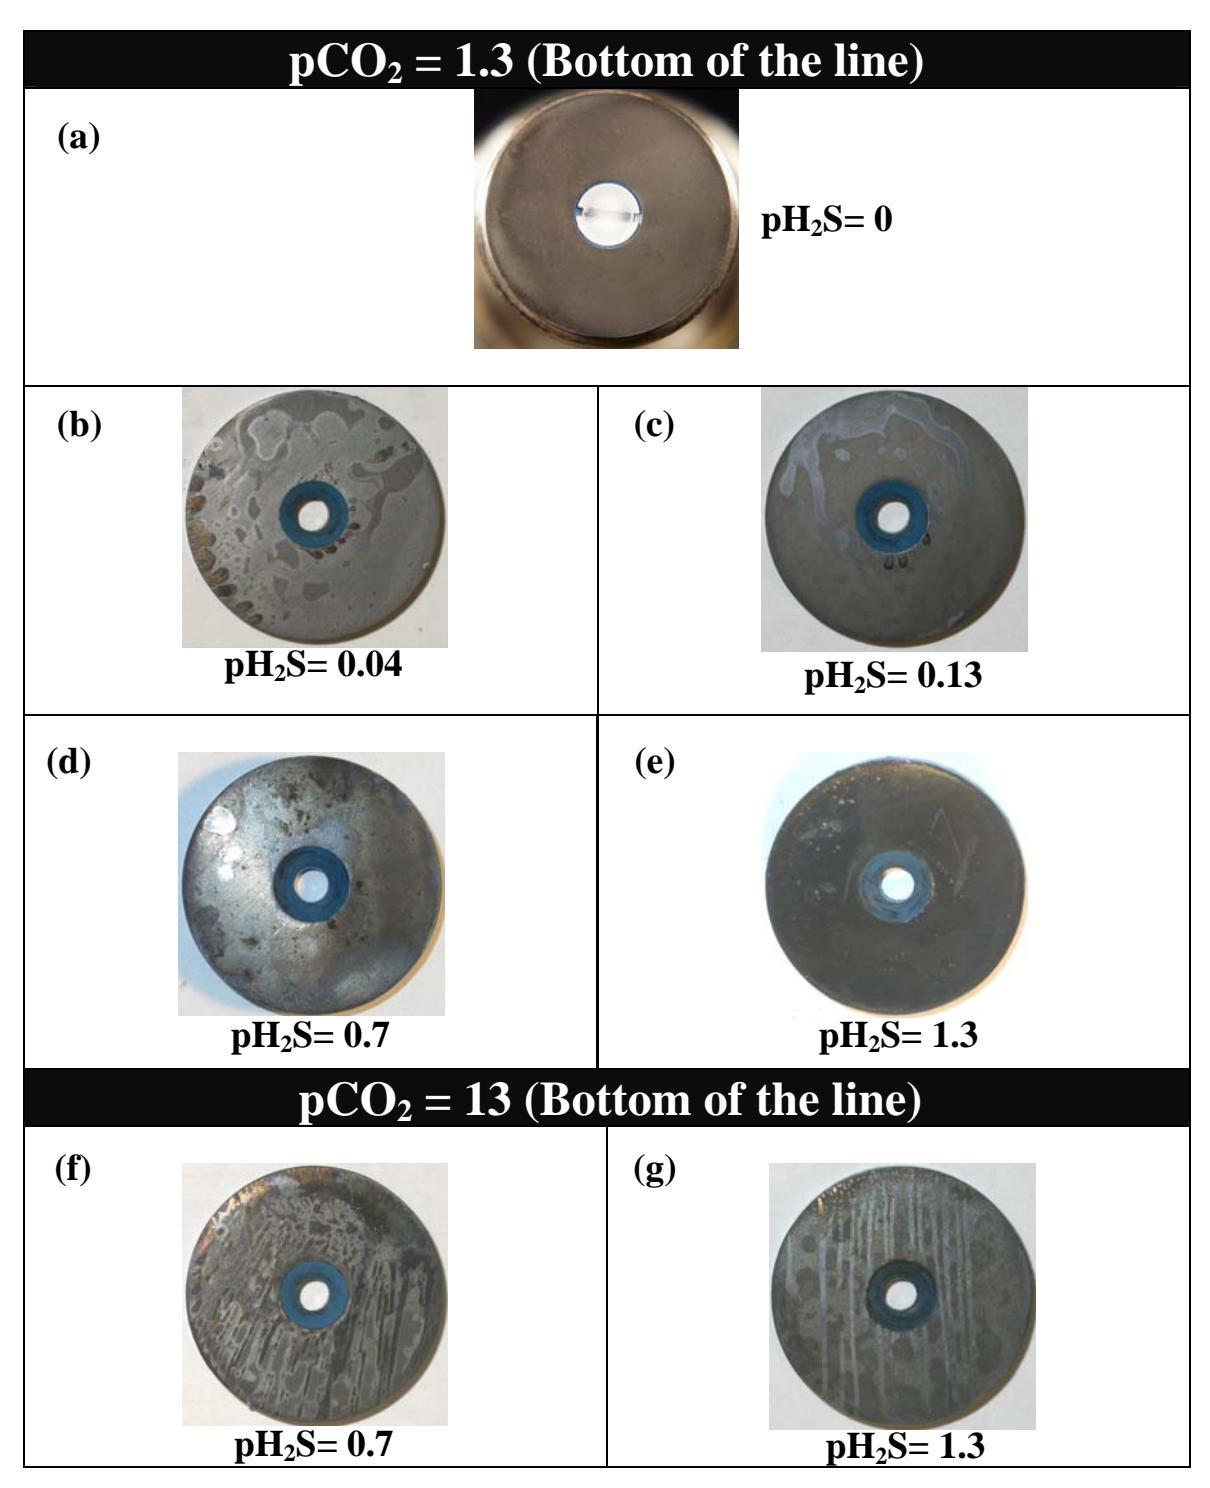
Figure 33. Series I. Morphology of carbon steel API X-65 coupons immediately after removal from the loop, tested at the bottom of the line. High temperature, P = 30,  $V_G = 5$  m/s, high condensation rate, test duration: 2 days (Corrosion rate are presented in Figures 16, 18, 21 and 22)

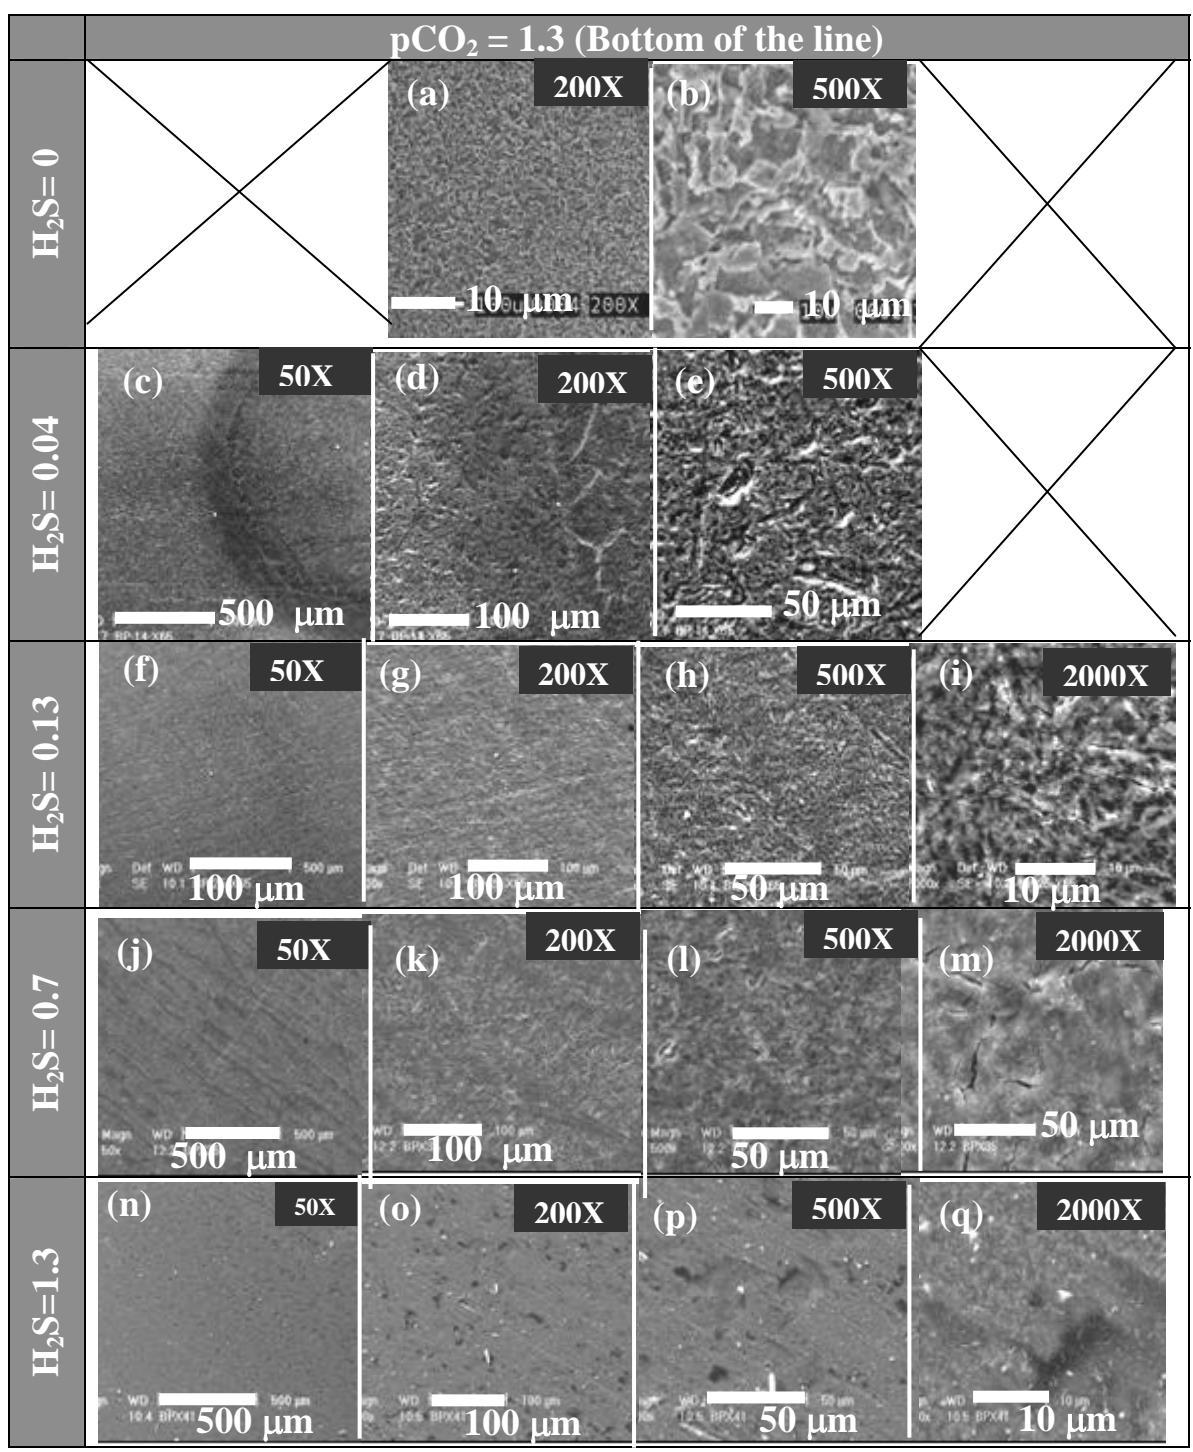
Figure 34. Series I. Bottom of the line. High temperature, P = 30,  $pCO_2 = 1.3$ ,  $V_G = 5$  m/s, high condensation rate, test duration: 2 days (Corr. rate are shown in Figures 16, 18, 21 - 22)

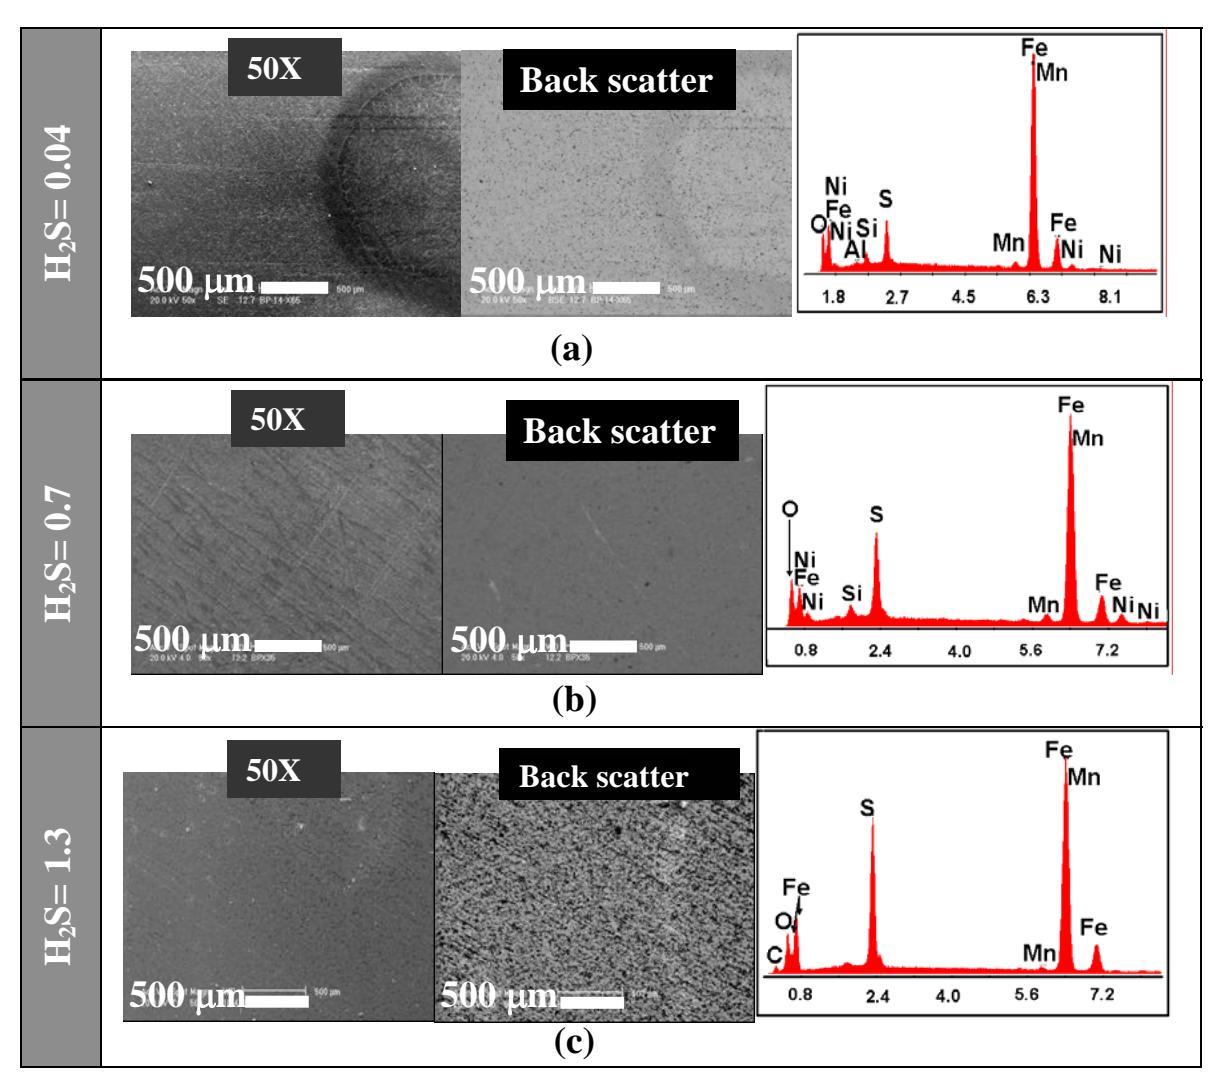
Figure 35. Series I. Bottom of the line. High temperature, P = 30,  $pCO_2 = 1.3$ ,  $V_G = 5$  m/s, high condensation rate, test duration: 2 days (Corrosion rate are presented in Figures 16, 18, 21 and 22)

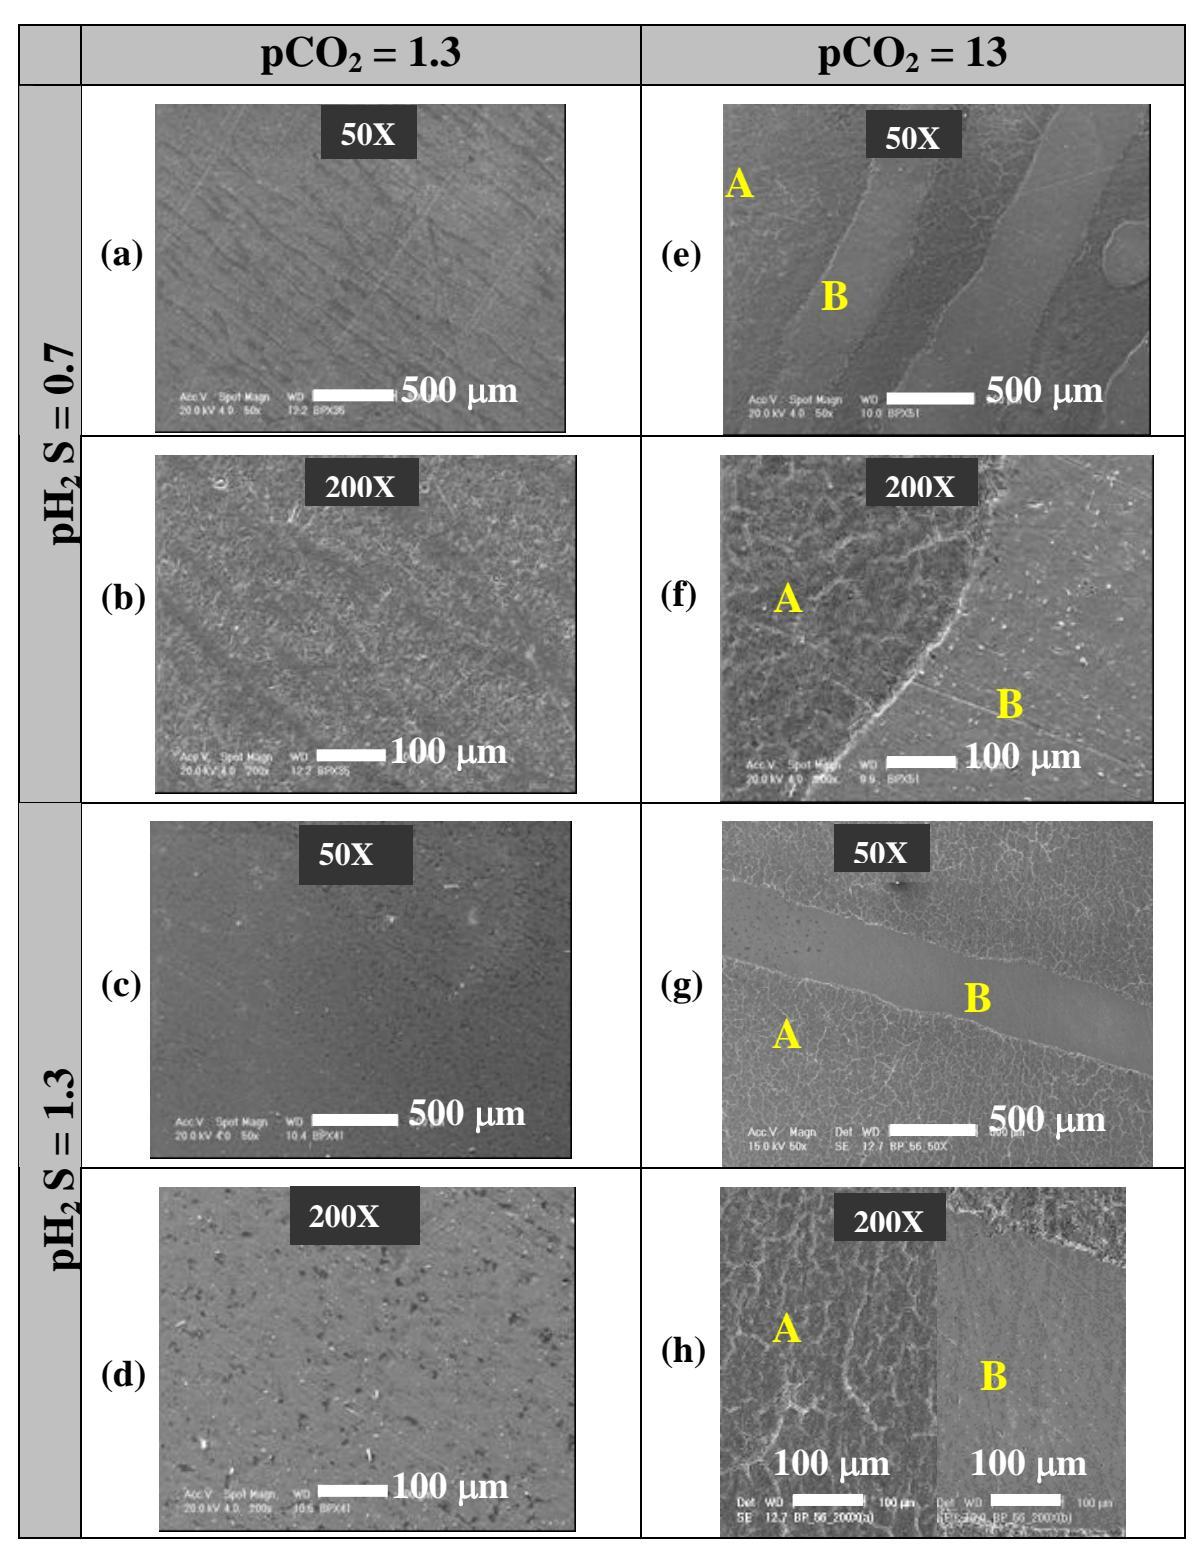
Figure 36. Series I, Test I-3 to I-6. Bottom of the line. High temperature, P = 30, V<sub>G</sub> = 5 m/s, high condensation rate, test duration: 2 days (Corrosion rate are presented in Figures 16, 18, 21 and 22)

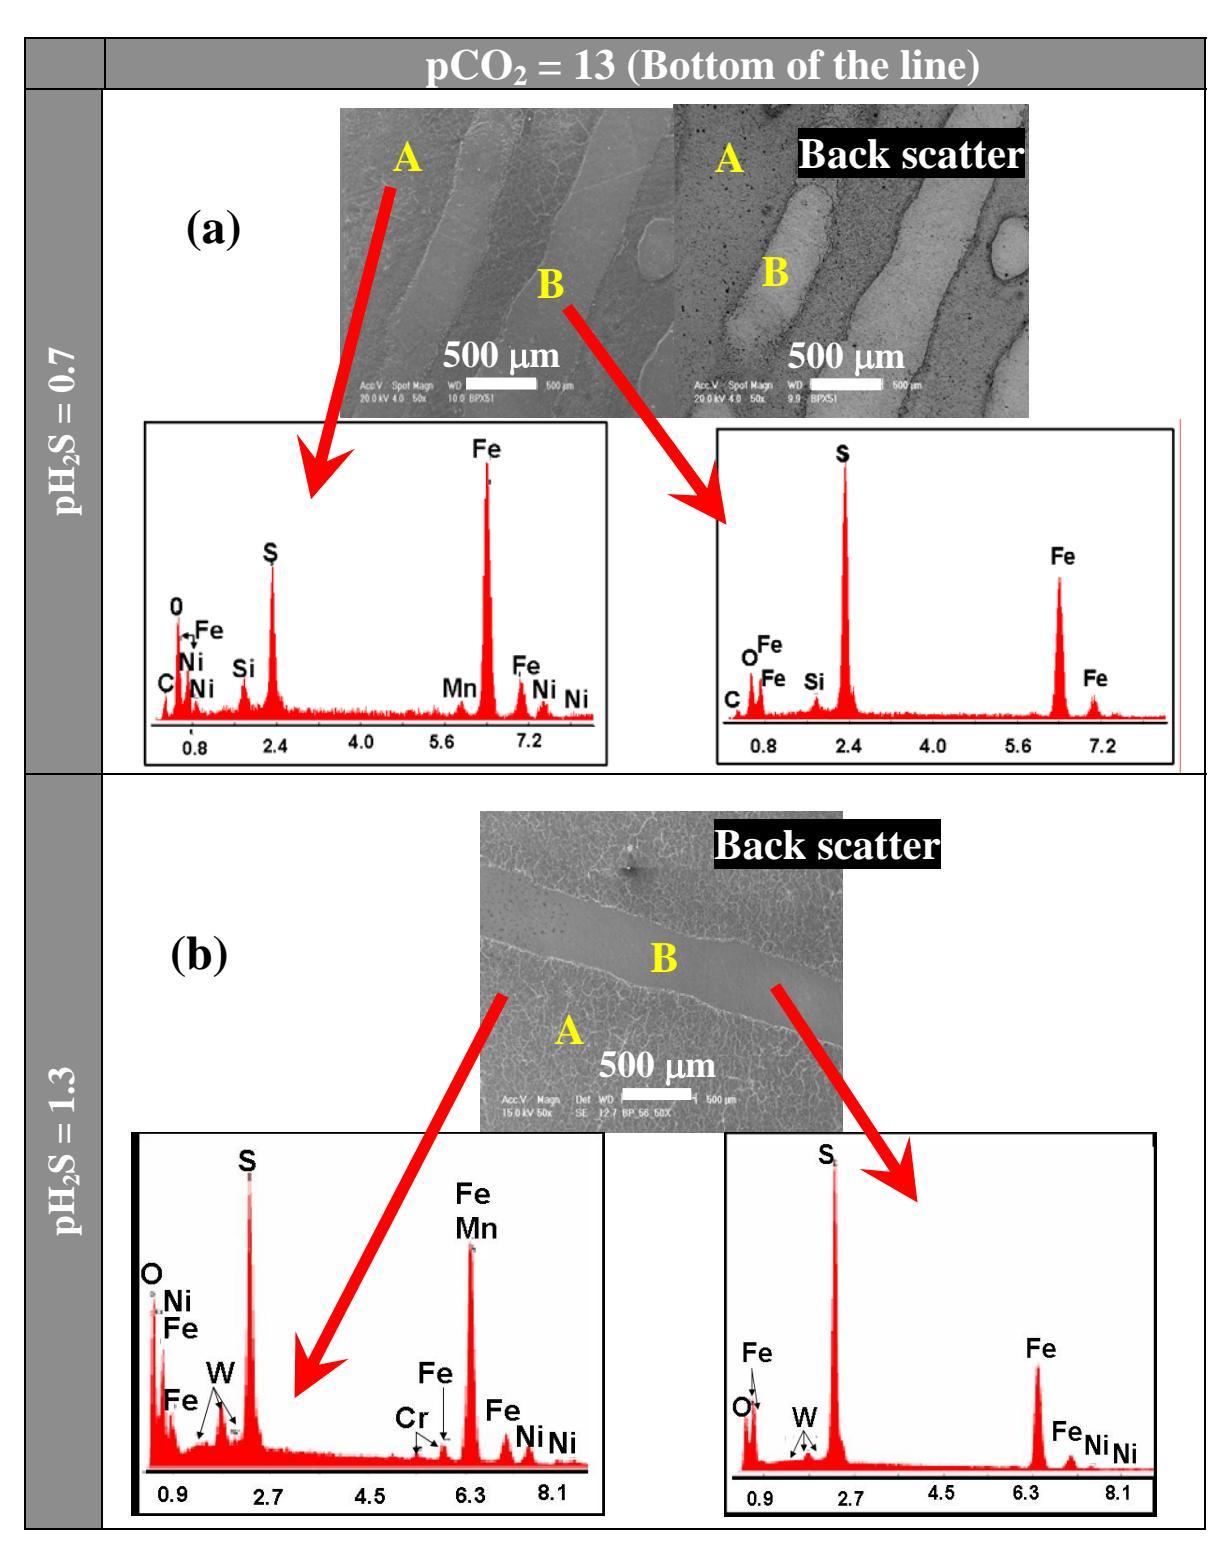
Figure 37. Series I, Backscatter. Test I-5 and I-6. Bottom of the line. High temperature, P = 30,  $pCO_2 = 13$ ,  $V_G = 5$  m/s, high condensation rate, test duration: 2 days (Corrosion rate are presented in Figures 16, 18, 21 and 22)

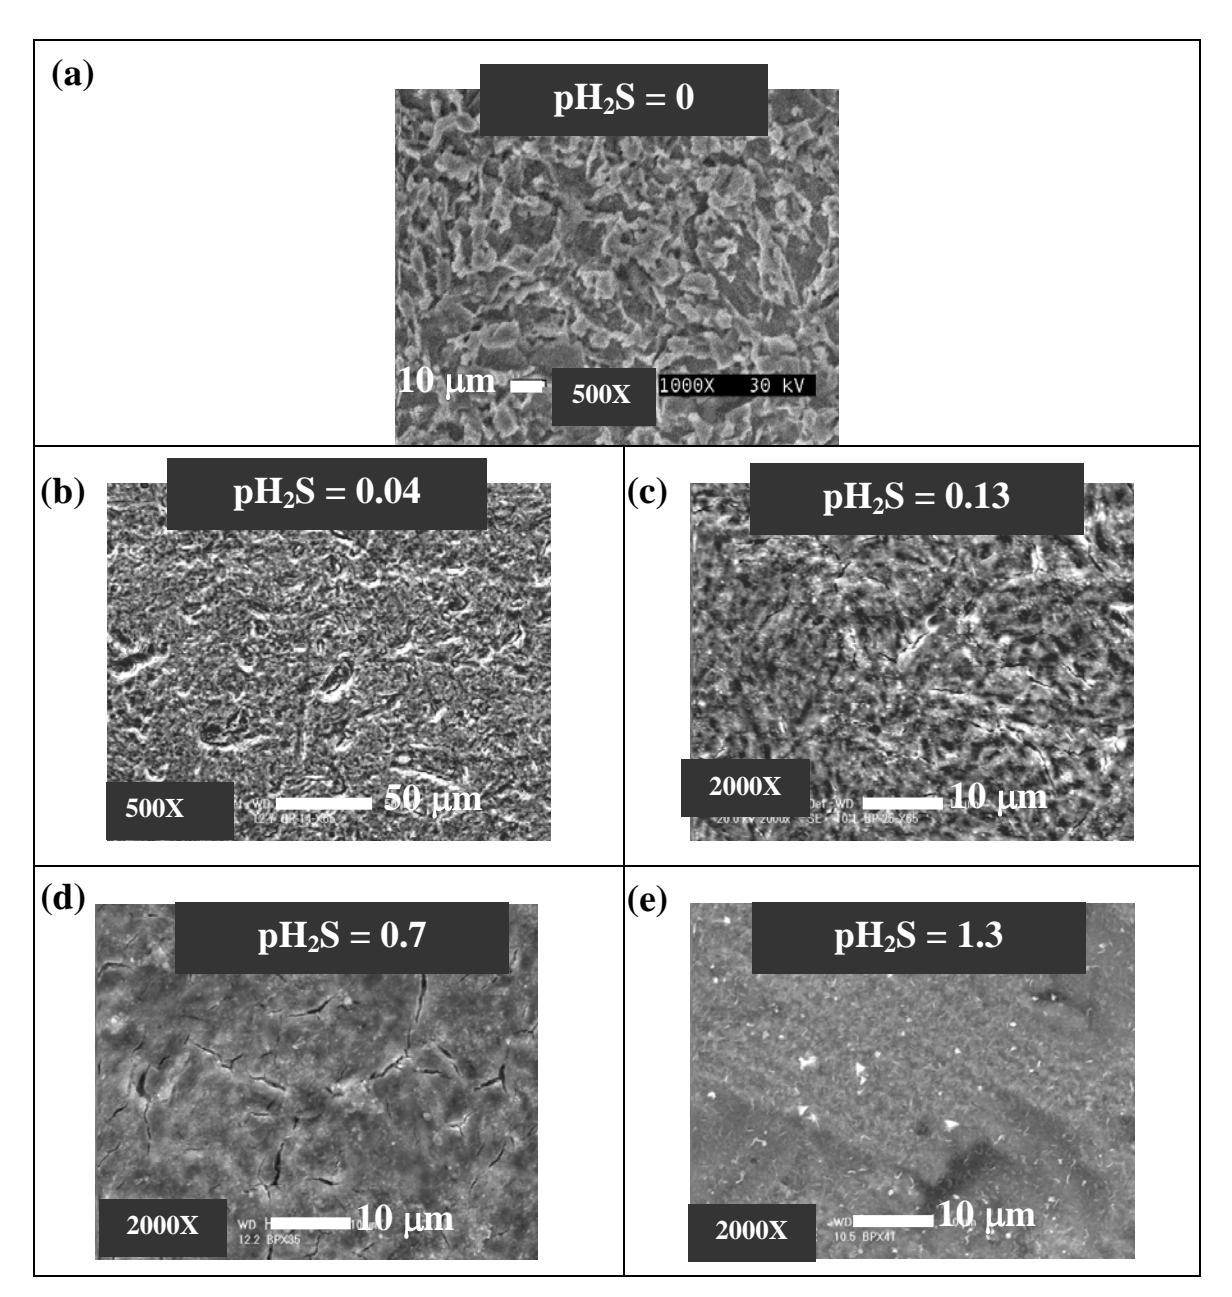
Figure 38. Series I. Series I. Bottom of the line. High temperature, P = 30,  $pCO_2 = 1.3$ ,  $V_G = 5$  m/s, high condensation rate = 2.5, test duration: 2 days (high magnification) (Corrosion rate are presented in Figures 16, 18, 21 and 22)

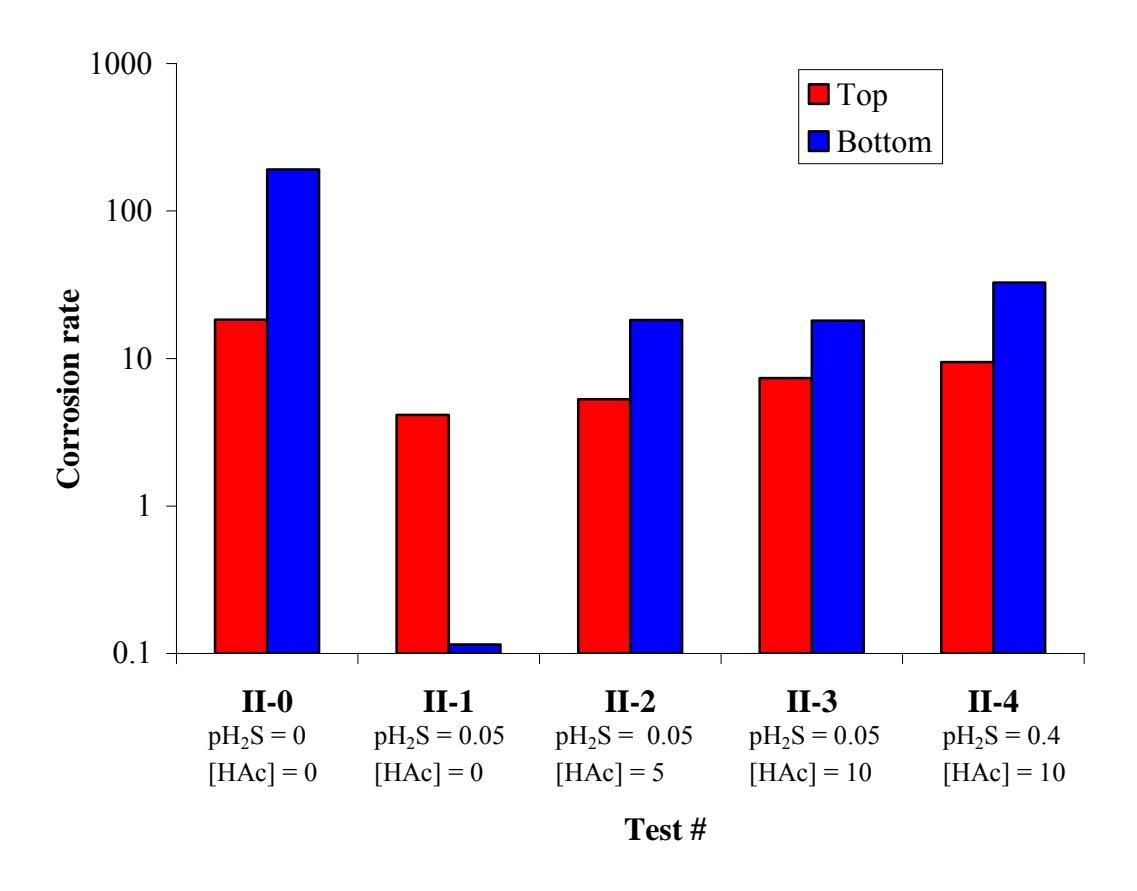
Figure 39. Series II. Effect of the H<sub>2</sub>S and HAc at the top and bottom of the line. High temperature, P = 83,  $pCO_2 = 80$ ,  $V_G = 5$  m/s, high condensation rate, test duration: 4 days (Surface analyses are shown in Figure 43 to 50)

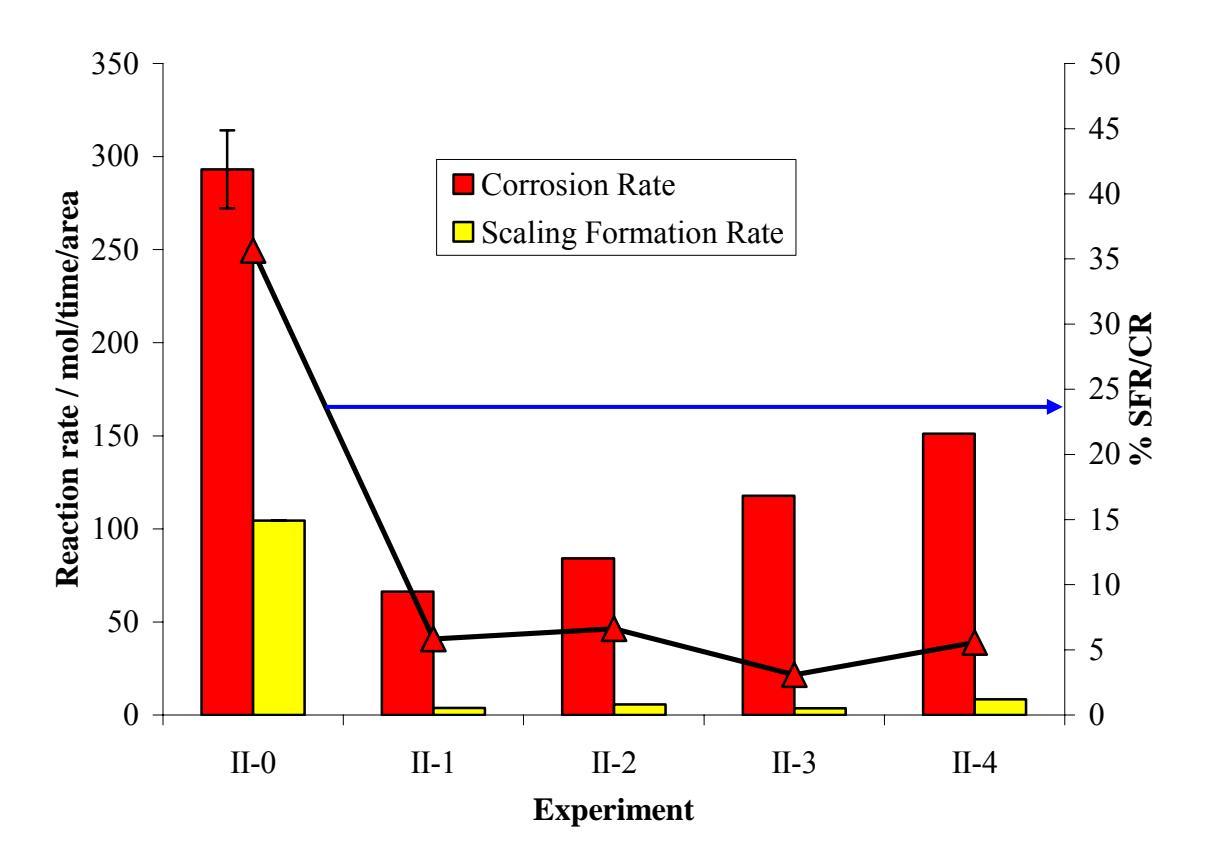
Figure 40. Series II, – Rate of reaction under the effect of the  $H_2S$  and HAc at the top of the line. High temperature, P = 83,  $pCO_2 = 80$ ,  $V_G = 5$  m/s, high condensation rate, test duration: 4 days (Surface analyses presented in Figure 43 to 50)

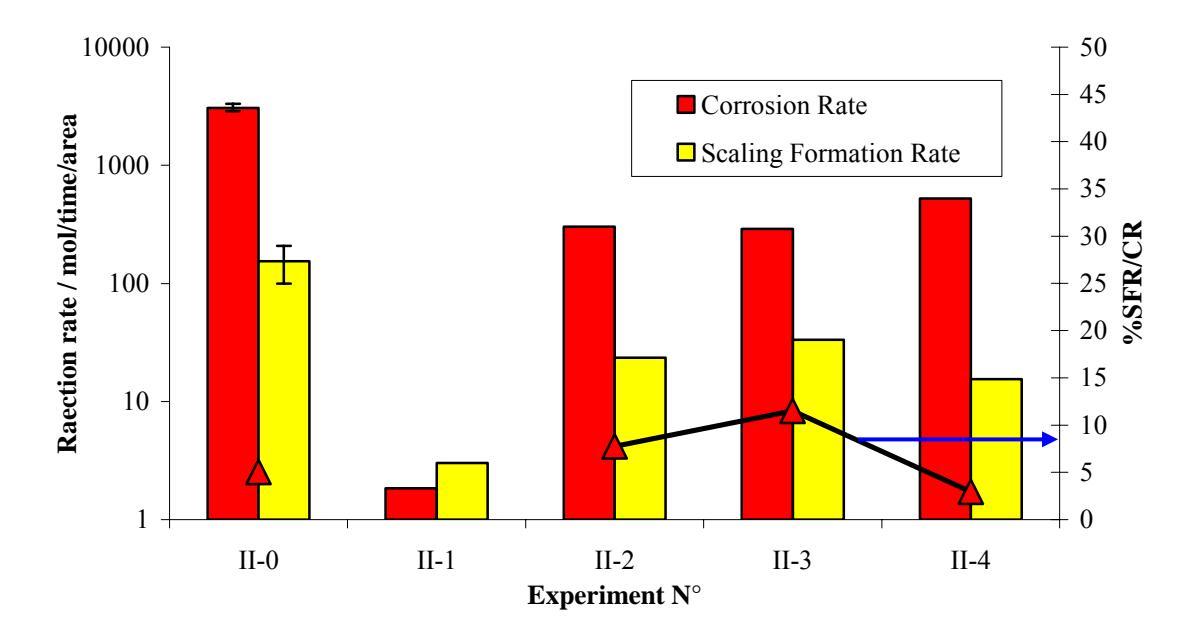
Figure 41. Series II, – Rate of reaction under the effect of the H<sub>2</sub>S and HAc at the bottom of the line. High temperature, P = 83, pCO<sub>2</sub> = 80, V<sub>G</sub> = 5 m/s, high condensation rate, test duration: 4 days (Surface analyses are presented in Figure 43 to 50)

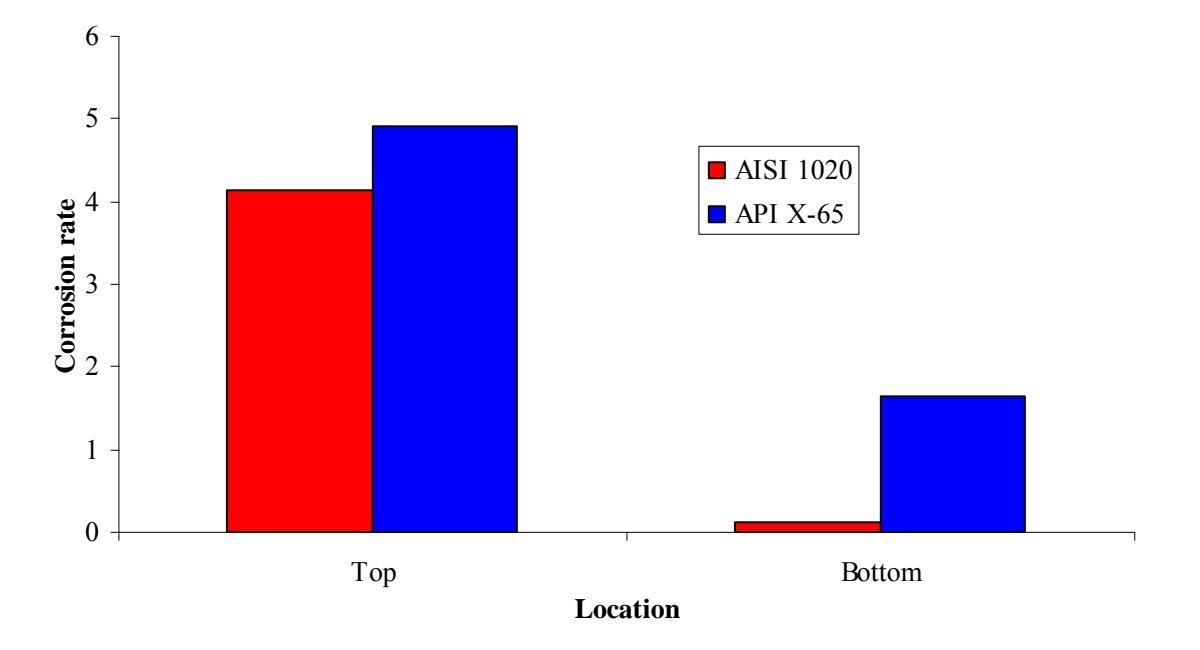
Figure 42. Series II. AISI 1020 and API X-65 corrosion performance in presence of  $CO_2$  and  $H_2S$ . High temperature, P = 83,  $pCO_2 = 80$ ,  $V_G = 5$  m/s, high condensation rate, test duration: 4 days

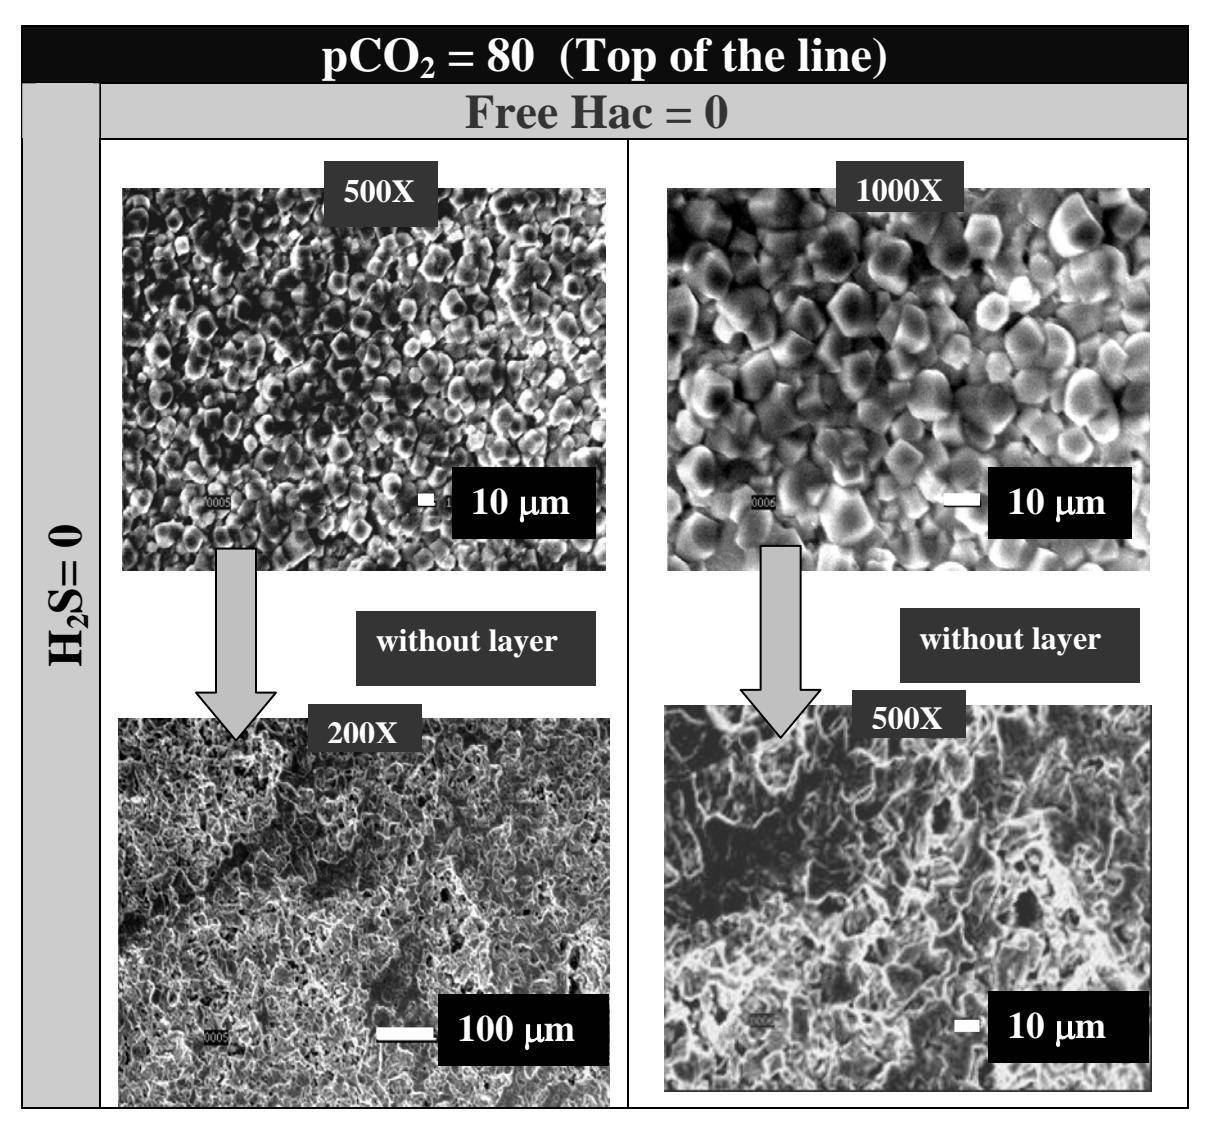
Figure 44. Series II. Top of the line, Test II-0. High temperature, P = 83,  $pCO_2 = 80$ ,  $pH_2S = 0$ , [Hac] = 0,  $V_G = 5$  m/s, high condensation rate, test duration: 4 days (Corrosion rate are presented in Figures 39 to 41)

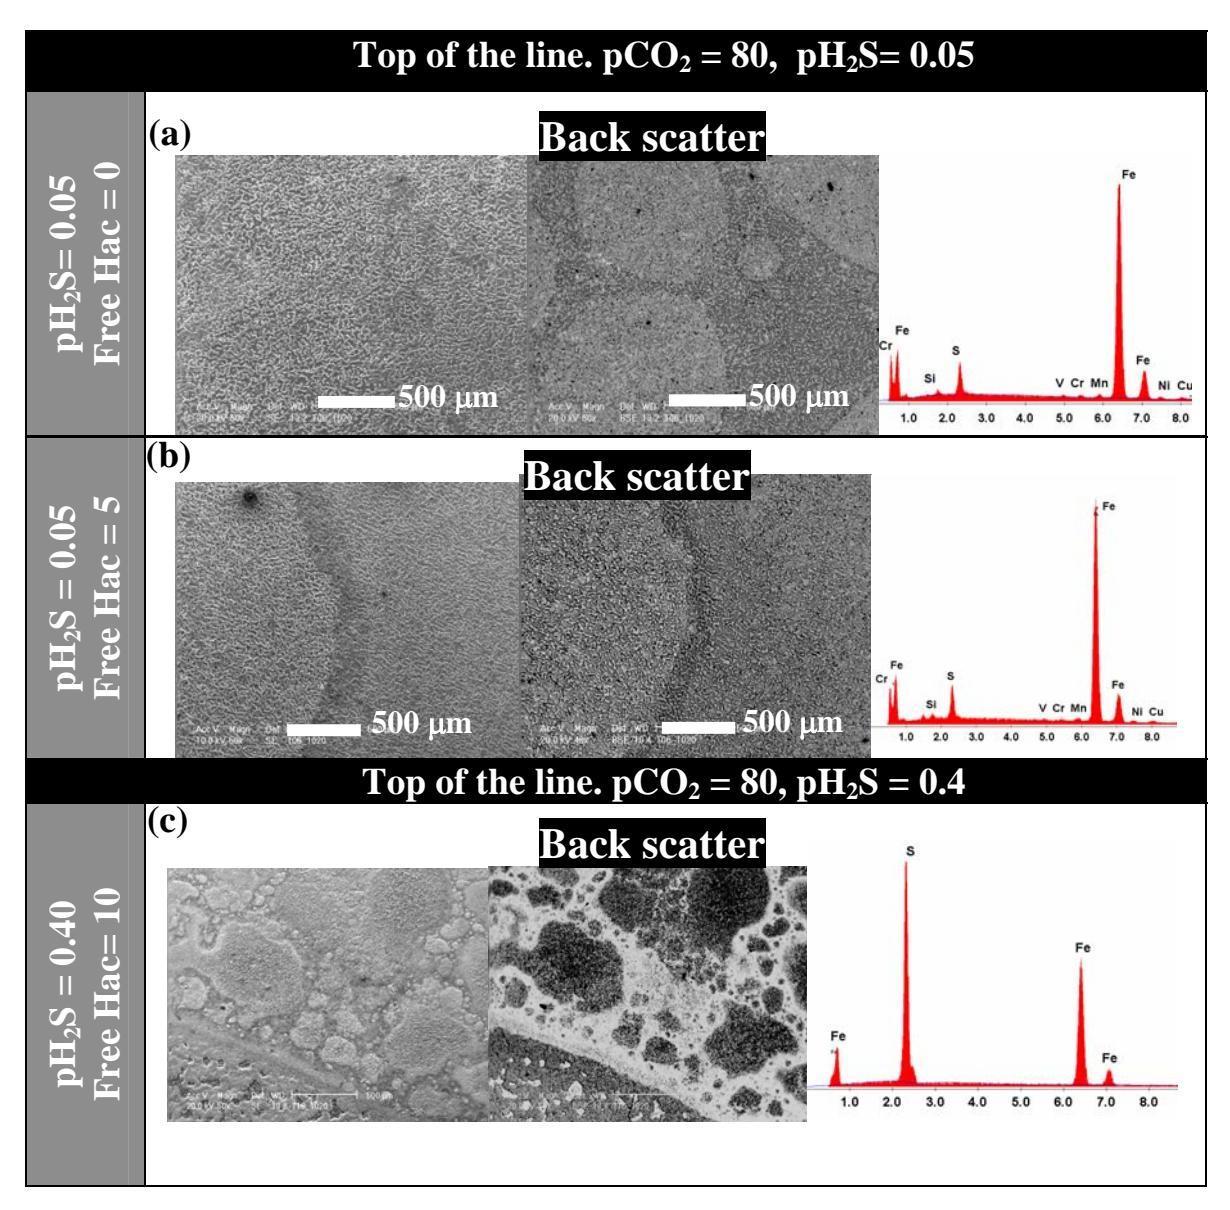
Figure 46. Series II. Backscatter. Top of the line. High temperature, P = 83,  $pCO_2 = 80$ ,  $V_G = 5$  m/s, high condensation rate, test duration: 4 days (Corrosion rate are presented in Figures 39 to 41)

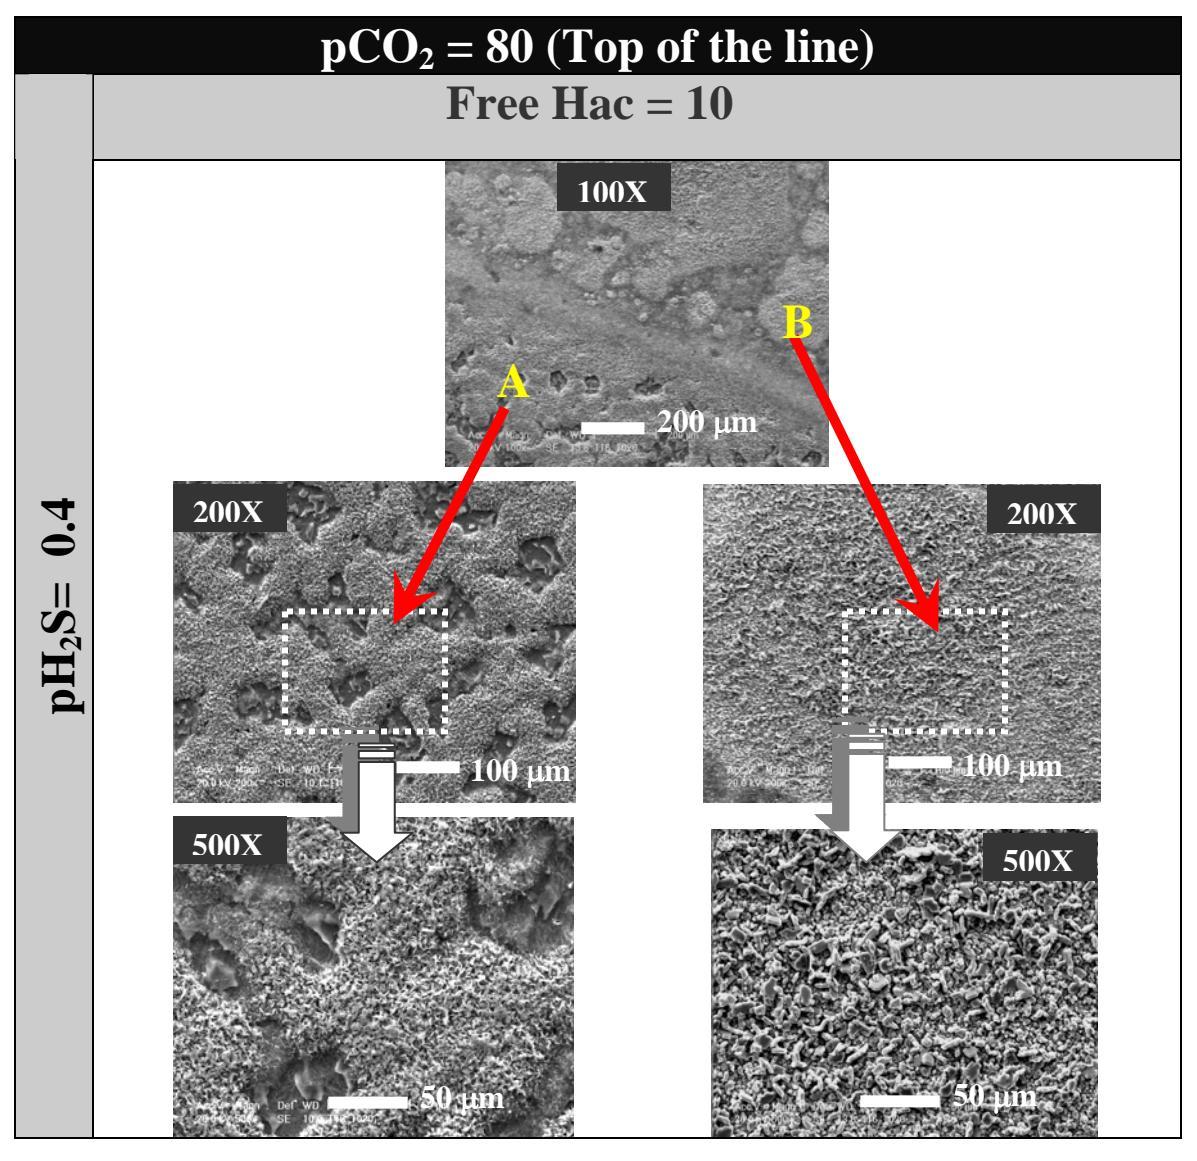
Figure 47. Series II, Experiment II-4. Top of the line. High temperature, P = 83,  $pCO_2 = 80$ ,  $pH_2S = 0.4$ , free [HAc] = 10,  $V_G = 5$  m/s, high condensation rate, test duration: 4 days (Corrosion rate are presented in Figures 39 to 41)

0.05 to 0.4 showing a more porous surface (see Figure 47).
