# $\mathrm{CO}_2$ TOP OF THE LINE CORROSION IN THE PRESENCE OF $\mathrm{H}_2\mathrm{S}$

the Russ College of Engineering and Technology of Ohio University

In partial fulfillment of the requirement for the degree Master of Science

Alvaro Camacho Manuitt

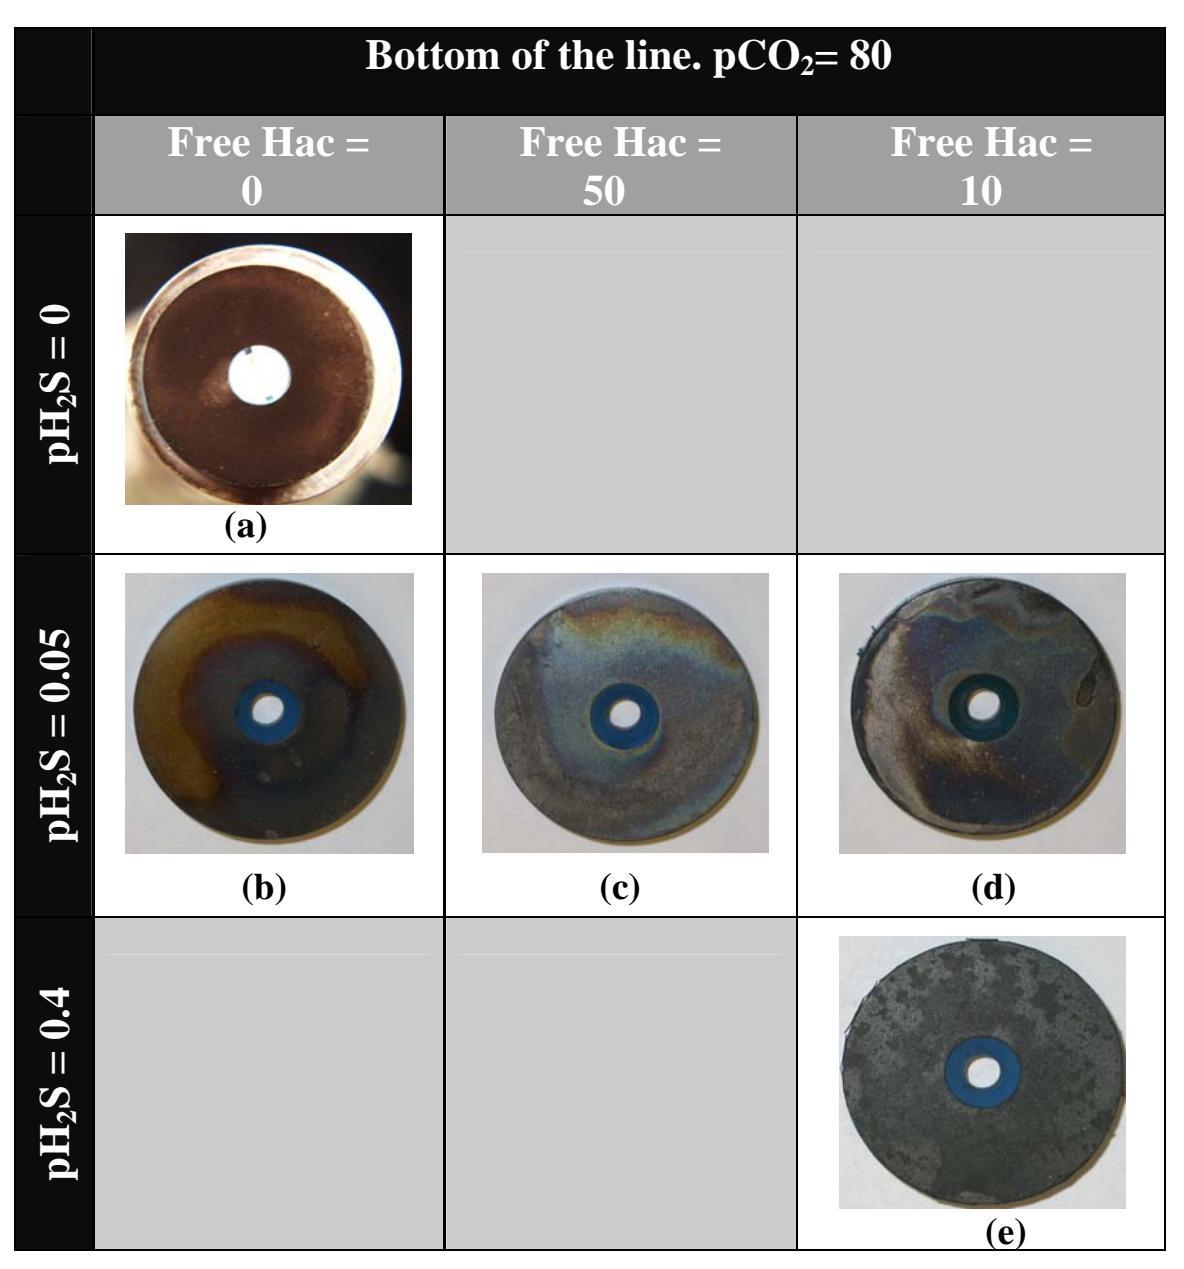
Figure 48. Series II. Morphology of carbon steel AISI 1020 coupons immediately after removal from the loop, tested at the bottom of the line. High temperature, P = 83,  $pCO_2 = 80$ ,  $V_G = 5$  m/s, high condensation rate, test duration: 4 days (Corrosion rate are presented in Figures 39 to 41)

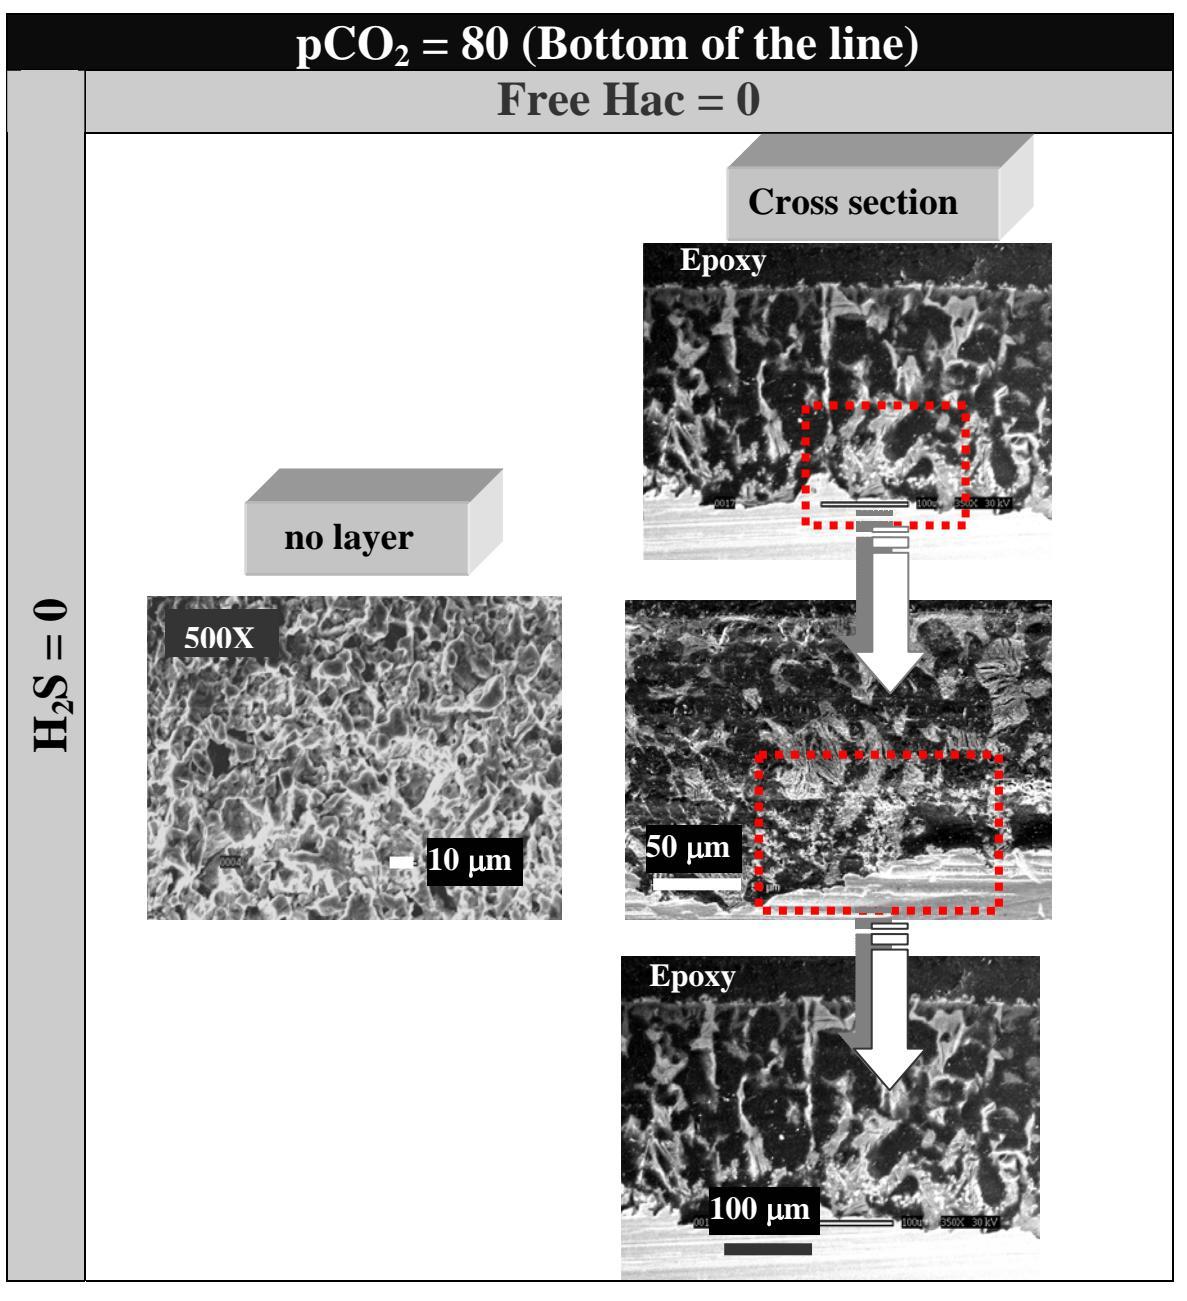
Figure 49. Series II. Cross section of carbon steel AISI 1020 tested at bottom of the line. High temperature, P = 83, pCO<sub>2</sub> = 80, pH<sub>2</sub>S = 0, free [HAc] = 0, V<sub>G</sub> = 5 m/s, high condensation rate, test duration: 4 days (Corrosion rate are presented in Figures 39 to 41)

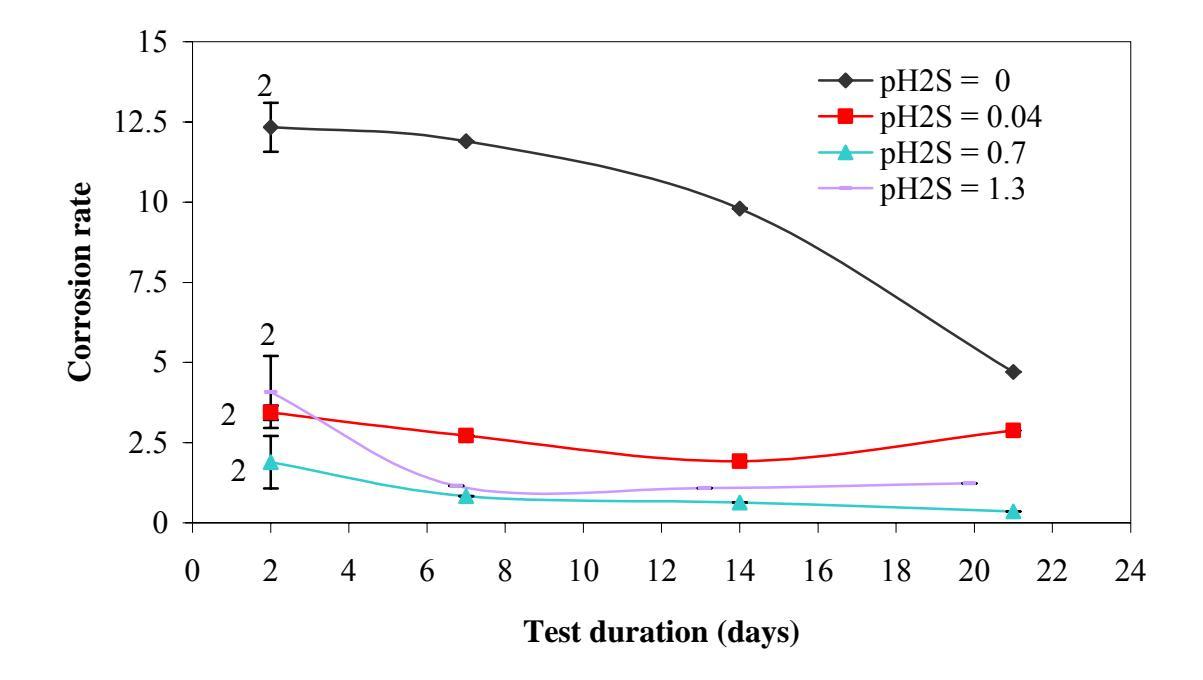
Figure 51. Series III, Effect of the H<sub>2</sub>S concentration at the top of the line. High temperature, P = 30,  $pCO_2 = 20$ ,  $V_G = 5$  m/s, high condensation rate (Surface analyses are presented in Figures 61 to 74)

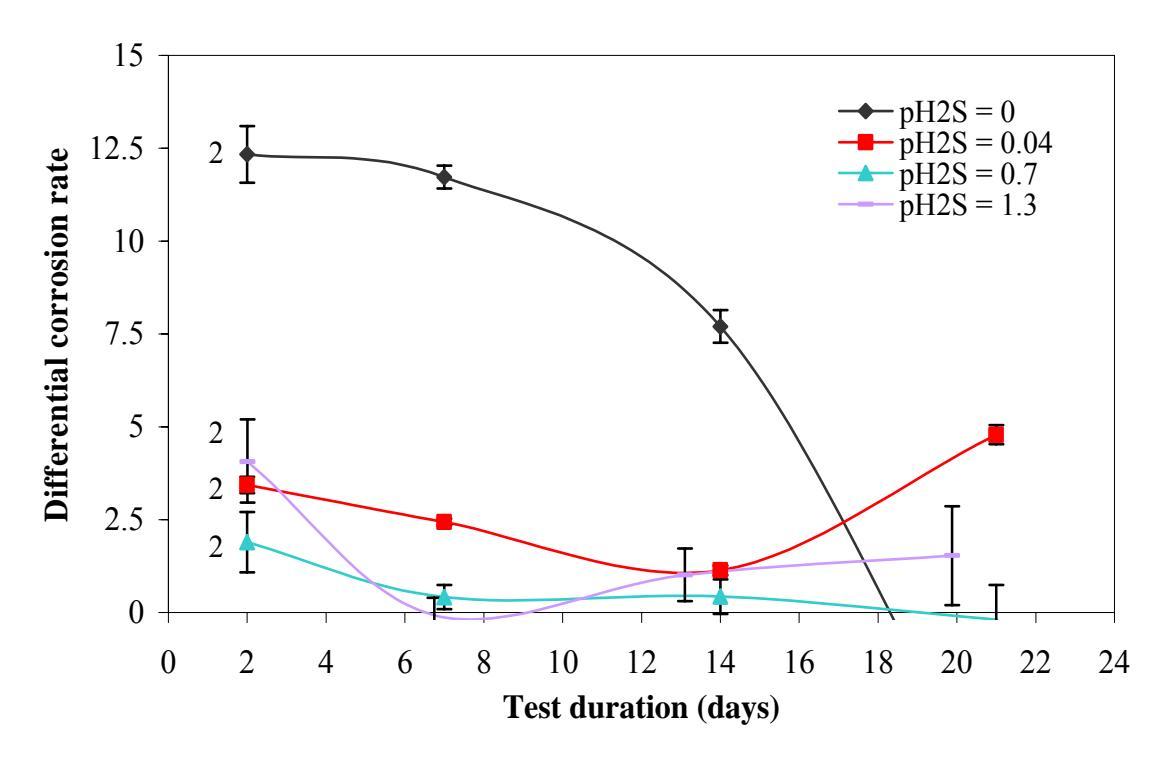
Figure 53. Series III, Differential corrosion rate. Effect of the H<sub>2</sub>S concentration at the top of the line. High temperature, P = 30,  $pCO_2 = 20$ ,  $V_G = 5$  m/s, high condensation rate (Surface analyses are shown in Figures 61 to 74)

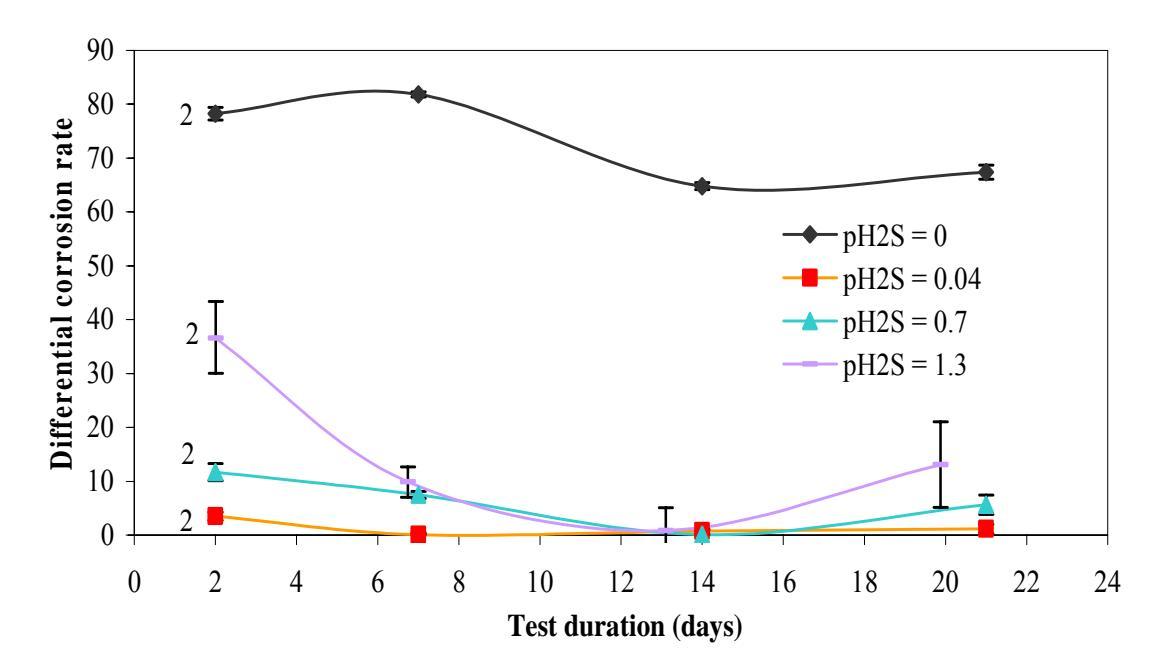
Figure 54. Series III, Differential corrosion rate. Effect of the H<sub>2</sub>S concentration at the bottom of the line. High temperature, P = 30,  $pCO_2 = 20$ ,  $V_G = 5$  m/s, high condensation rate (Surface analyses are shown in Figures 75 to 89)

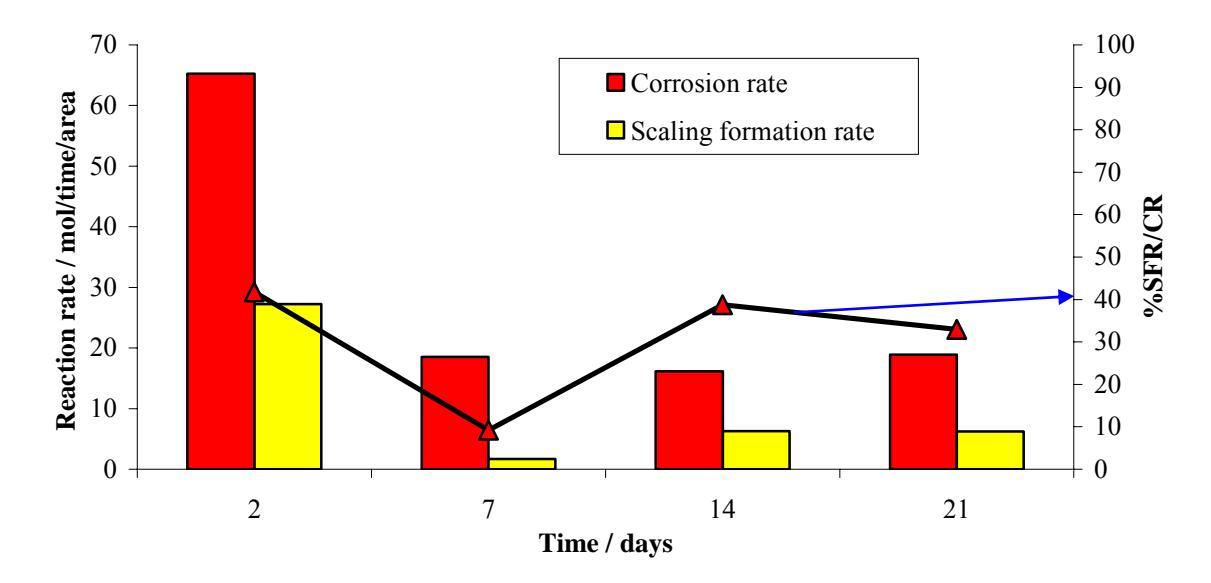
Figure 57. Series III, Experiment III-3. Top of the line. Rate of reaction with time. High temperature, P = 30,  $pCO_2 = 20$ ,  $pH_2S = 1.30$ ,  $V_G = 5$  m/s, high condensation rate (Surface analyses presented in Figure 64, 73 - 75)

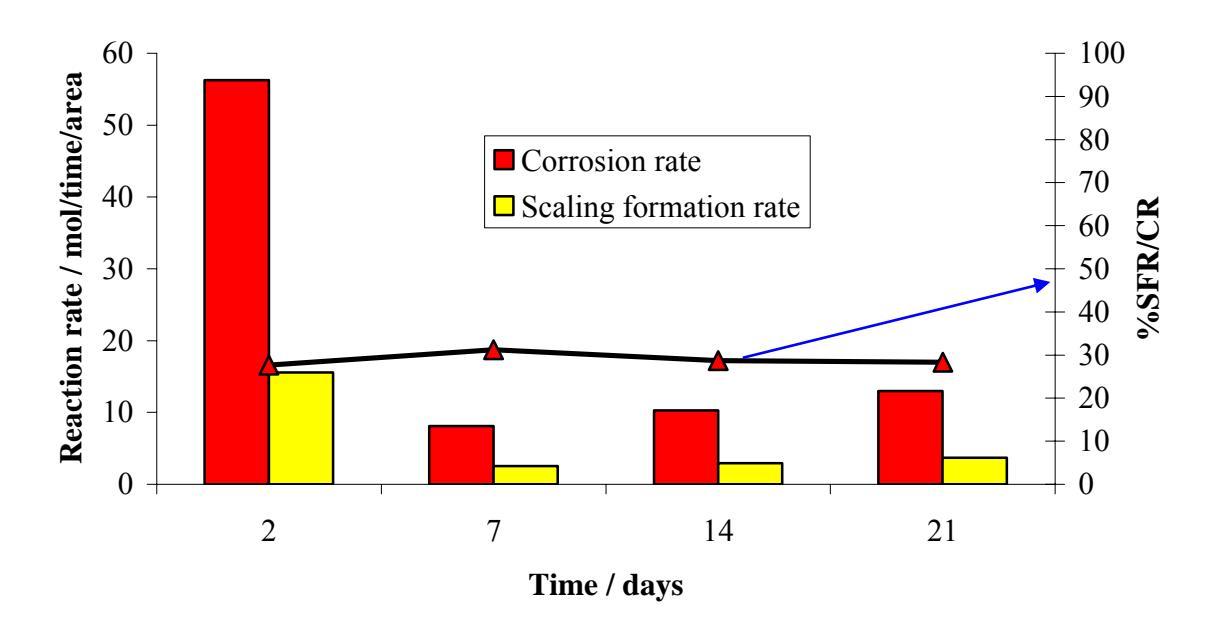
Figure 58. Series III, Experiment III-1. Bottom of the line. Rate of reaction with time. High temperature, P = 30, pCO<sub>2</sub> = 20, pH<sub>2</sub>S = 1.3, V<sub>G</sub> = 5 m/s, high condensation rate (Surface analyses are presented in Figures 77, 82 - 84)

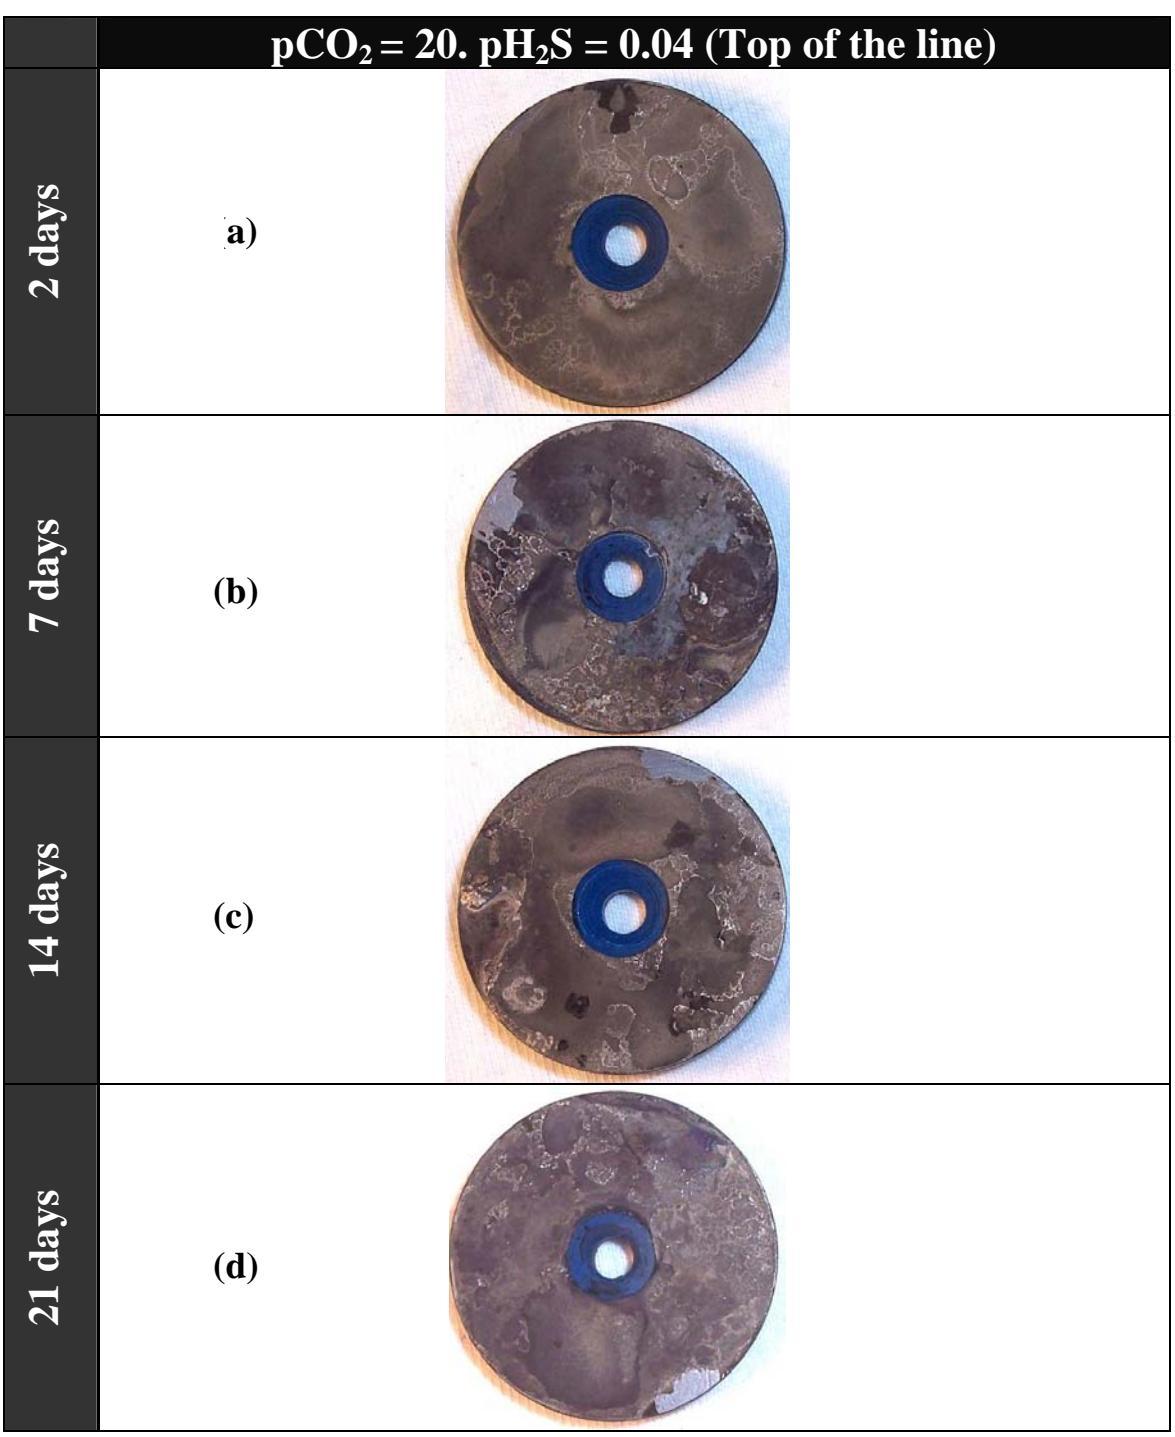
Figure 62. Series III, Experiment III-1. Morphology of carbon steel API X-65 coupons immediately after removal from the loop, tested at the top of the line. High temperature, P = 30,  $pCO_2 = 20$ ,  $pH_2S = 0.04$ ,  $V_G = 5$  m/s, high condensation rate (Corrosion rates are presented in Figures 51, 53 and 55)

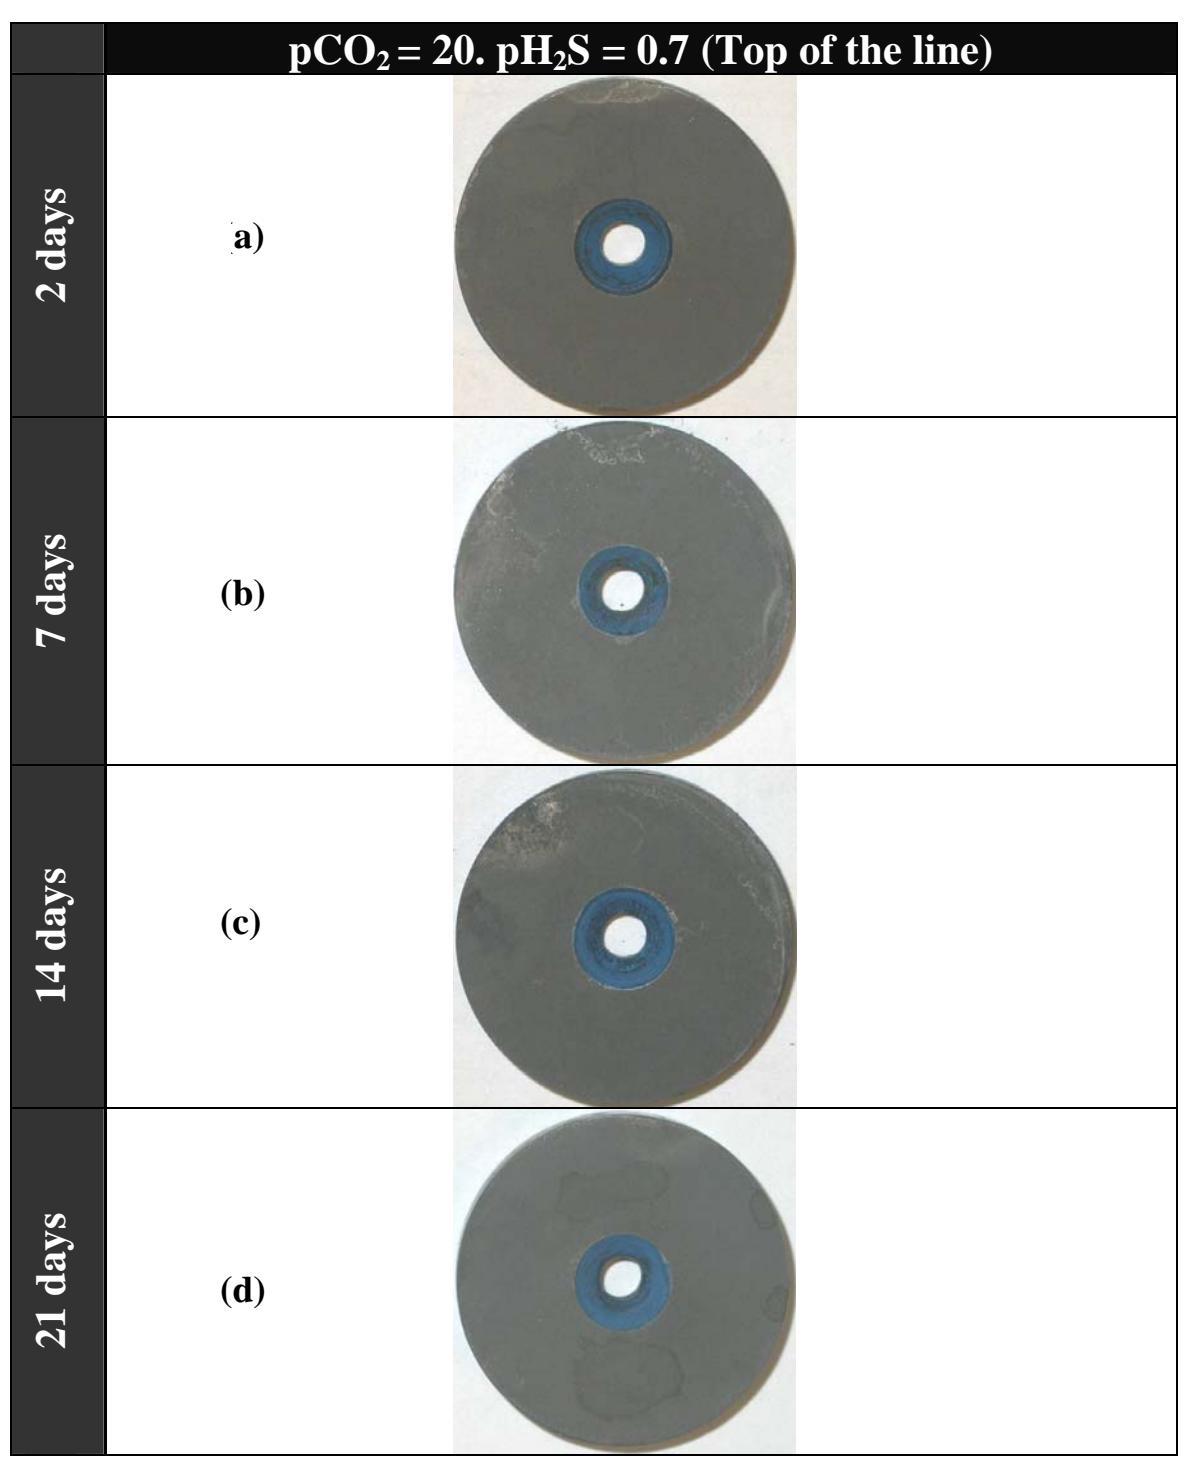
Figure 63. Series III, Experiment III-2. Morphology of carbon steel API X-65 coupons immediately after removal from the loop, tested at the top of the line. High temperature, P = 30,  $pCO_2 = 20$ ,  $pH_2S = 0.70$ ,  $V_G = 5$  m/s, high condensation rate (Corrosion rates are presented in Figures 51, 53 and 56)

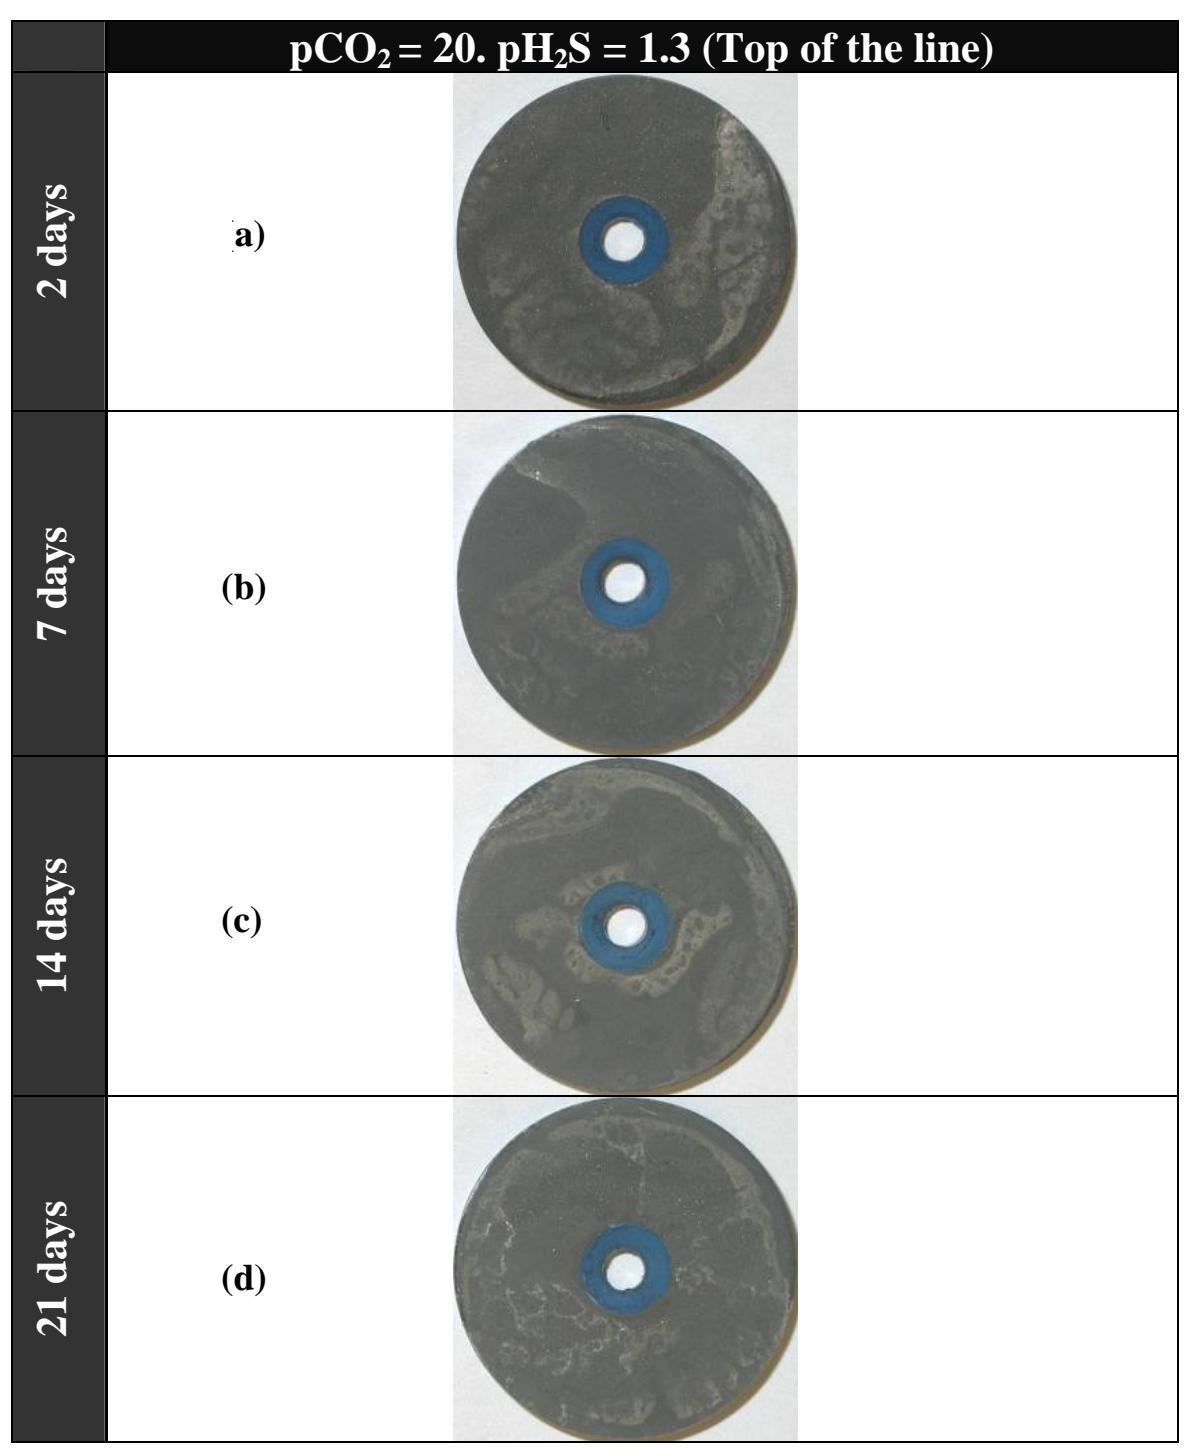
Figure 64. Series III, Experiment III-3. Morphology of carbon steel API X-65 coupons immediately after removal from the loop, tested at the top of the line. High temperature, P = 30,  $pCO_2 = 20$ ,  $pH_2S = 1.3$ ,  $V_G = 5$  m/s, high condensation rate (Corrosion rates are presented in Figures 51, 53 and 57)

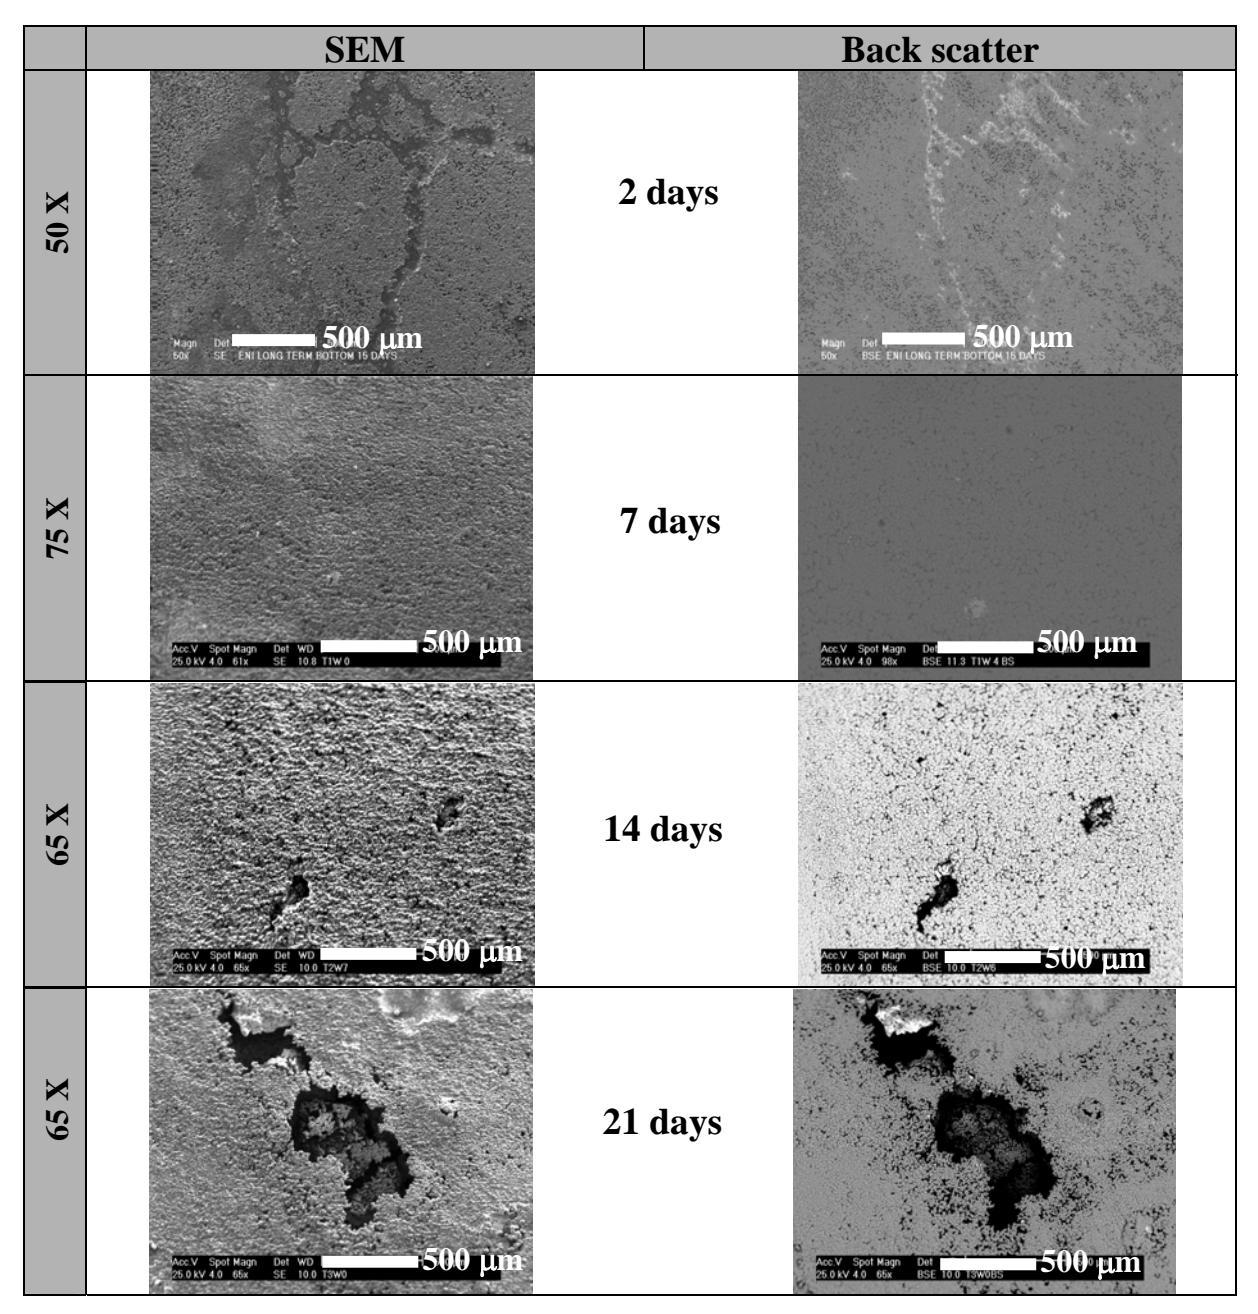
Figure 65. Series III, Experiment III-0. SEM and Backscatter images. Top of the line. High temperature, P = 30,  $pCO_2 = 20$ ,  $pH_2S = 0$ ,  $V_G = 5$  m/s, high condensation rate (Corrosion rates are presented in Figures 51a and 53)

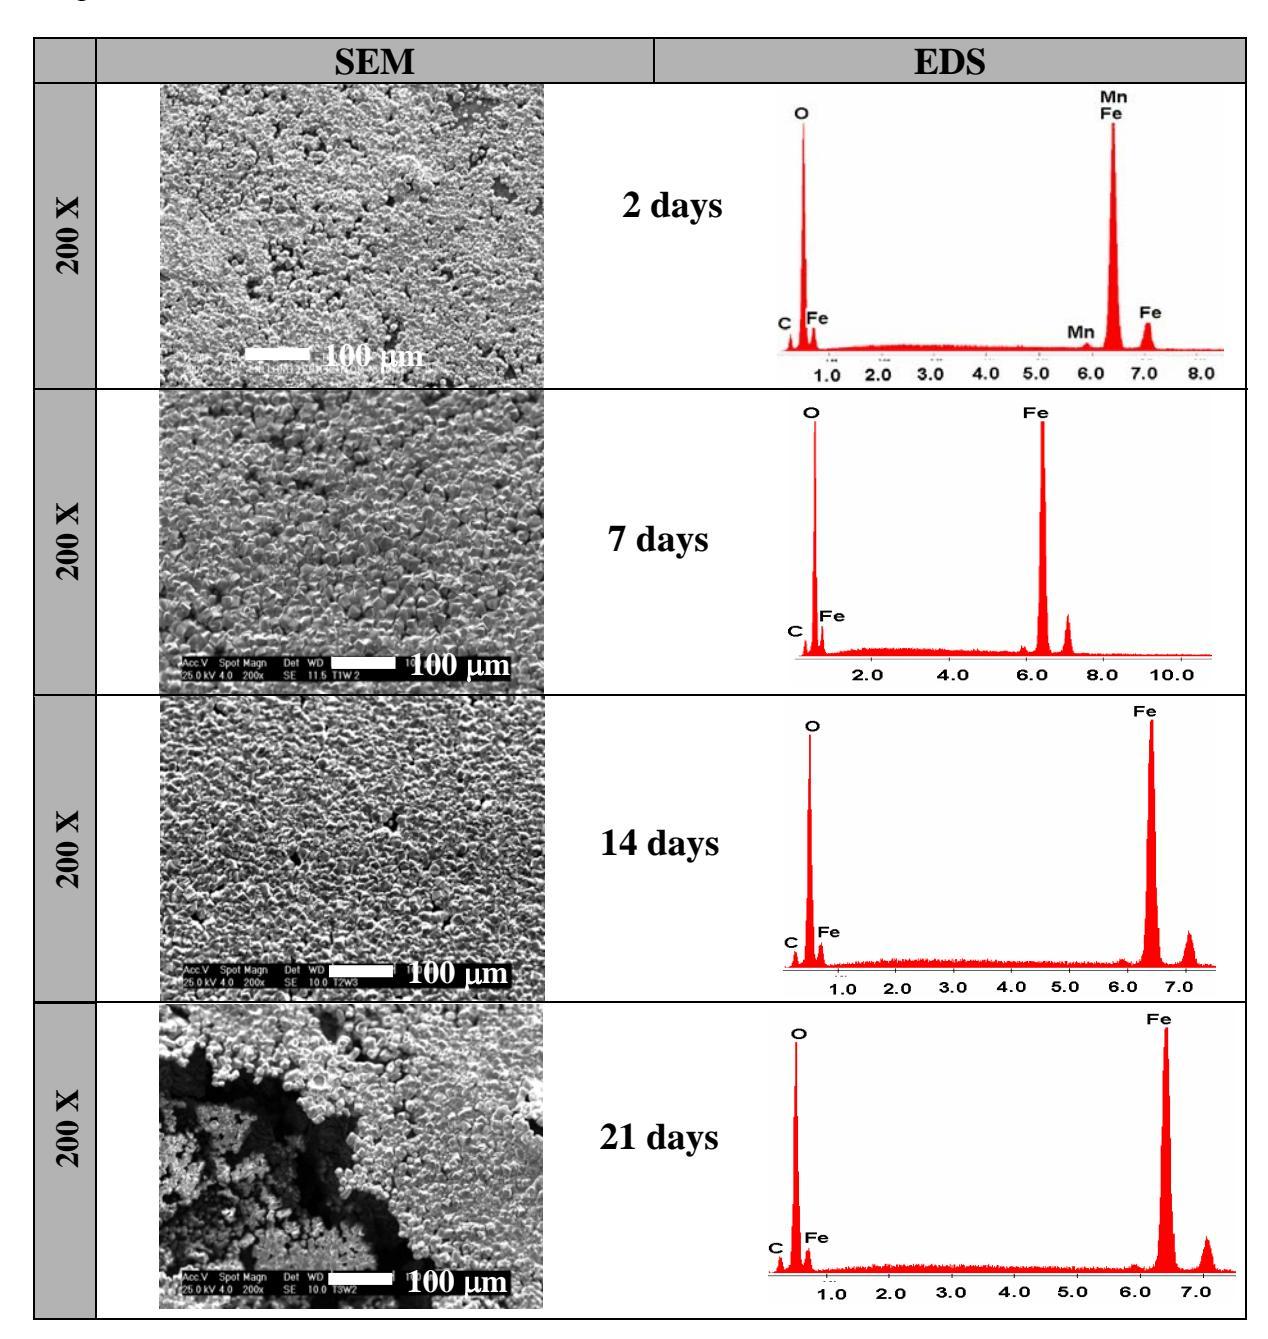
Traces of localized corrosion can be observed very clearly on both coupons exposed to the  $CO_2$  environment with no  $H_2S$ .

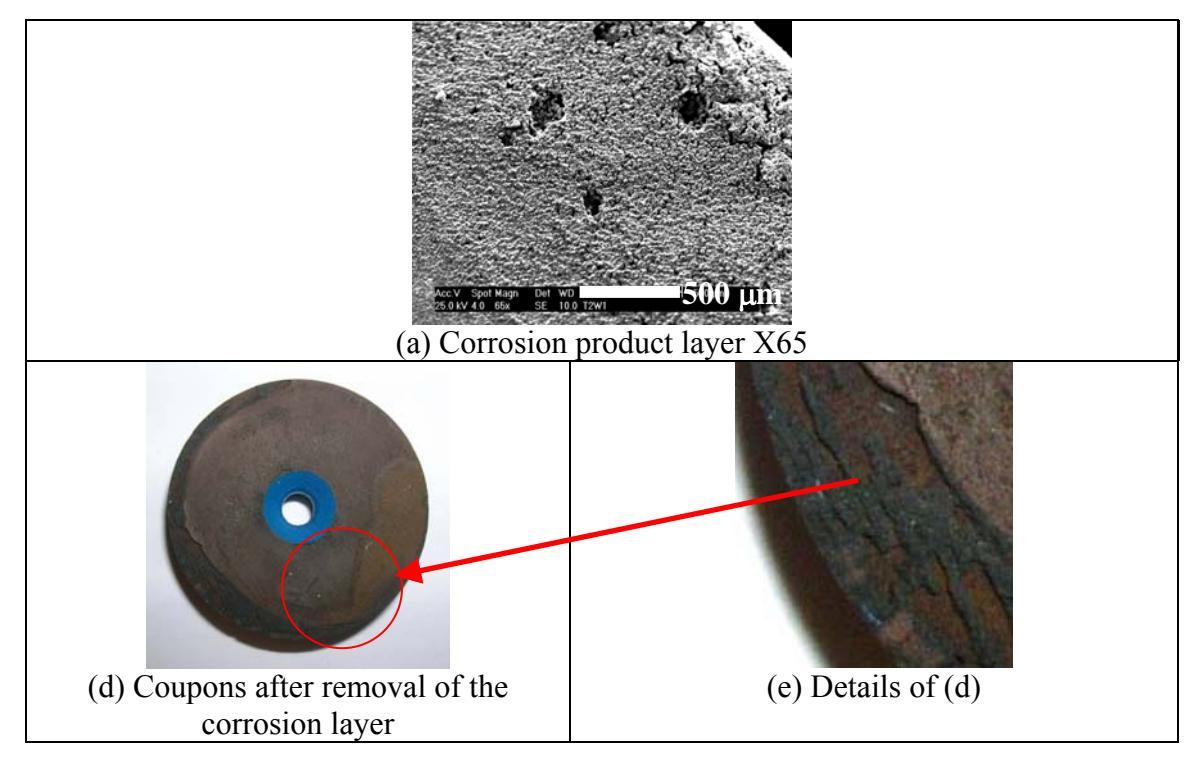
Figure 67. Series III, Experiment III-0. SEM and EDS analysis. Top of the line. High temperature, P = 30,  $pCO_2 = 20$ ,  $pH_2S = 0$ ,  $V_G = 5$  m/s, high condensation rate (Corrosion rates are presented in Figures 51 and 53)

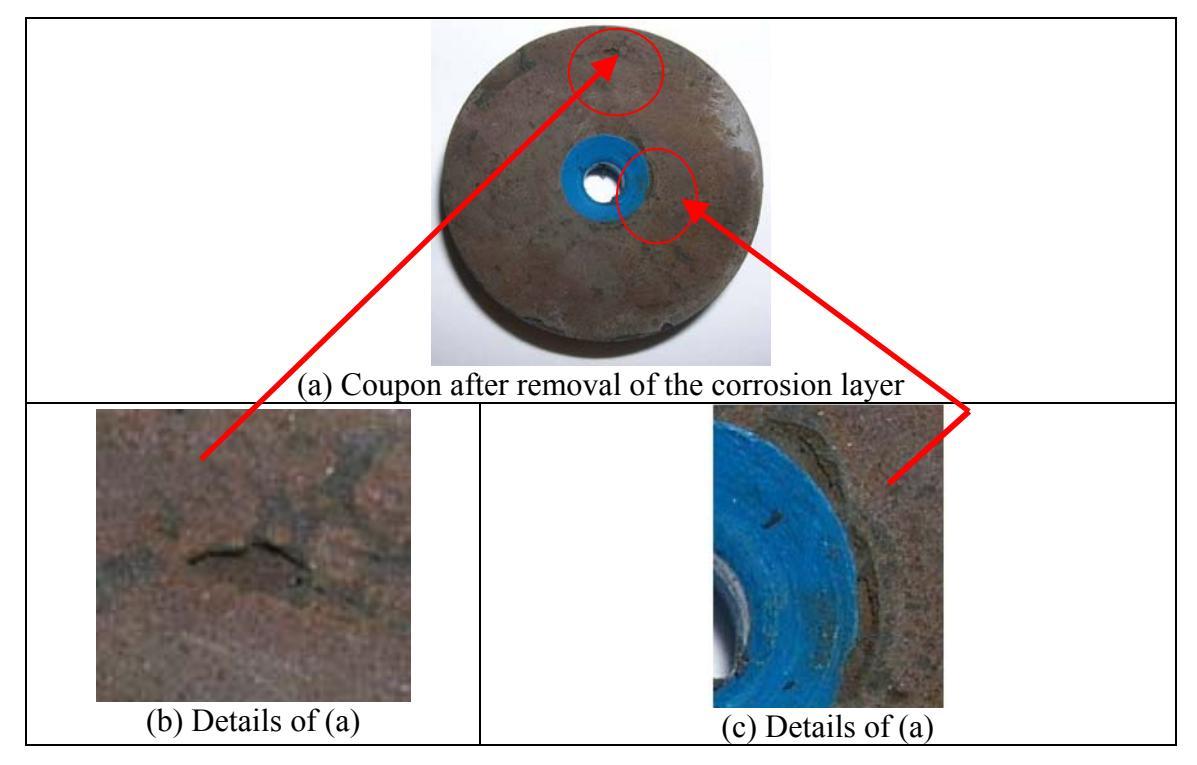
Figure 68. Series III, Experiment III-0. SEM and EDS analysis. Top of the line. High temperature, P = 30,  $pCO_2 = 20$ ,  $pH_2S = 0$ ,  $V_G = 5$  m/s, high condensation rate (Corrosion rates are presented in Figures 51 and 53)

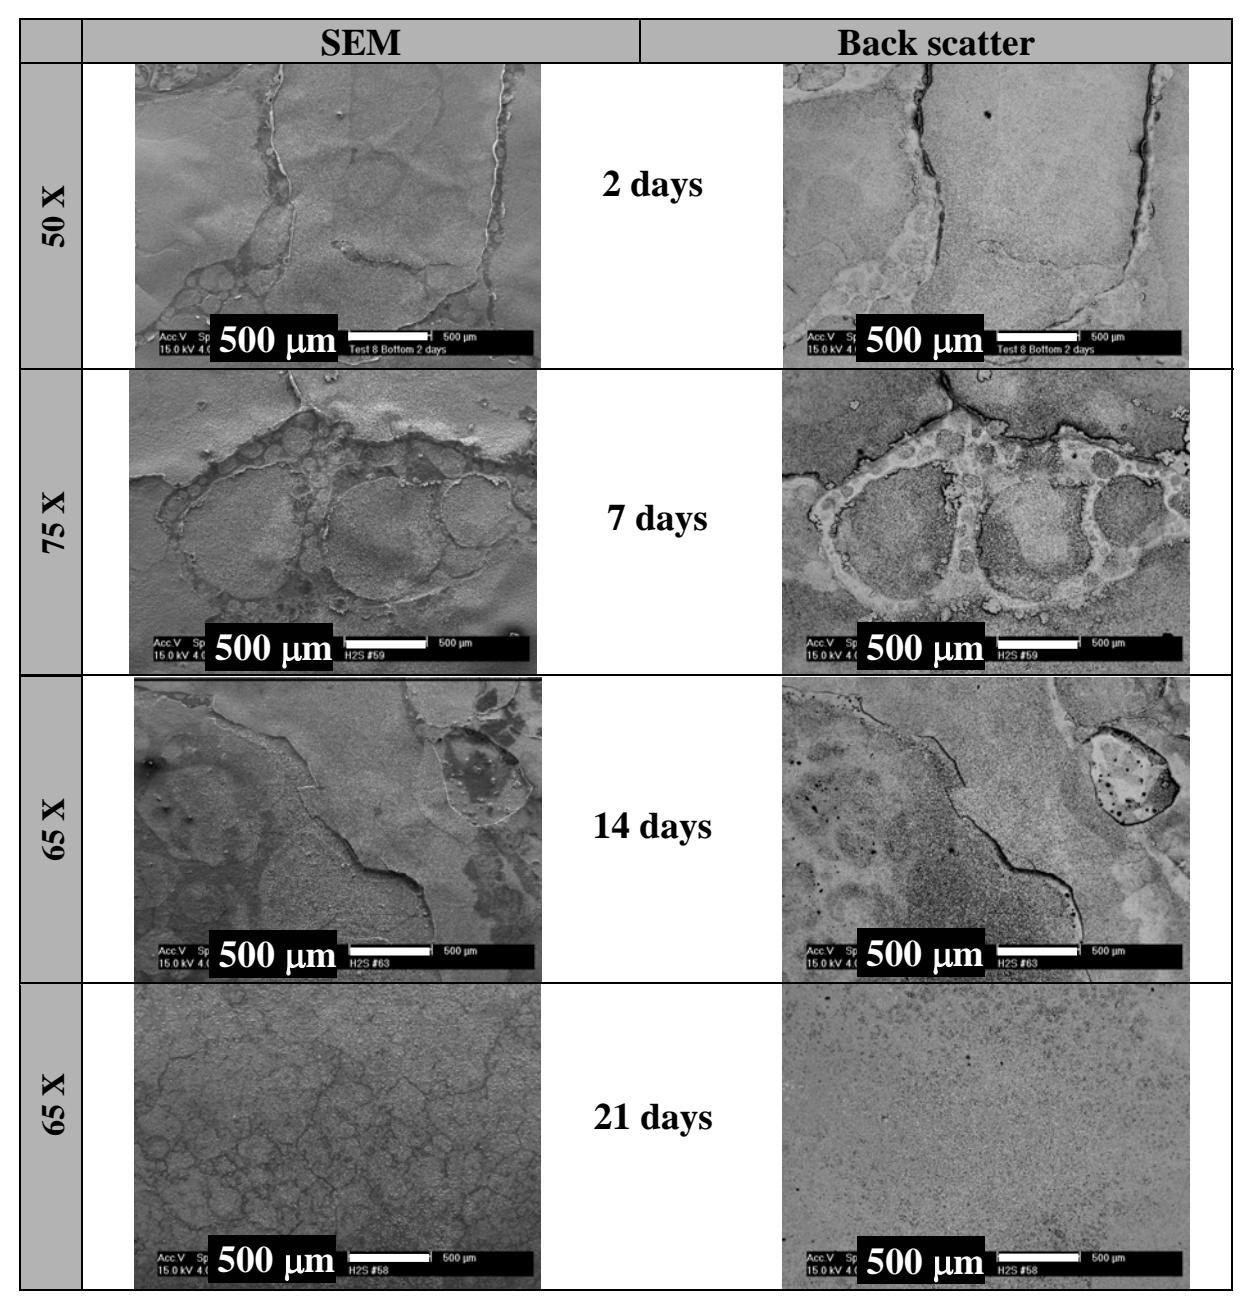
Figure 69. Series III, Experiment III-1. SEM and Backscatter images. Top of the line. High temperature, P = 30,  $pCO_2 = 20$ ,  $pH_2S = 0.04$ ,  $V_G = 5$  m/s, high condensation rate (Corrosion rates are presented in Figures 51, 53 and 55)

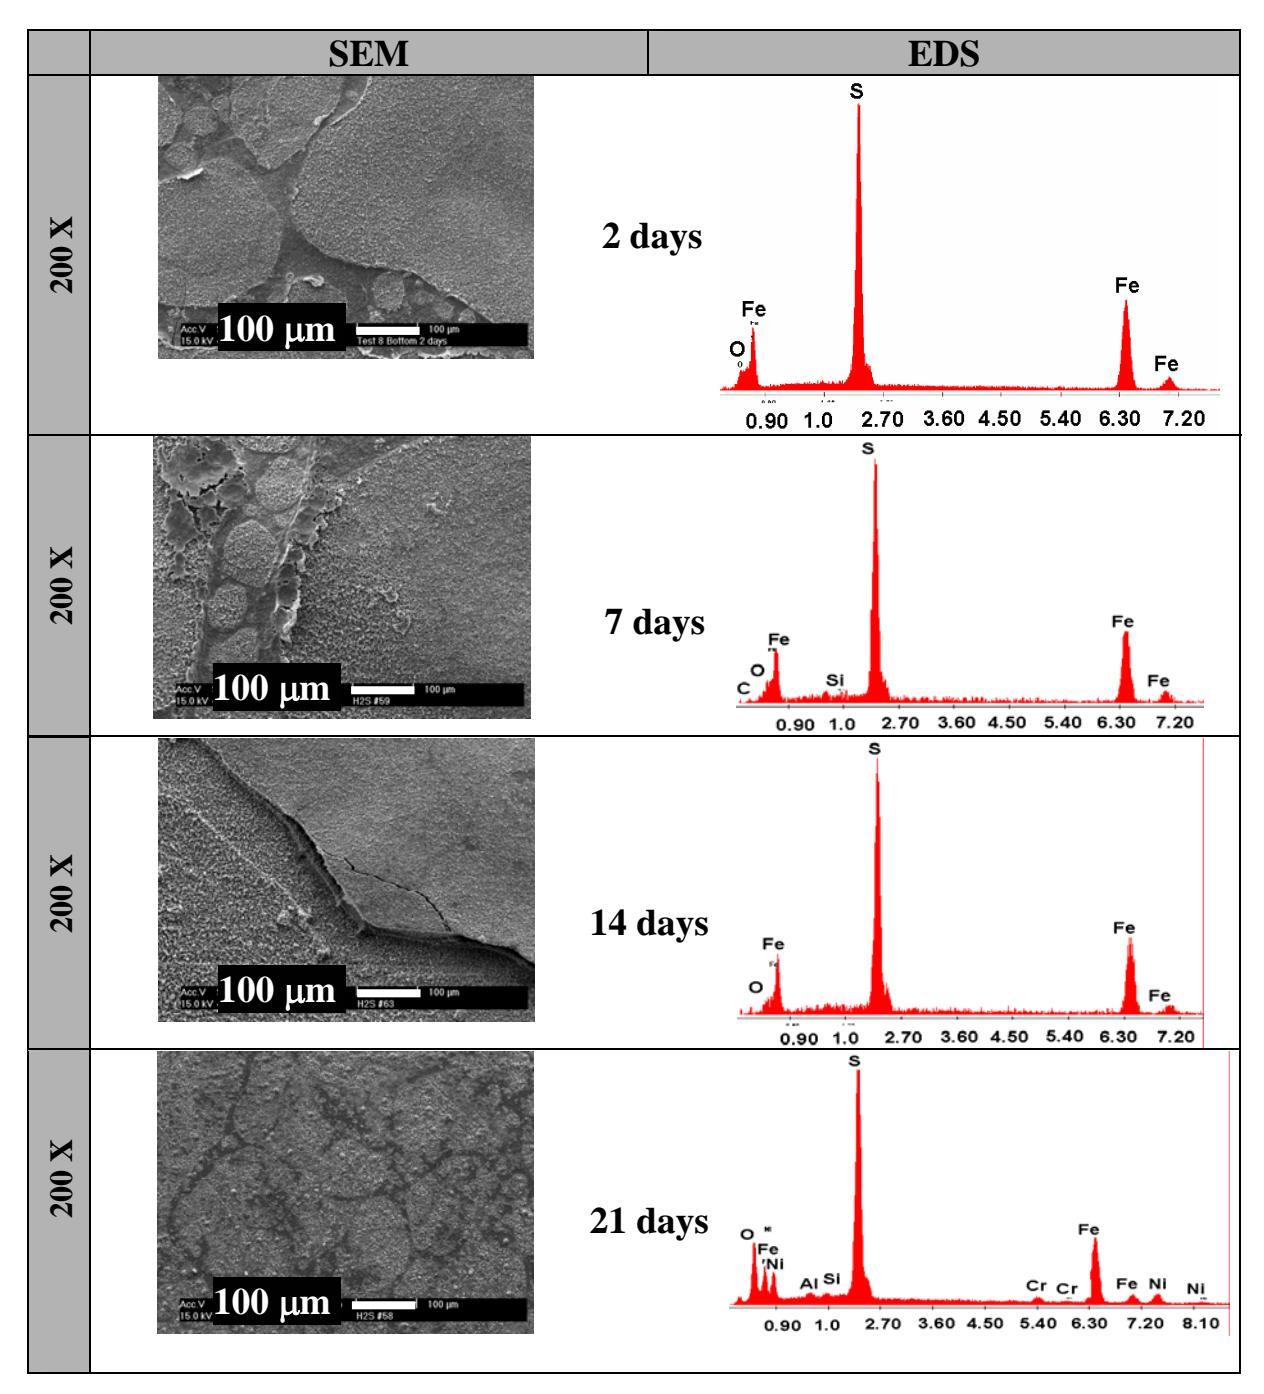
Moreover, EDS analysis shows the presence of sulfur and iron but do not indicate the presence of FeCO<sub>3</sub>.
