# $\mathrm{CO}_2$ TOP OF THE LINE CORROSION IN THE PRESENCE OF $\mathrm{H}_2\mathrm{S}$

the Russ College of Engineering and Technology of Ohio University

In partial fulfillment of the requirement for the degree Master of Science

Alvaro Camacho Manuitt

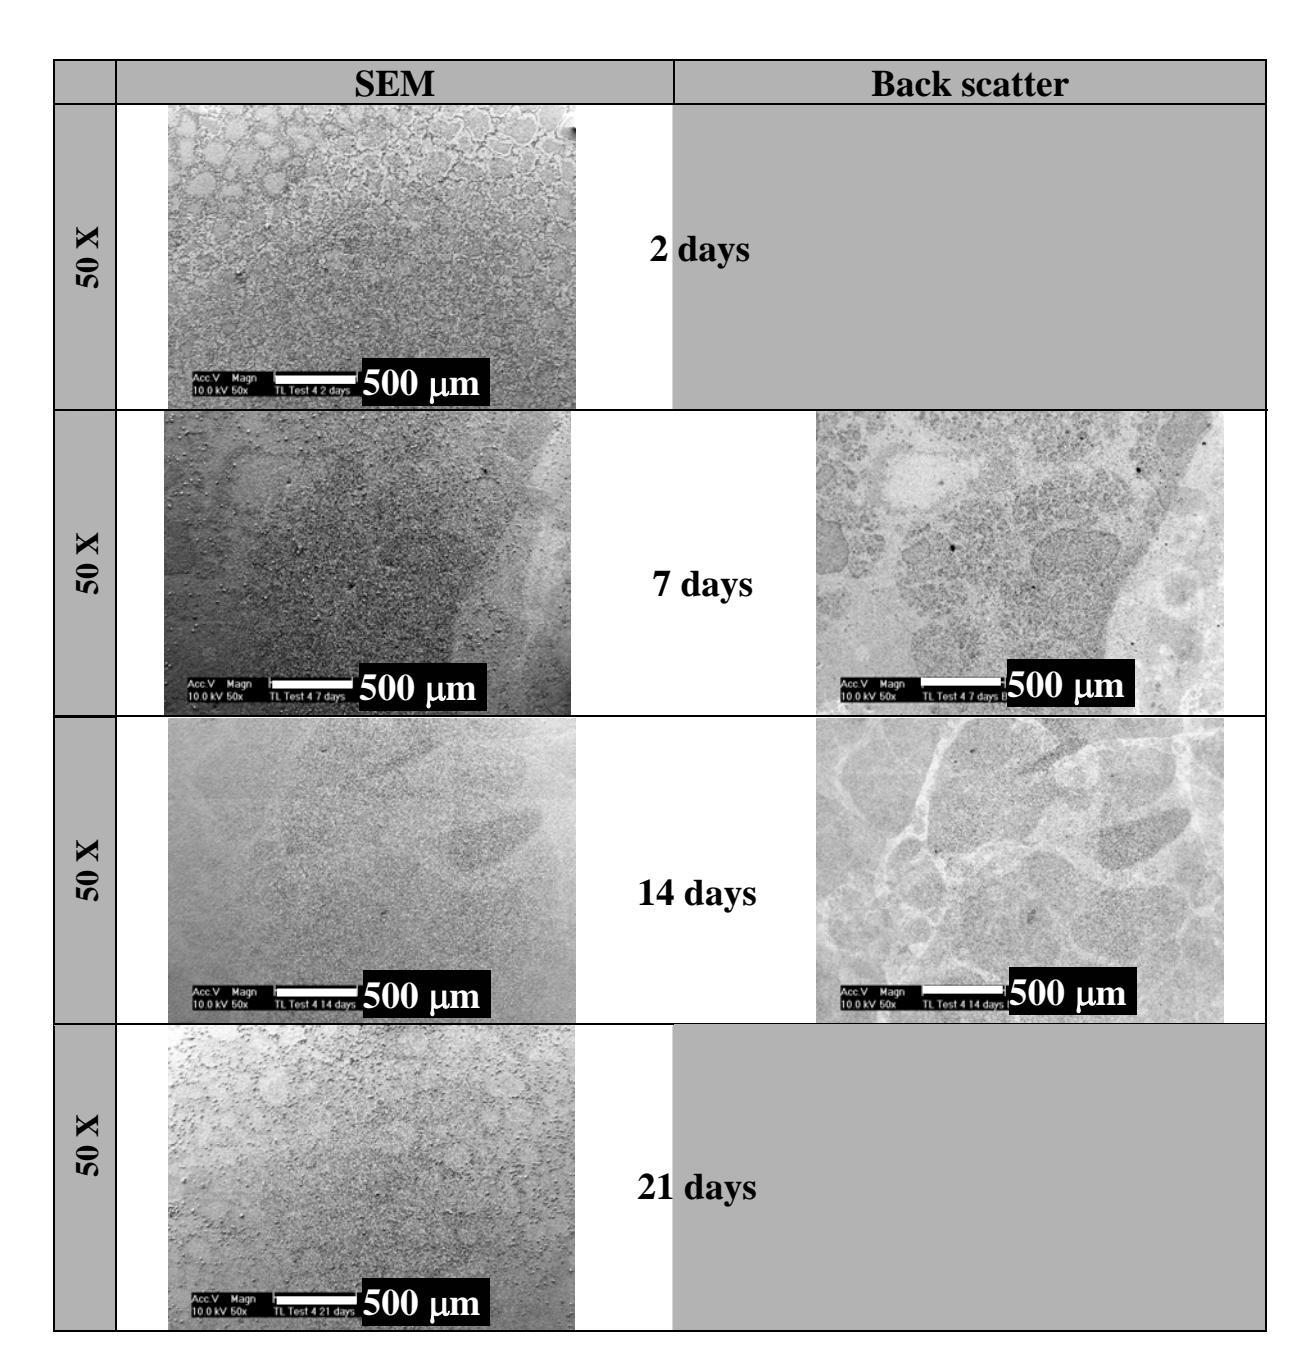
Figure 71. Series III, Experiment III-2. SEM and Backscatter images. Top of the line. High temperature, P = 30,  $pCO_2 = 20$ ,  $pH_2S = 0.7$ ,  $V_G = 5$  m/s, high condensation rate (Corrosion rates are presented in Figures 51, 53 and 56)

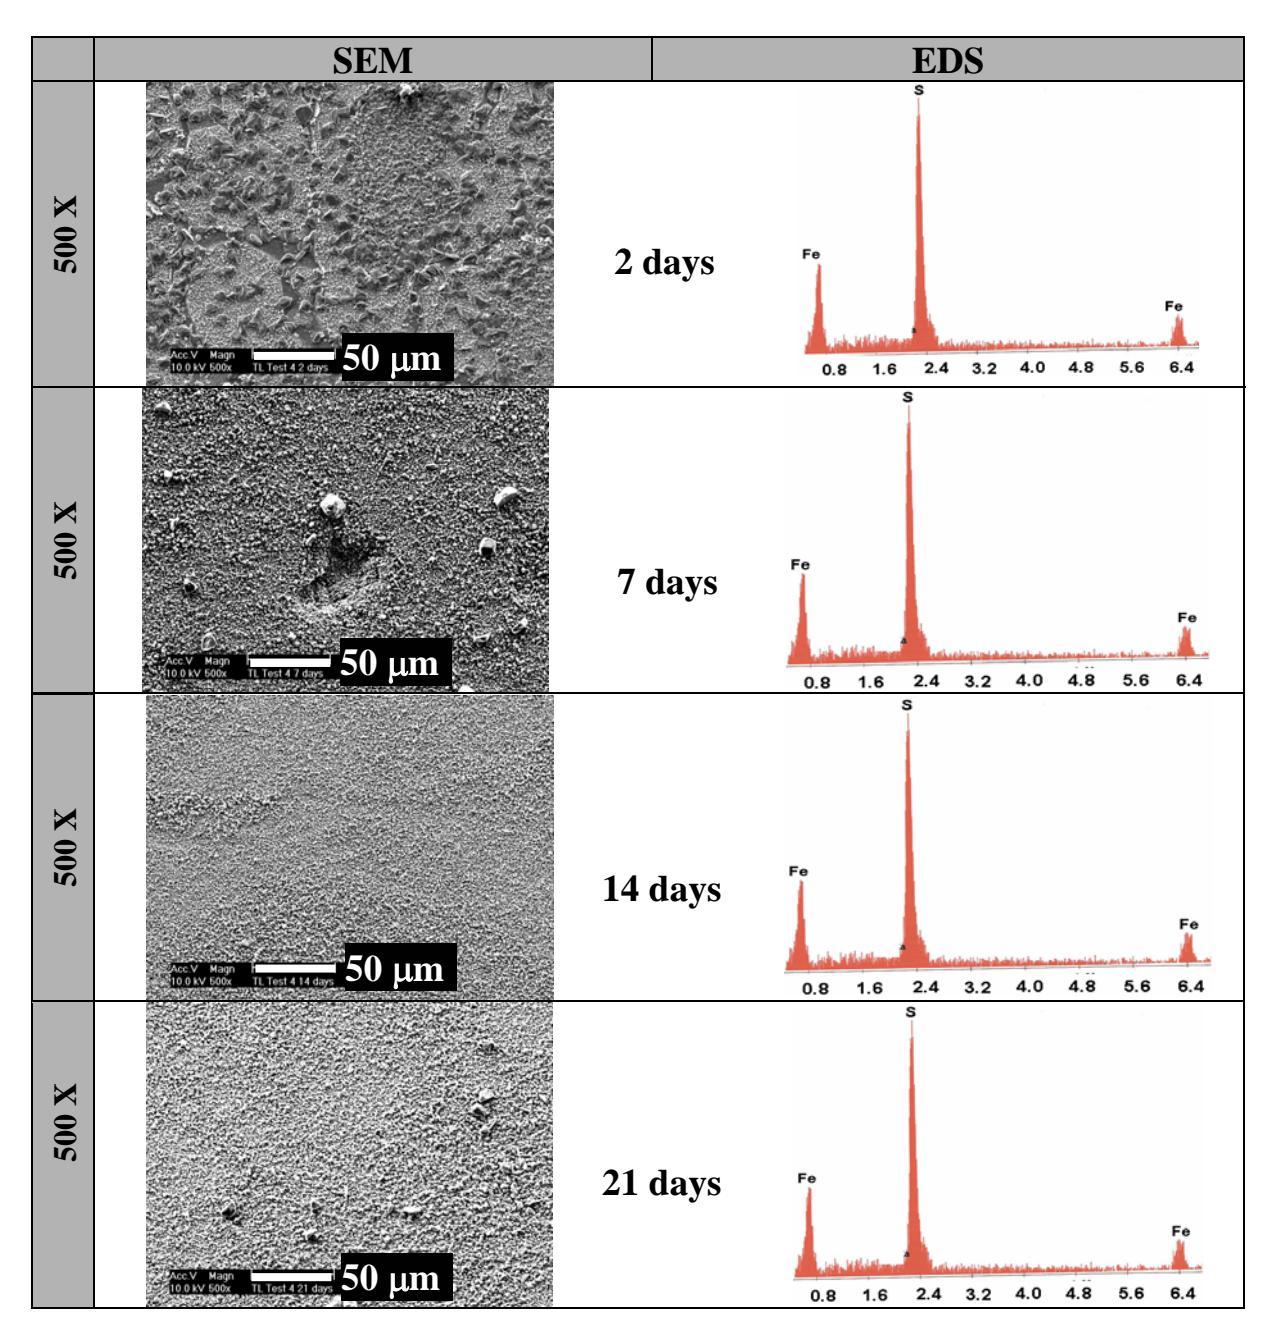
Figure 72. Series III, Experiment III-2. SEM and EDS analysis. Top of the line. High temperature, P = 30,  $pCO_2 = 20$ ,  $pH_2S = 0.7$ ,  $V_G = 5$  m/s, high condensation rate (Corrosion rates are presented in Figures 51, 53 and 56)

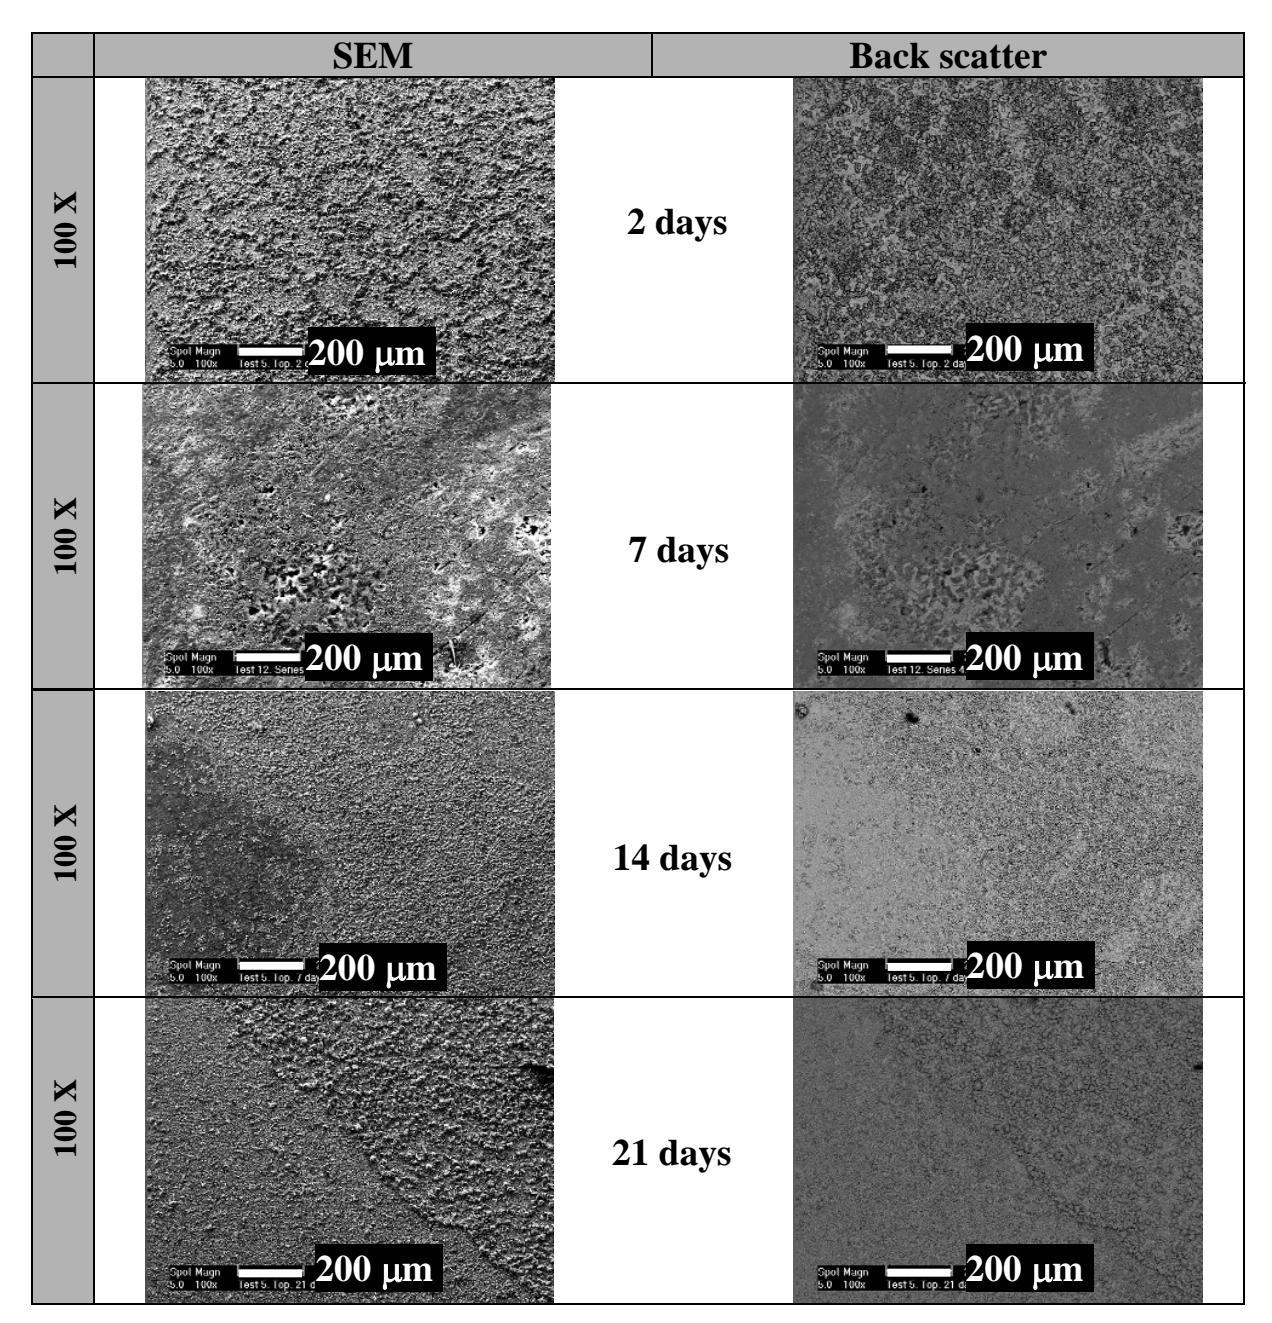
Figure 73. Series III, Experiment III-3. SEM and Backscatter images. Top of the line. High temperature, P = 30,  $pCO_2 = 20$ ,  $pH_2S = 1.3$ ,  $V_G = 5$  m/s, high condensation rate (Corrosion rates are presented in Figures 51, 53 and 57)

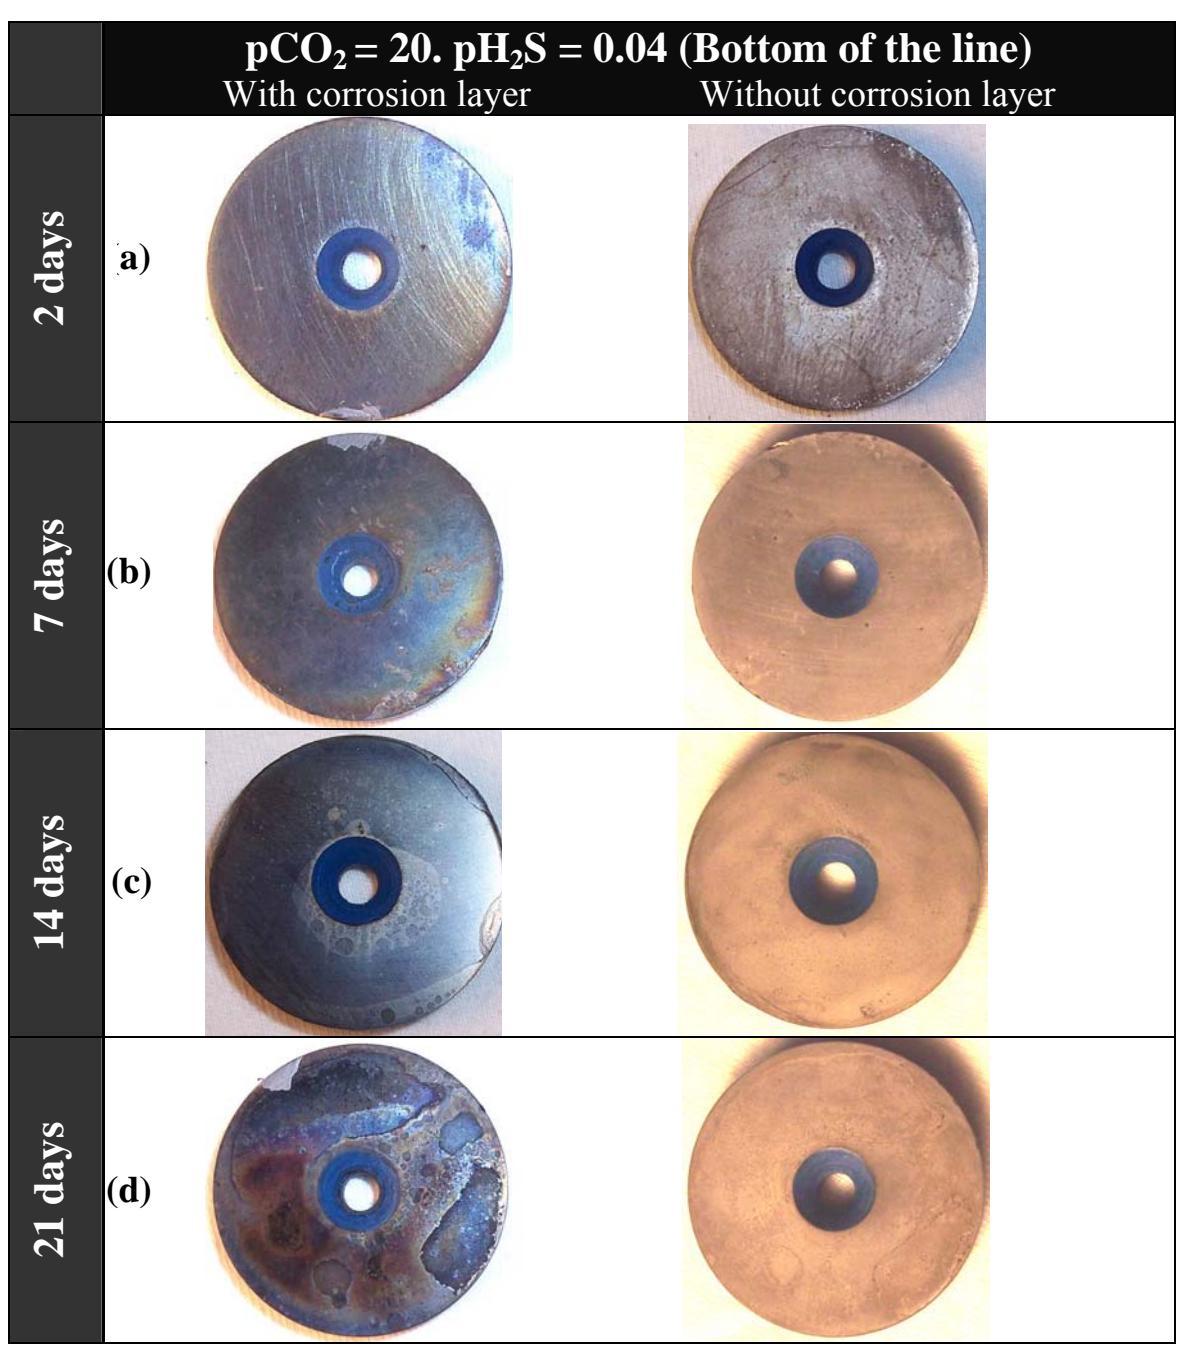
During the test, the layer may have been under mechanical stress due to the thickness increase and may have cracked, allowing large sheets of the top layer to peel away.
